JULY 2004

Peer Review of Asset Maintenance Standards

Waikanae & Otaki Rivers

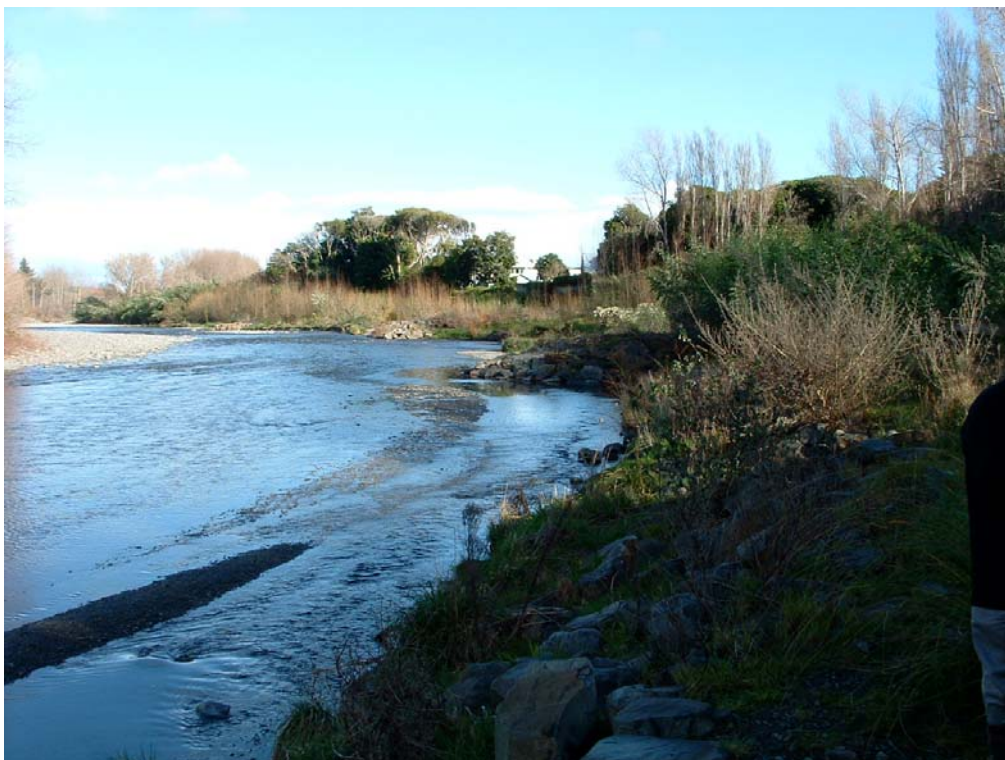
5.1 Sunny Glen rock groynes

The present rock groynes and rock lining appeared to have consolidated well and were in good condition. Only the groyne no 5 appeared to have lost some toe rock which could be easily rectified under the annual maintenance programme. The natives and willows planted between the groynes in the reclaimed area had consolidated well and were in good condition. The review team endorse the actions taken at this vulnerable site to repair flood damage and improve the protection standard for the houses nearby.

Condition rating for all groynes and toe rock lining is 2 except groyne No 5 which is given a rating of 3.

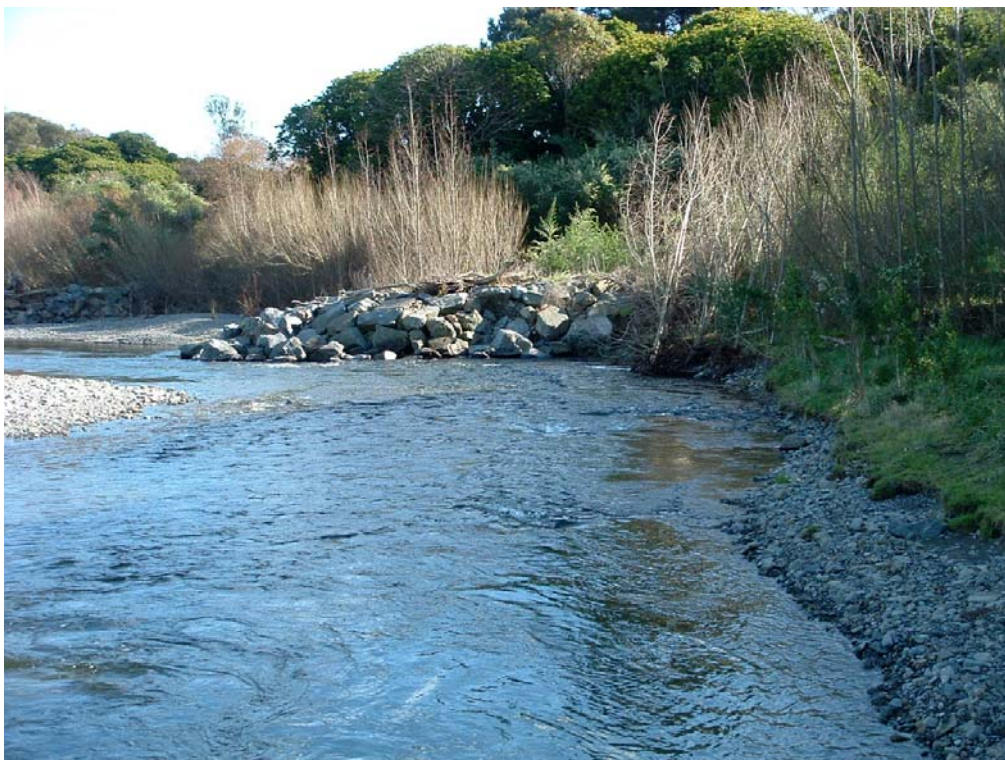
5.2 Maple Lane rock groynes

Overall the rock groynes were in good condition. However groyne no 2 & 3 appeared to have lost some rock especially at the toe and needed replacement. Some willow trees planted above the groyne number 3 were being undermined. Reviewers agree with the plans to plant more willow trees between groynes and to realign the river to satisfy the design alignment requirements. Reviewers would suggest that the actual design alignment may require some review. Reviewers reckon addition of another groyne between groyne no 2 and 3 would enhance the protection standard and prevent the undermining of planted willows.

Condition rating for all rock groynes is 2 except for groyne Nos 2 & 3 which are rated

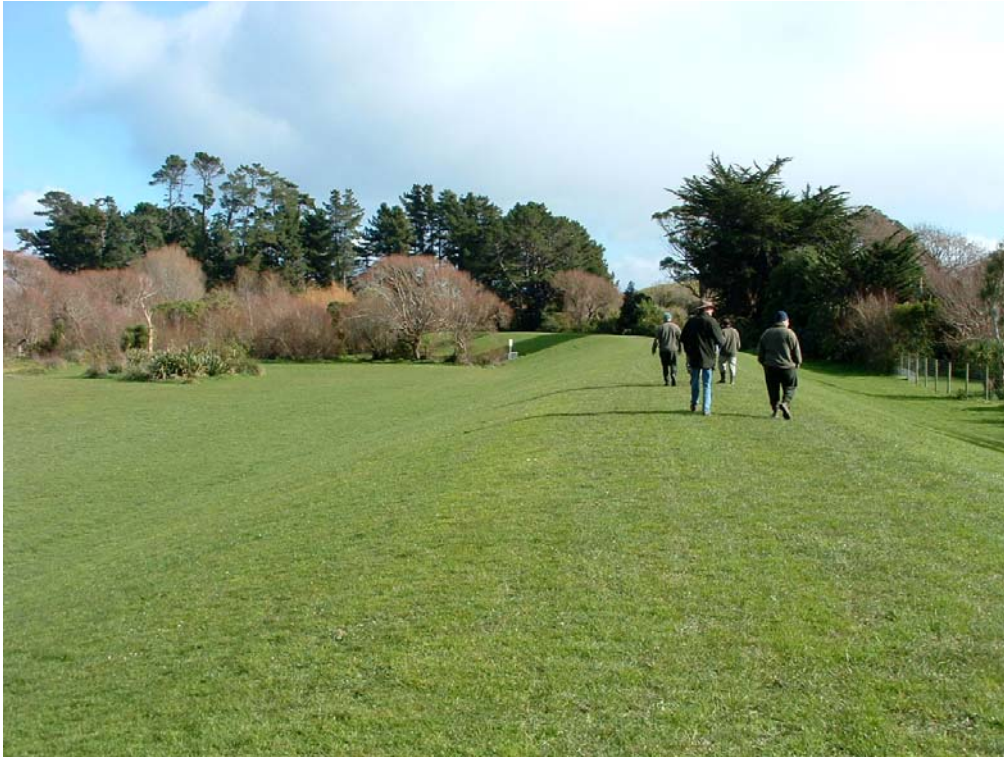
5.3 Kauri Puriri stopbank

The review team considers that the stopbank is being maintained to a high standard..

Reviewers condition rating for the stopbank is 2.

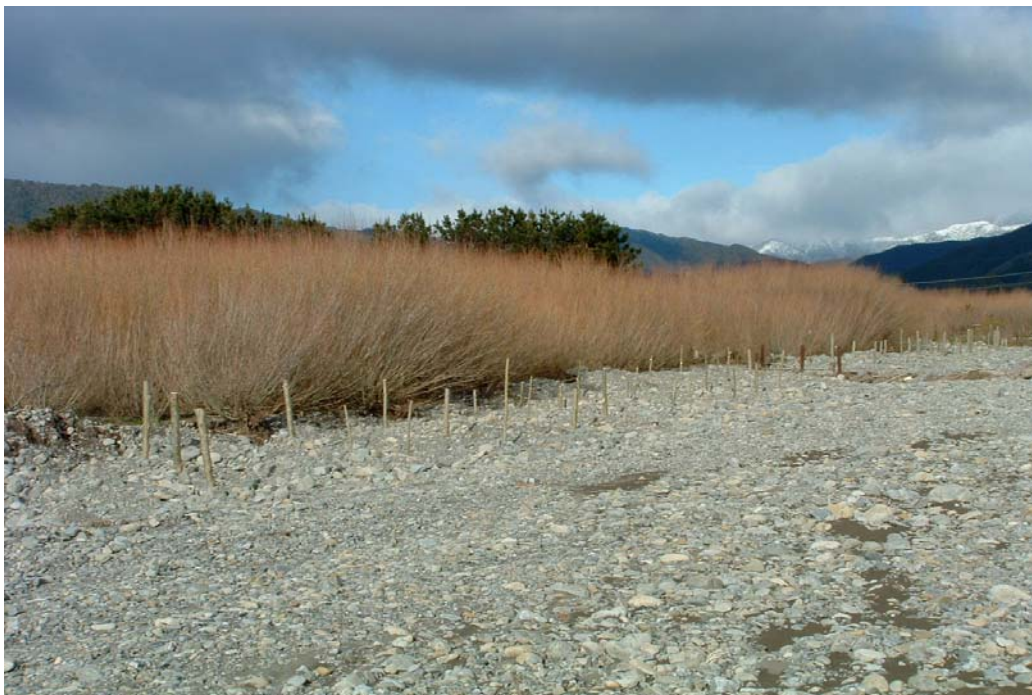
5.4 Upper Rahui - Shrub willows

Completed works were in good condition. Some flood debris on the beaches needs to be removed. Reviewers are happy with the overall maintenance standard of the assets at this location. Review team condition rating for debris fences and planting is 2.

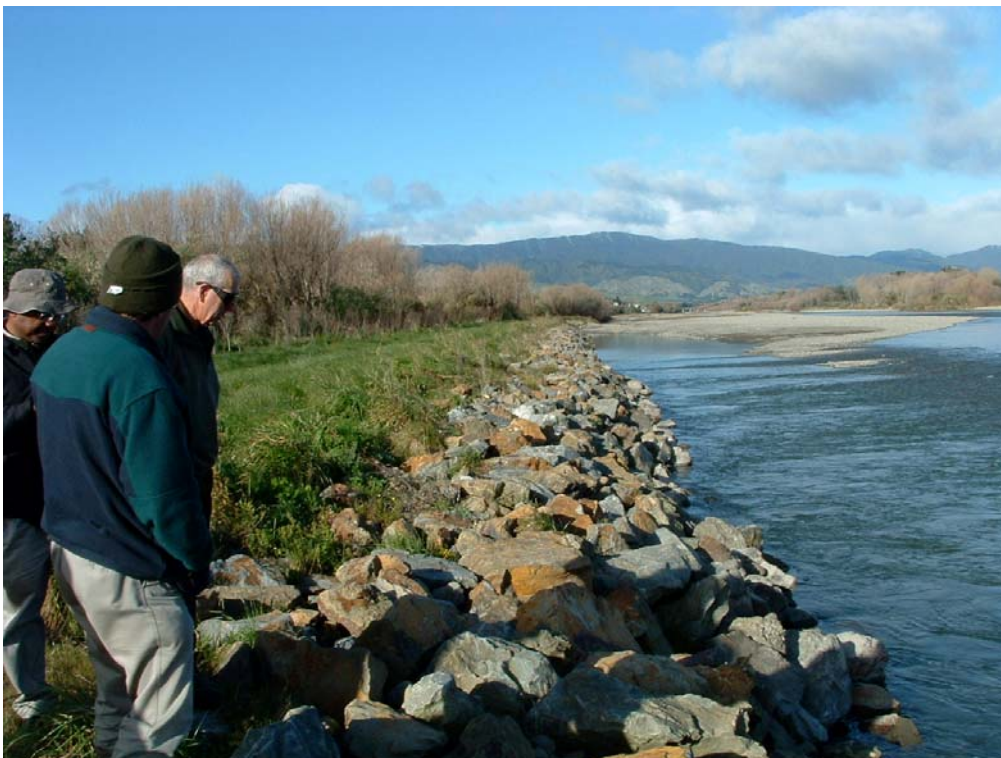
5.5 Below Winstones RB - Toe rock lining

Rock lining was in a good condition and no urgent maintenance was required. Minor slumping of rock was observed at one location but this should be easily corrected under the annual maintenance programme. Reviewers condition rating for this asset is 2.

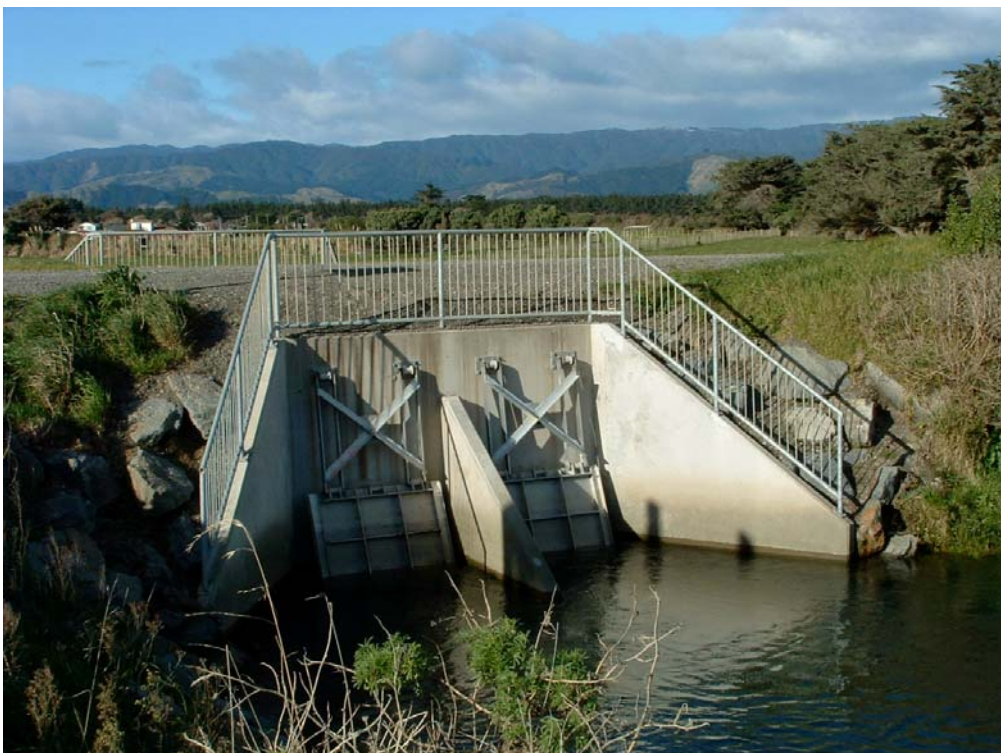
5.6 Rangiuuru Floodgates

The new culvert and twin aluminium flood gates had been constructed to alleviate flooding concerns during high tide for the houses in the vicinity. The old timber floodgates which were still operating had been found to be inadequate during high tide to drain the area resulting in flooding and inconvenience for the residents in the area. The new floodgates, the old floodgates, the handrail and the surrounding area were being maintained in an excellent condition.

Reviewers condition rating for this asset is 2.
