**Orongorongo tunnel portal and scoured out creek**

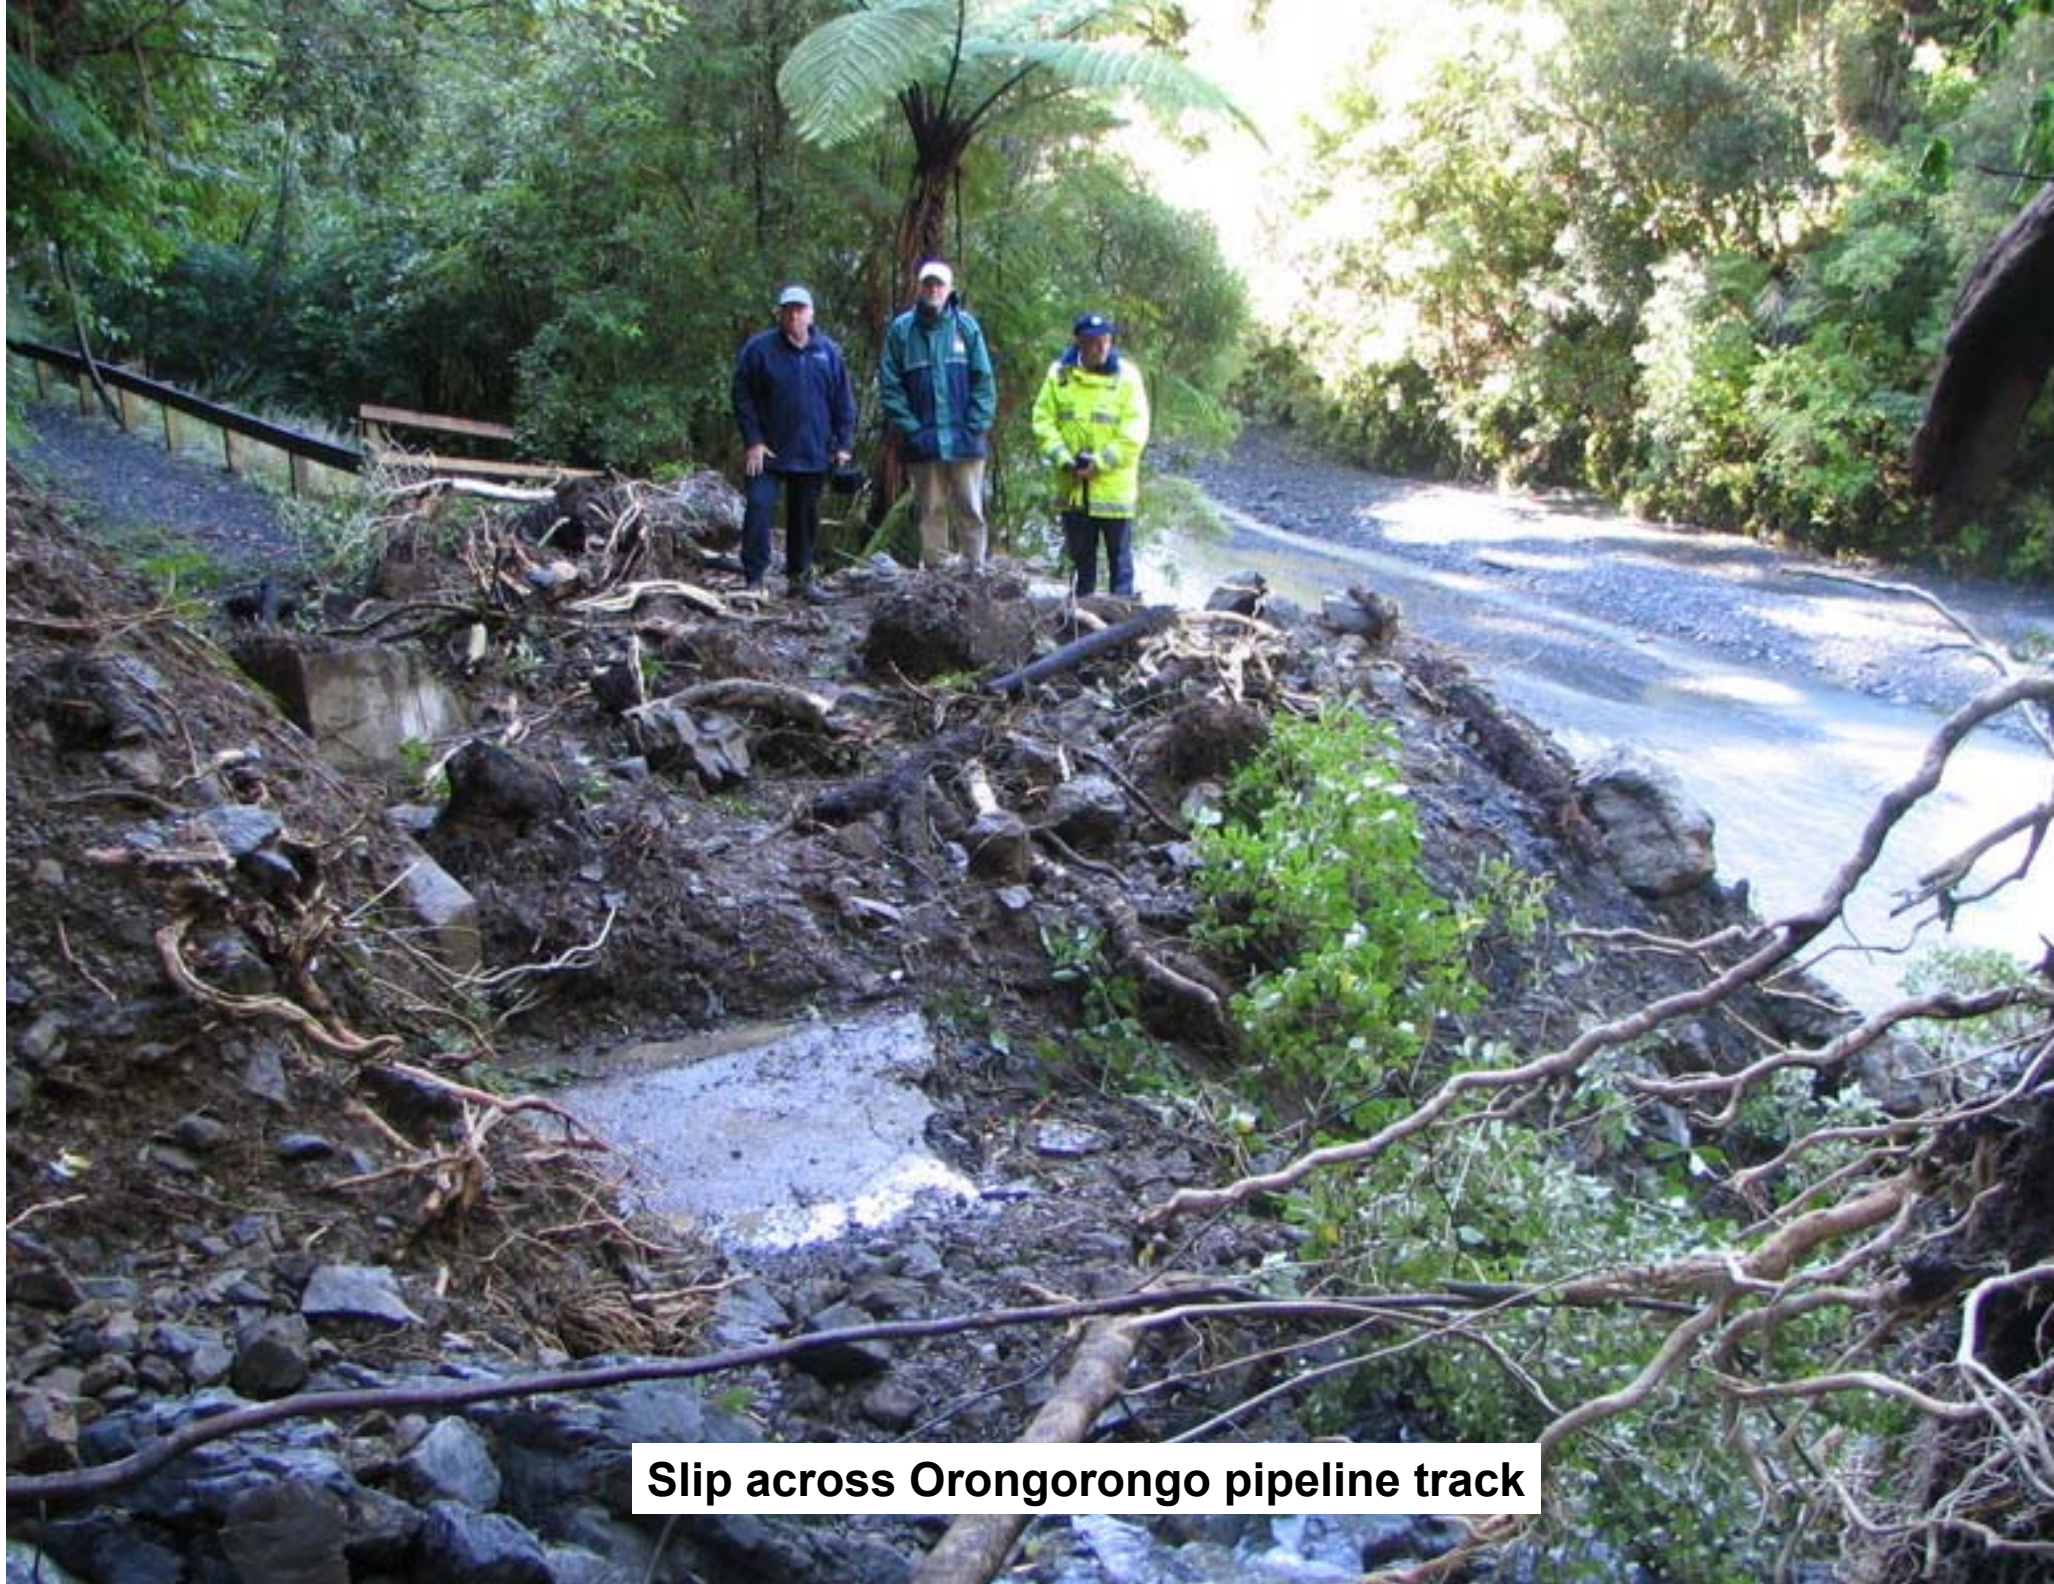
**Slip across Orongorongo pipeline track**

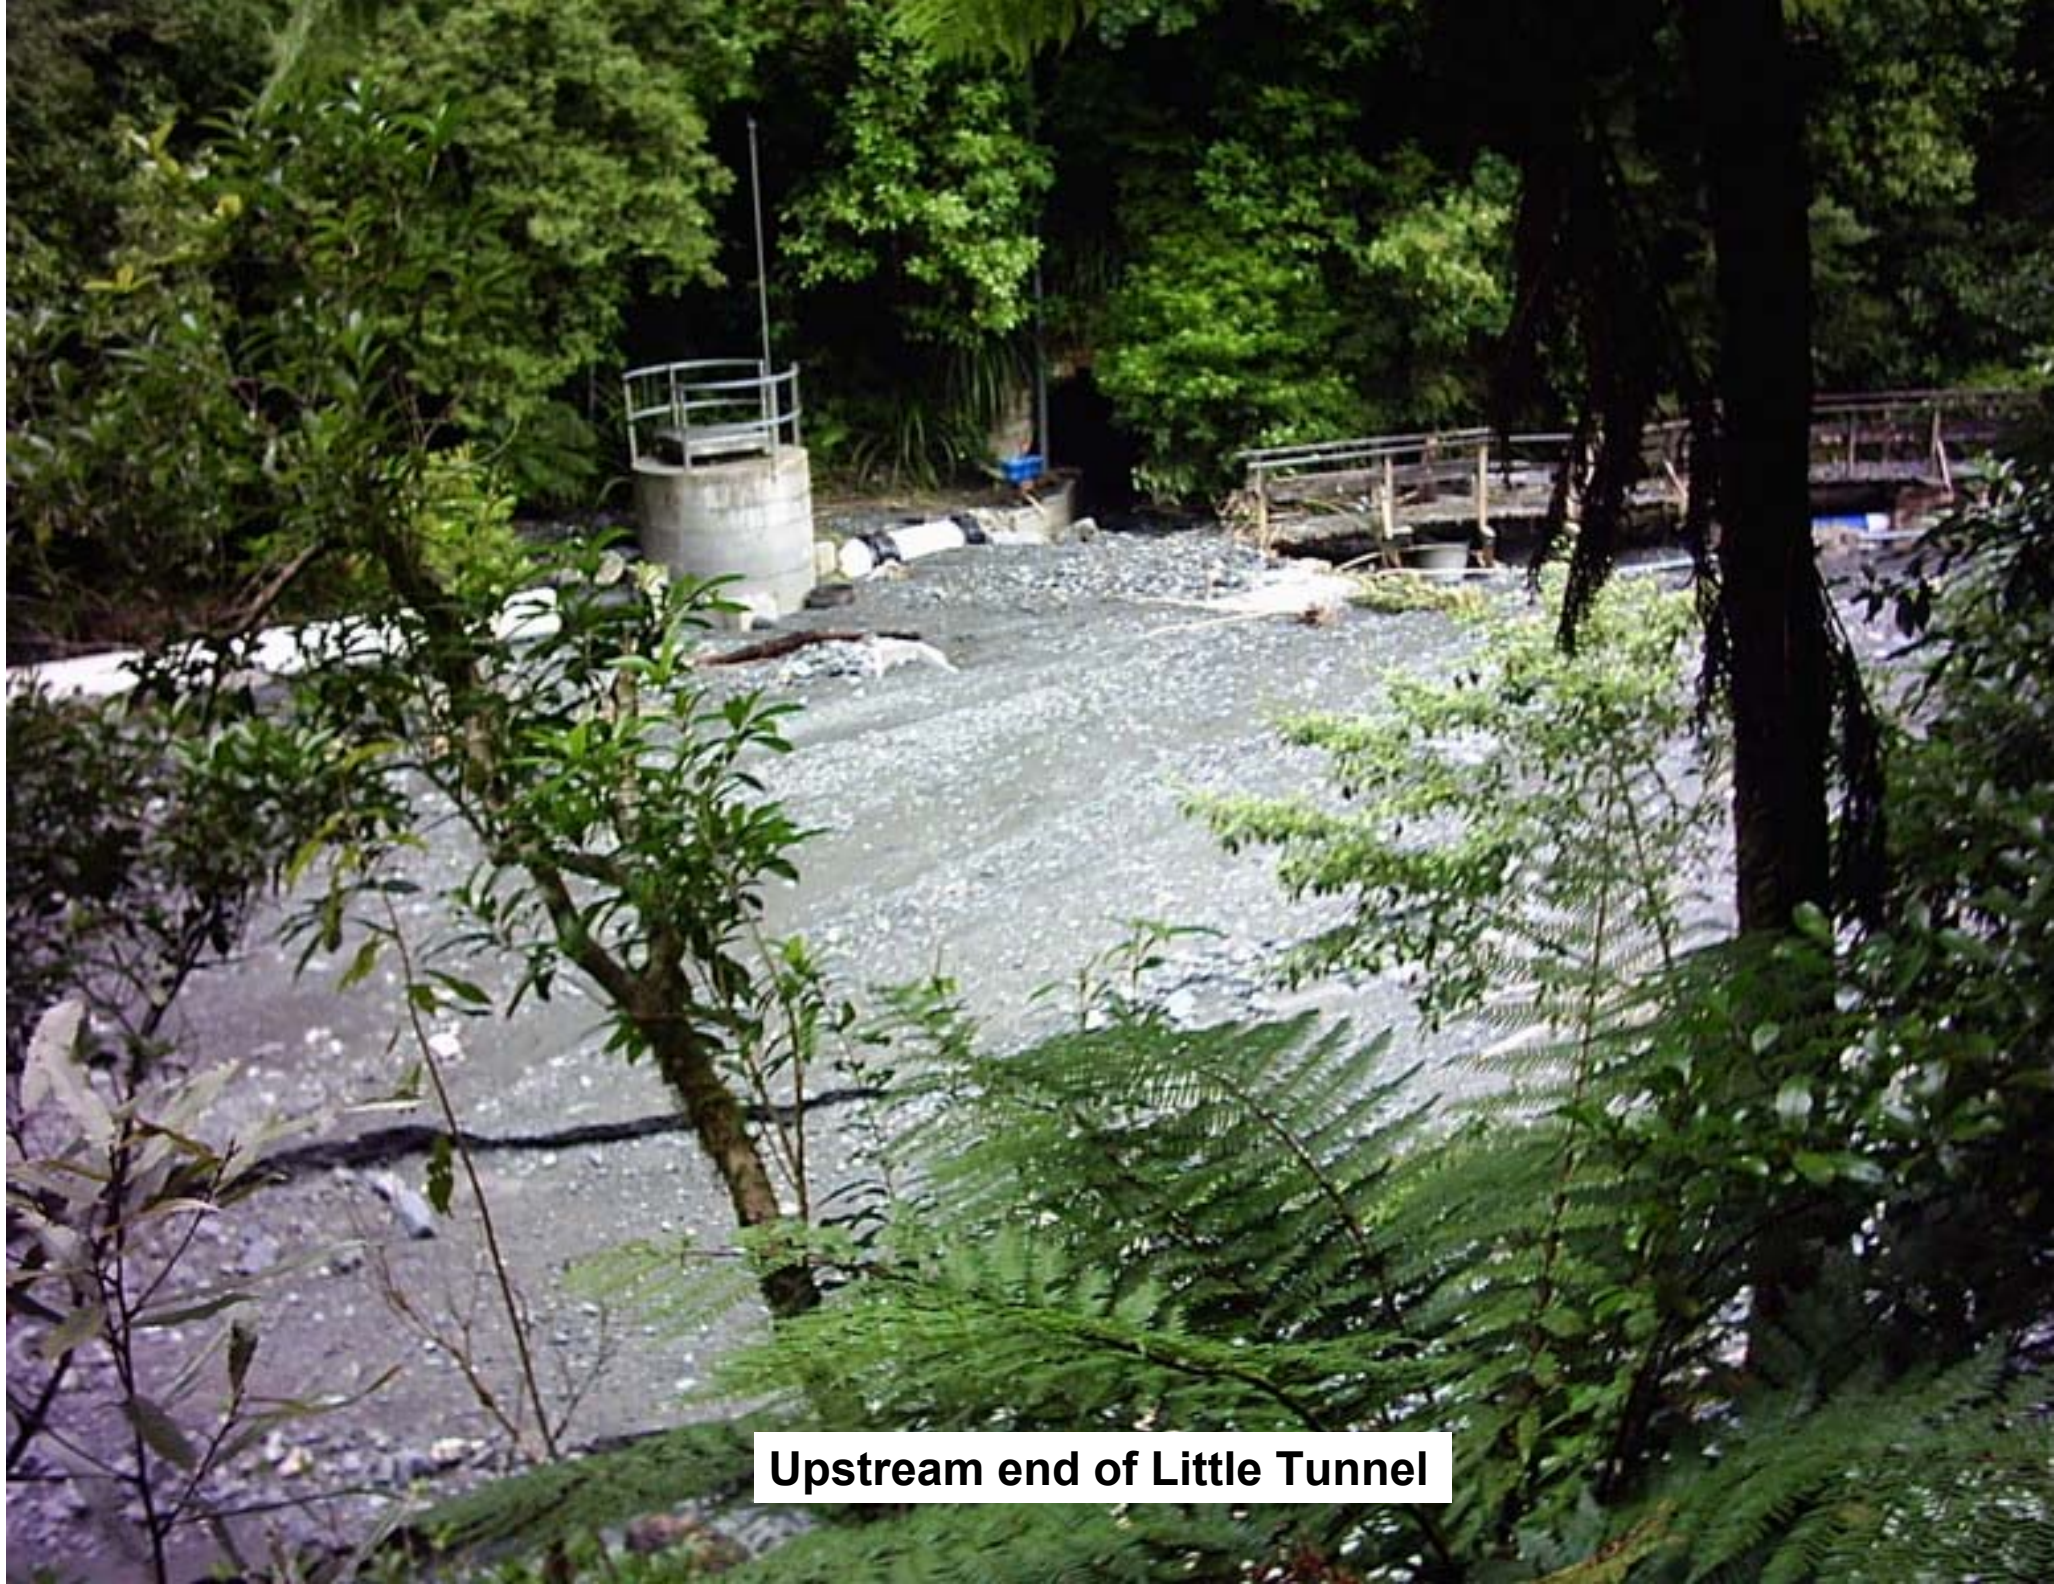
**Upstream end of Little Tunnel**

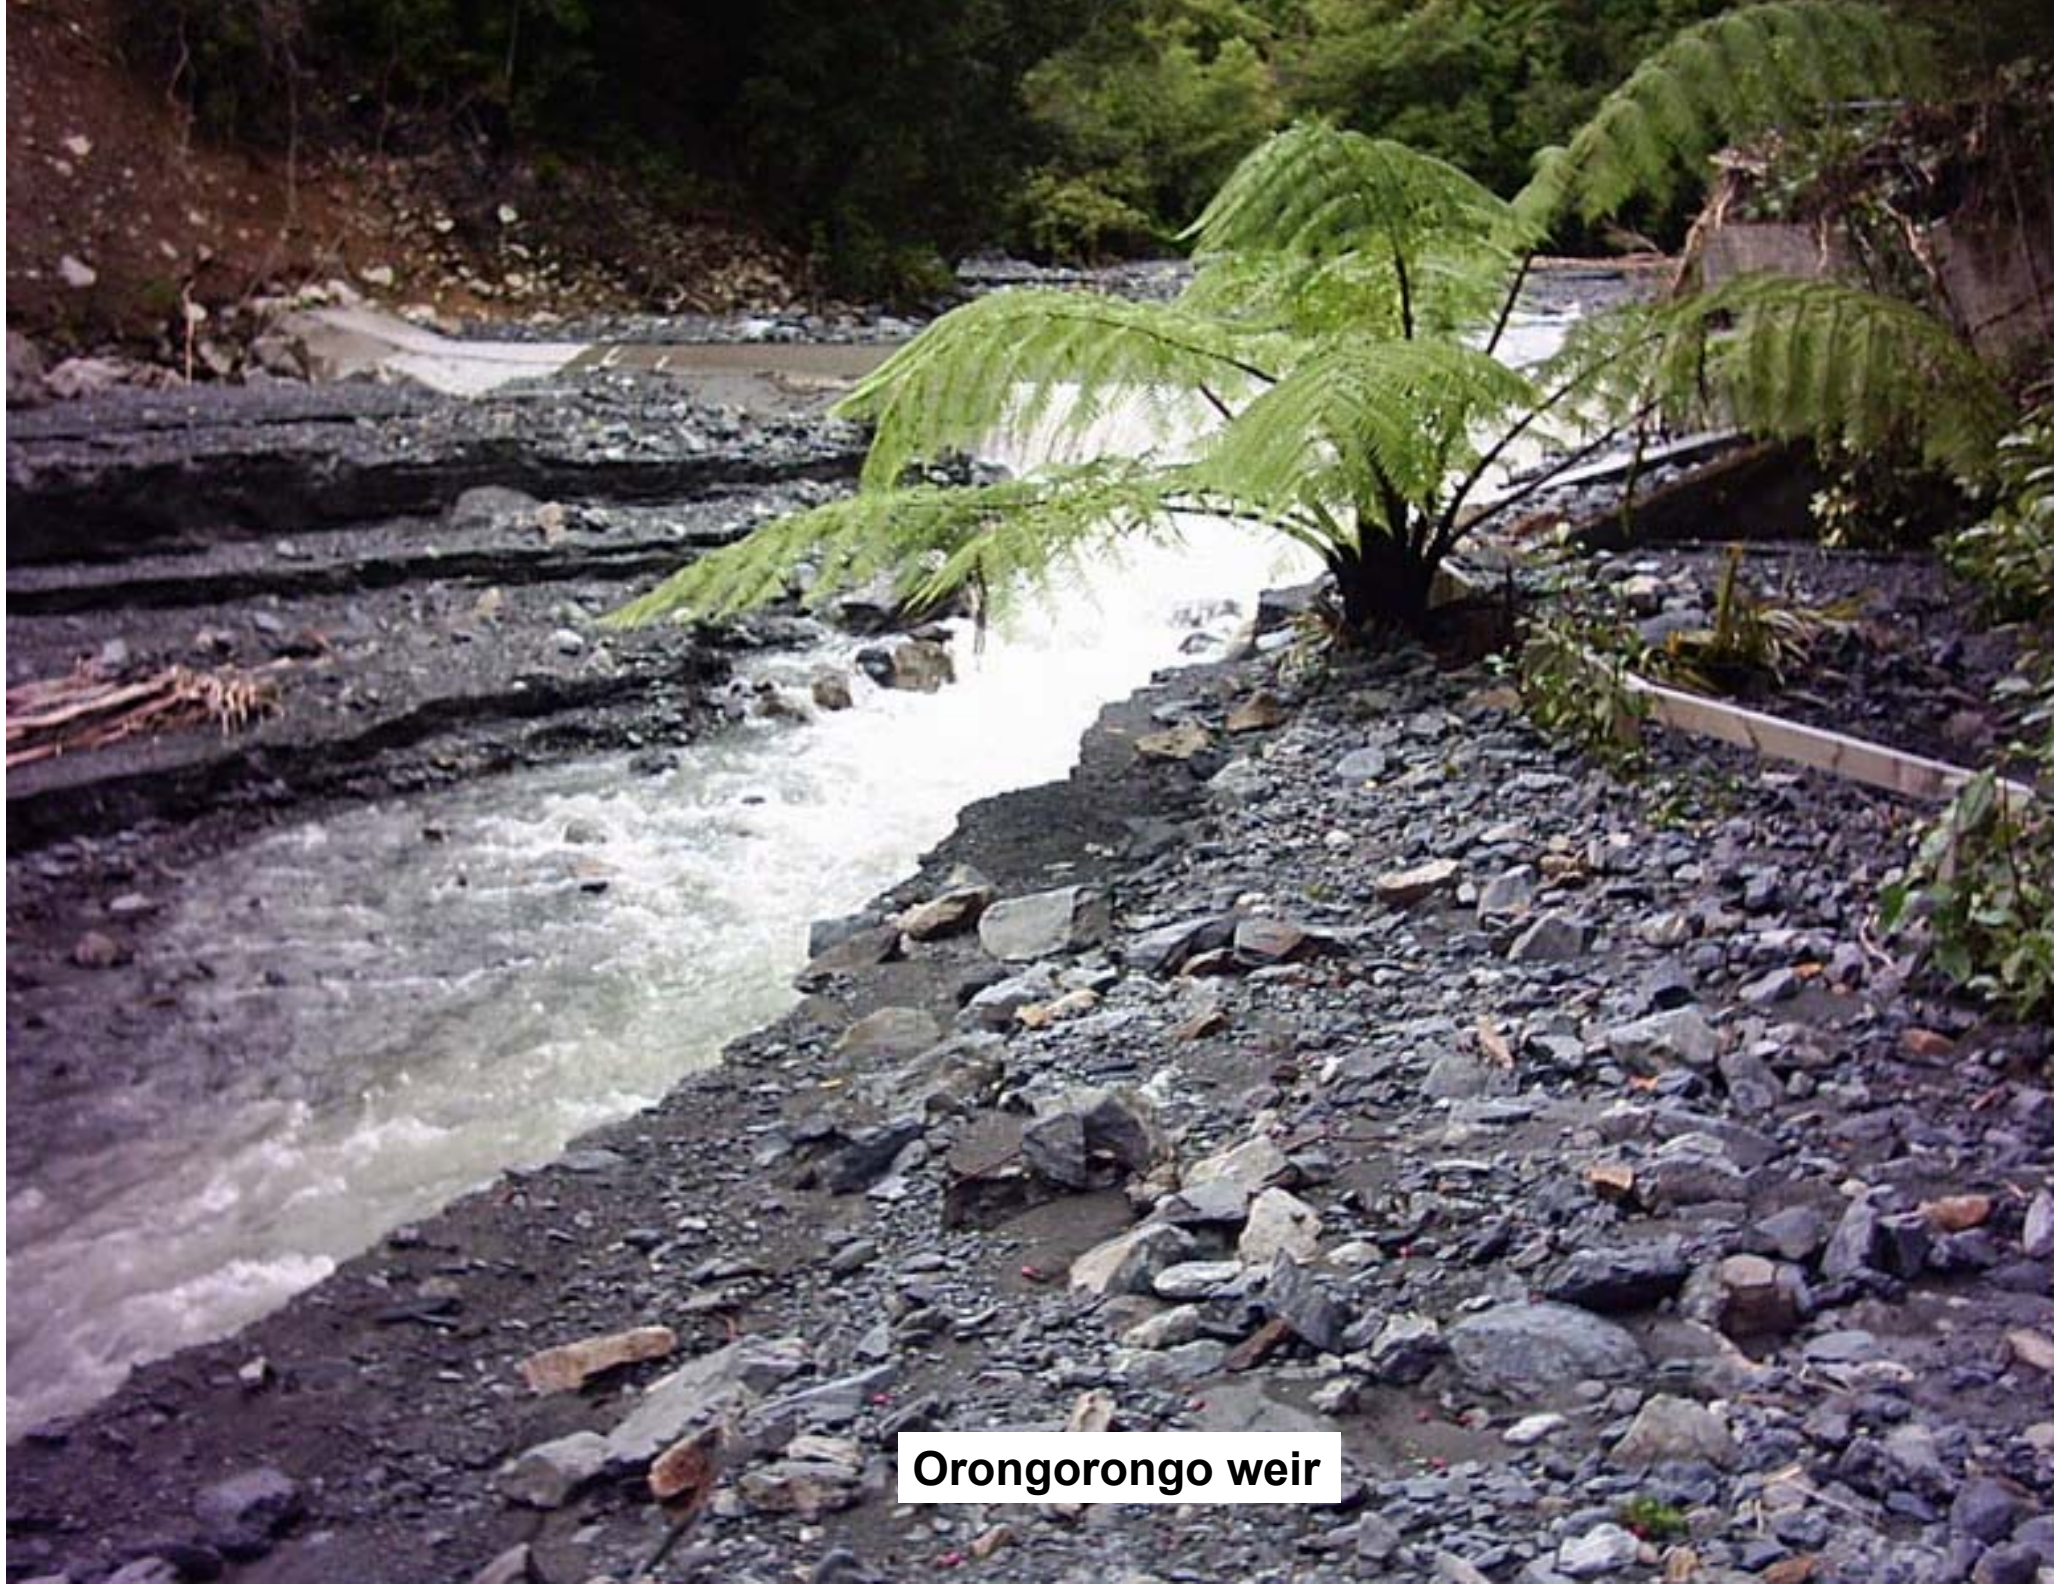
**Orongorongo weir**

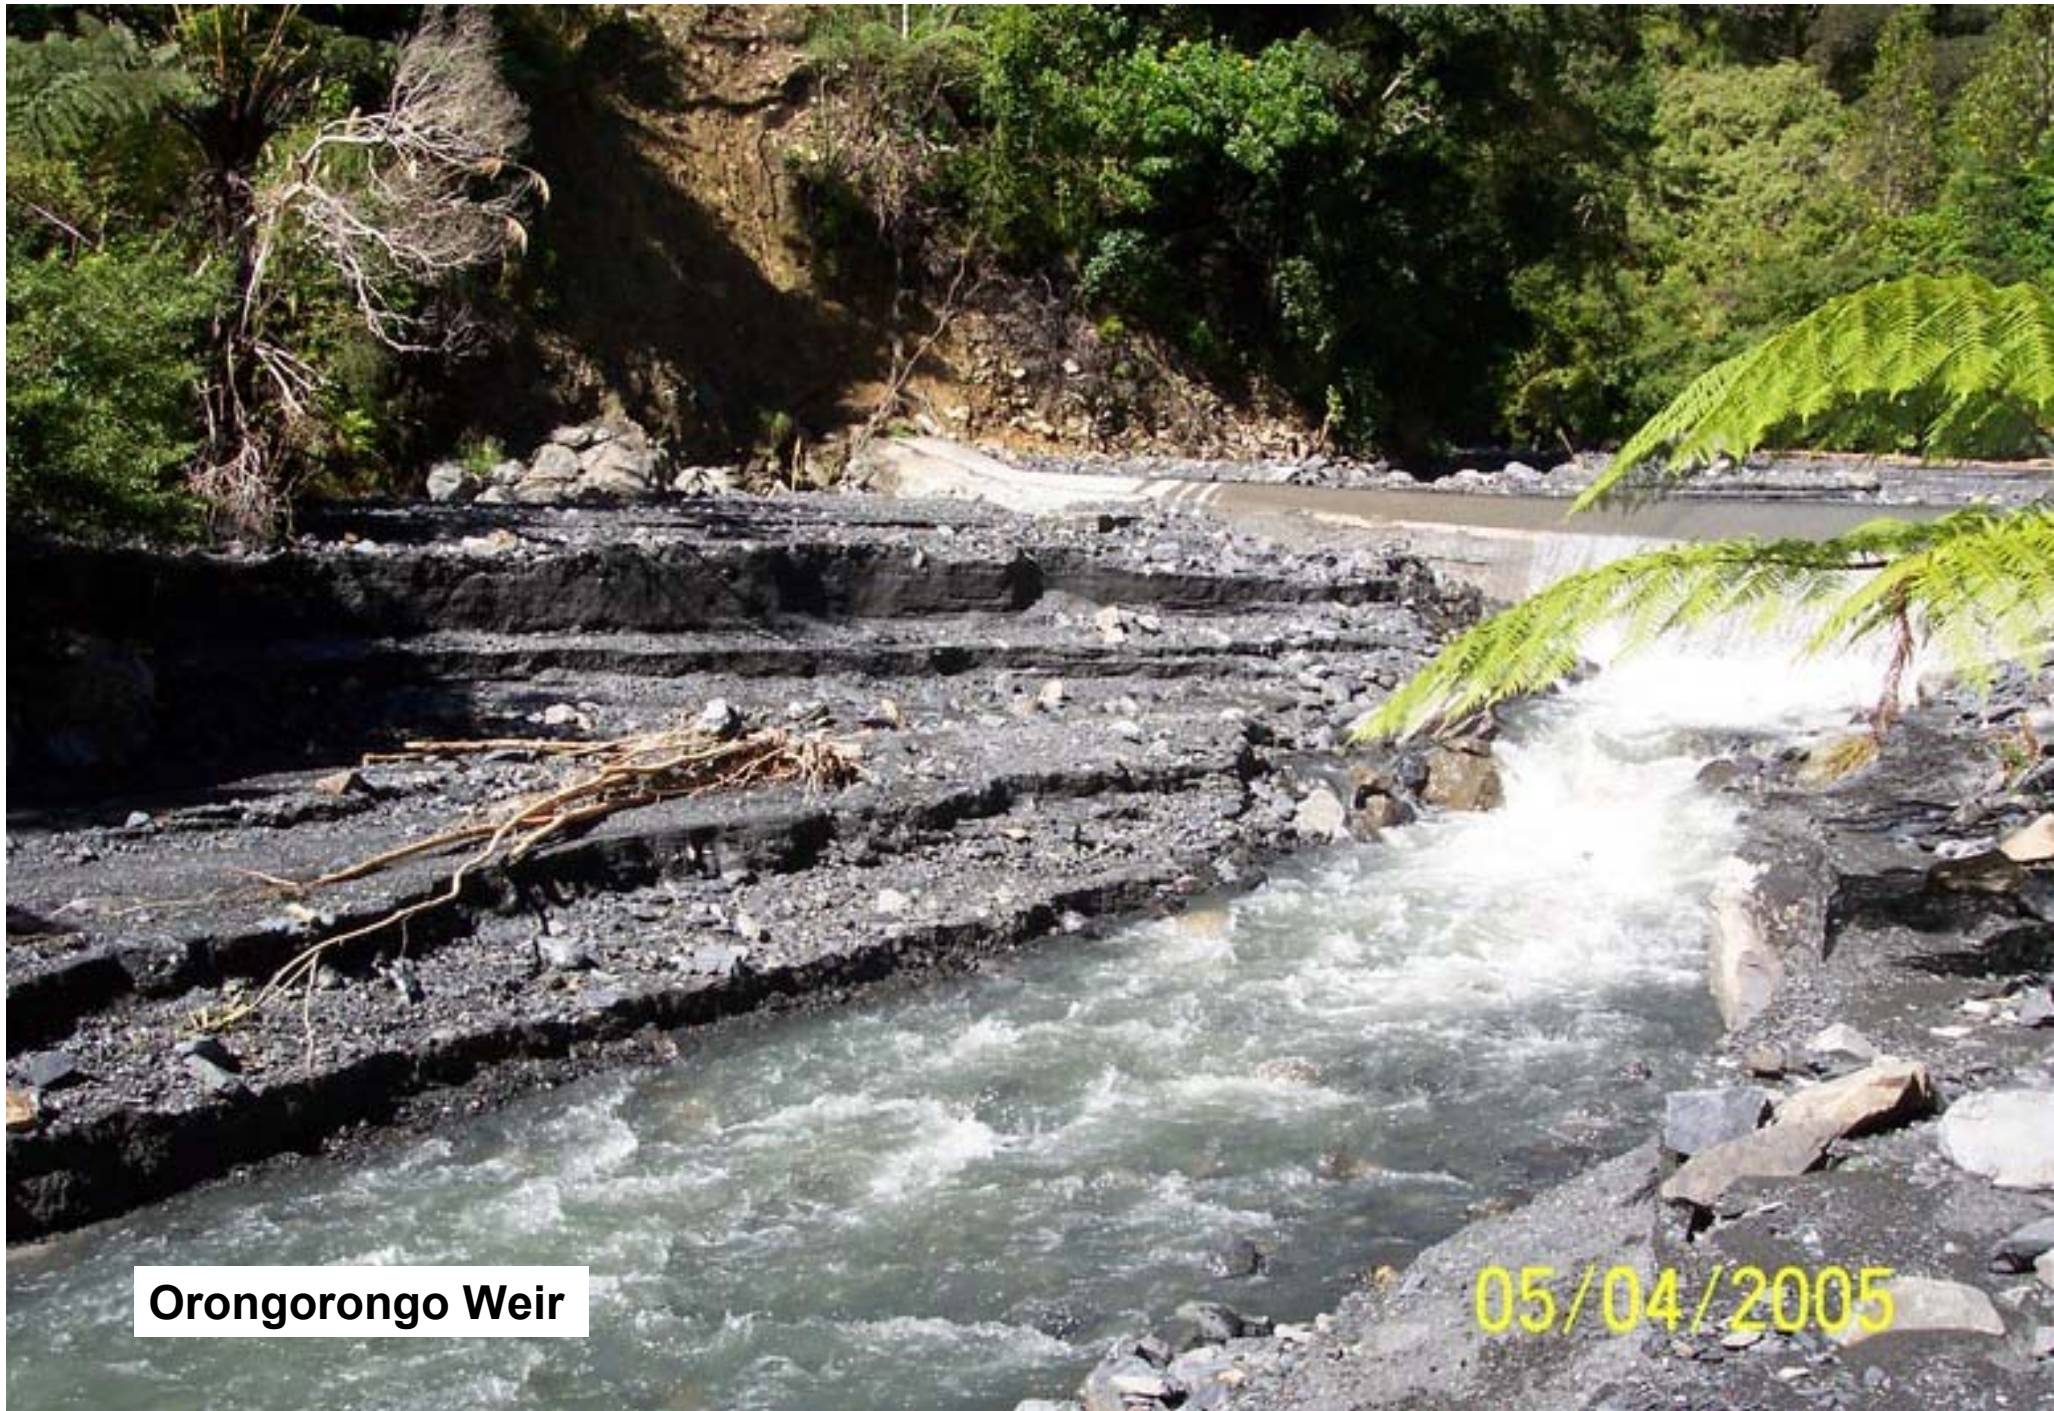
**Orongorongo Weir**

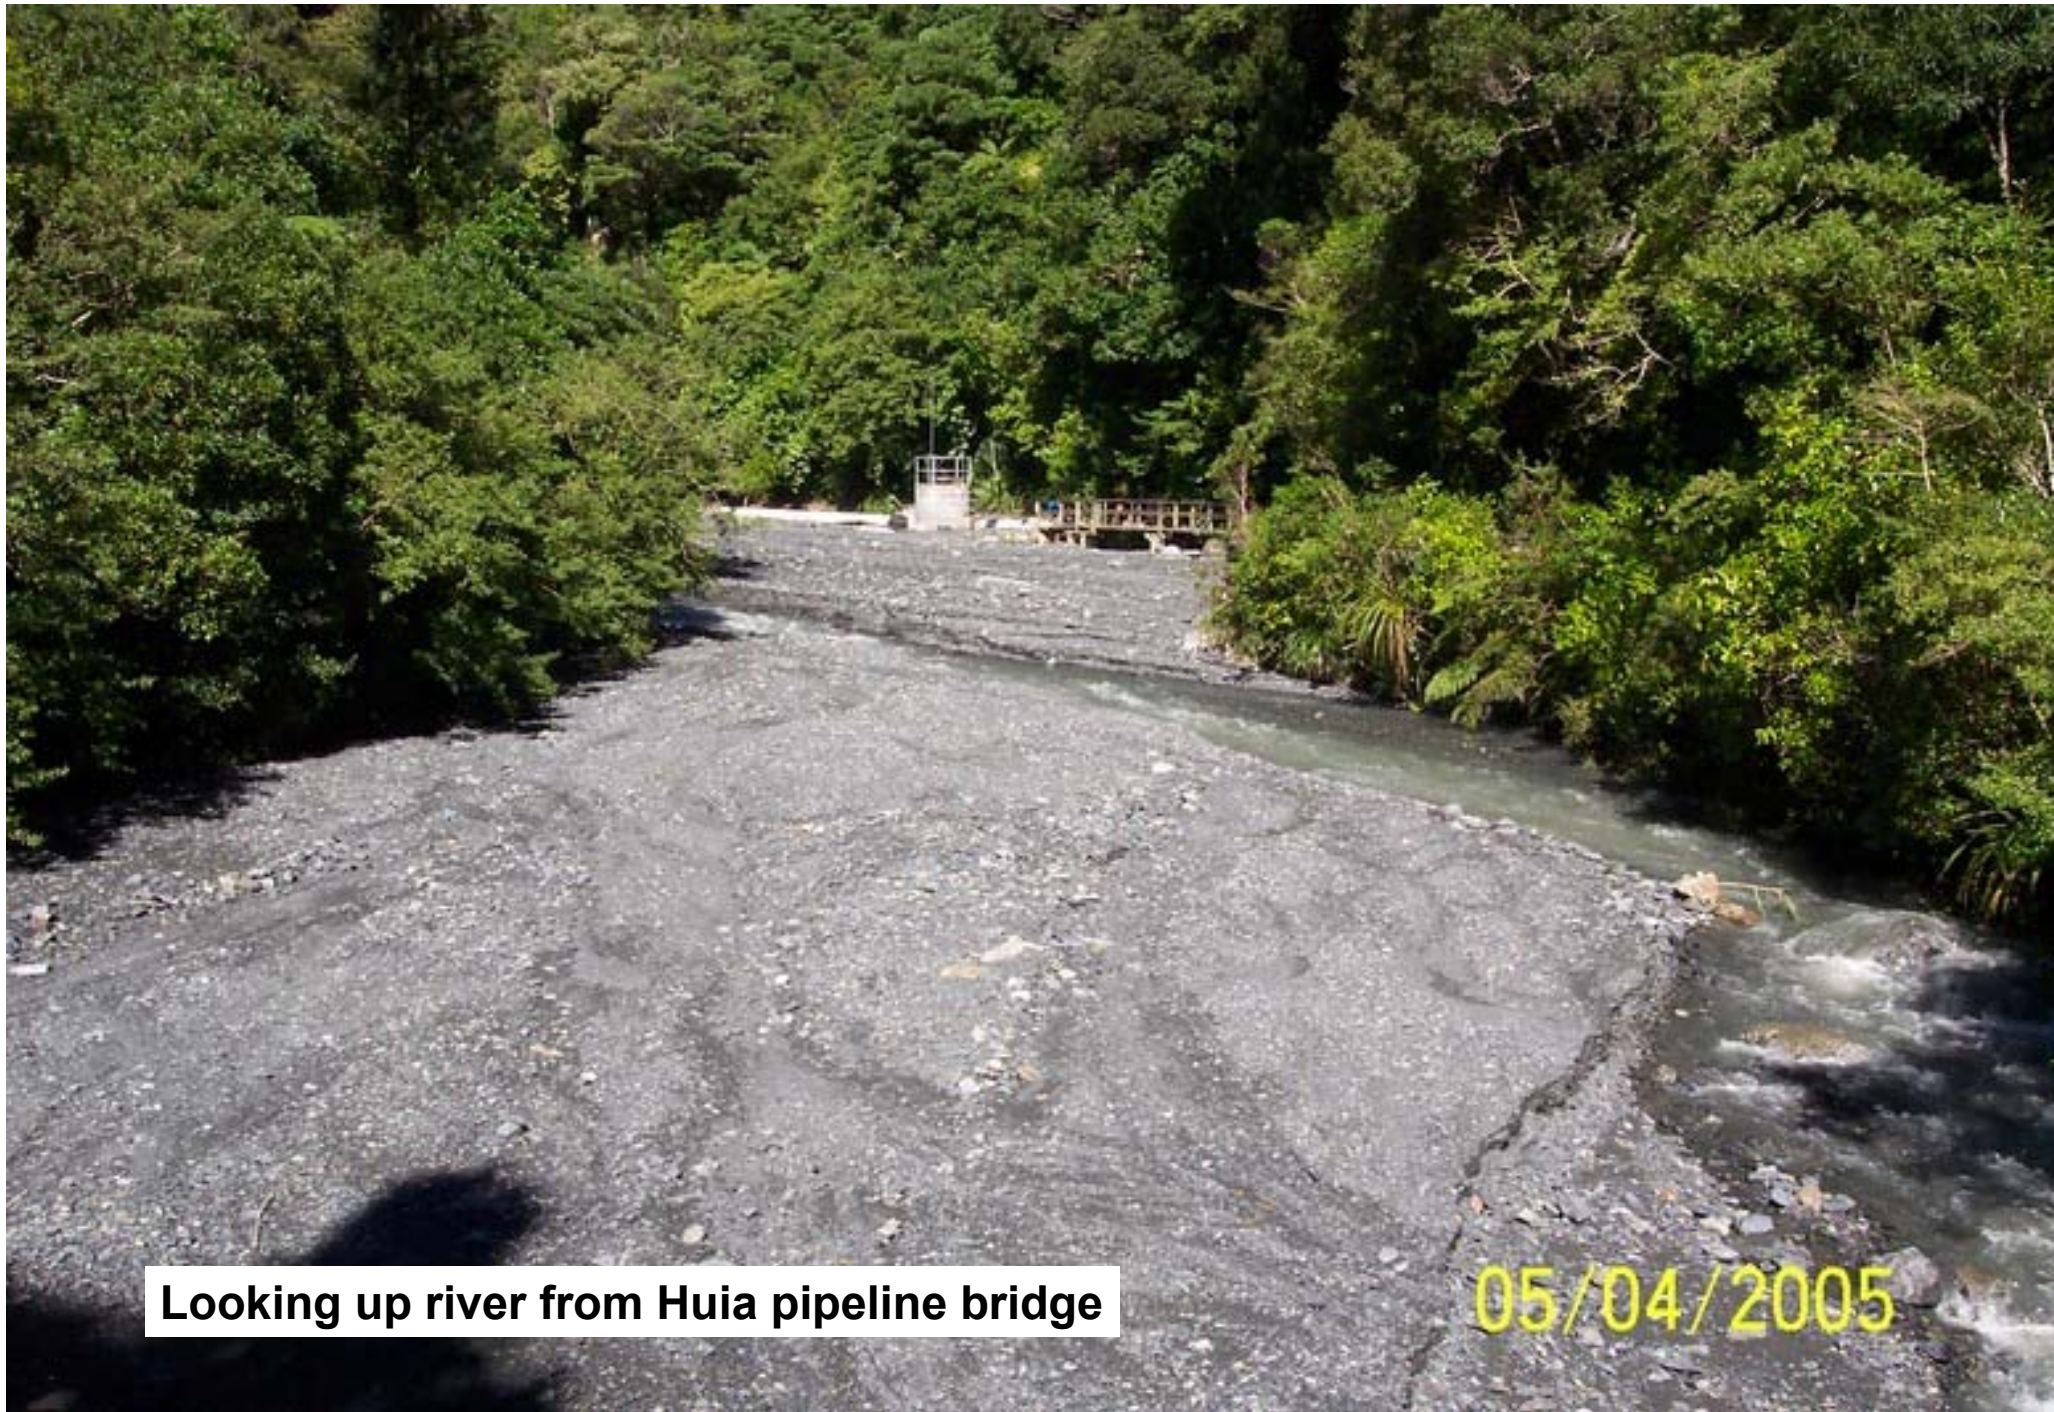
Looking up river from Huia pipeline bridge

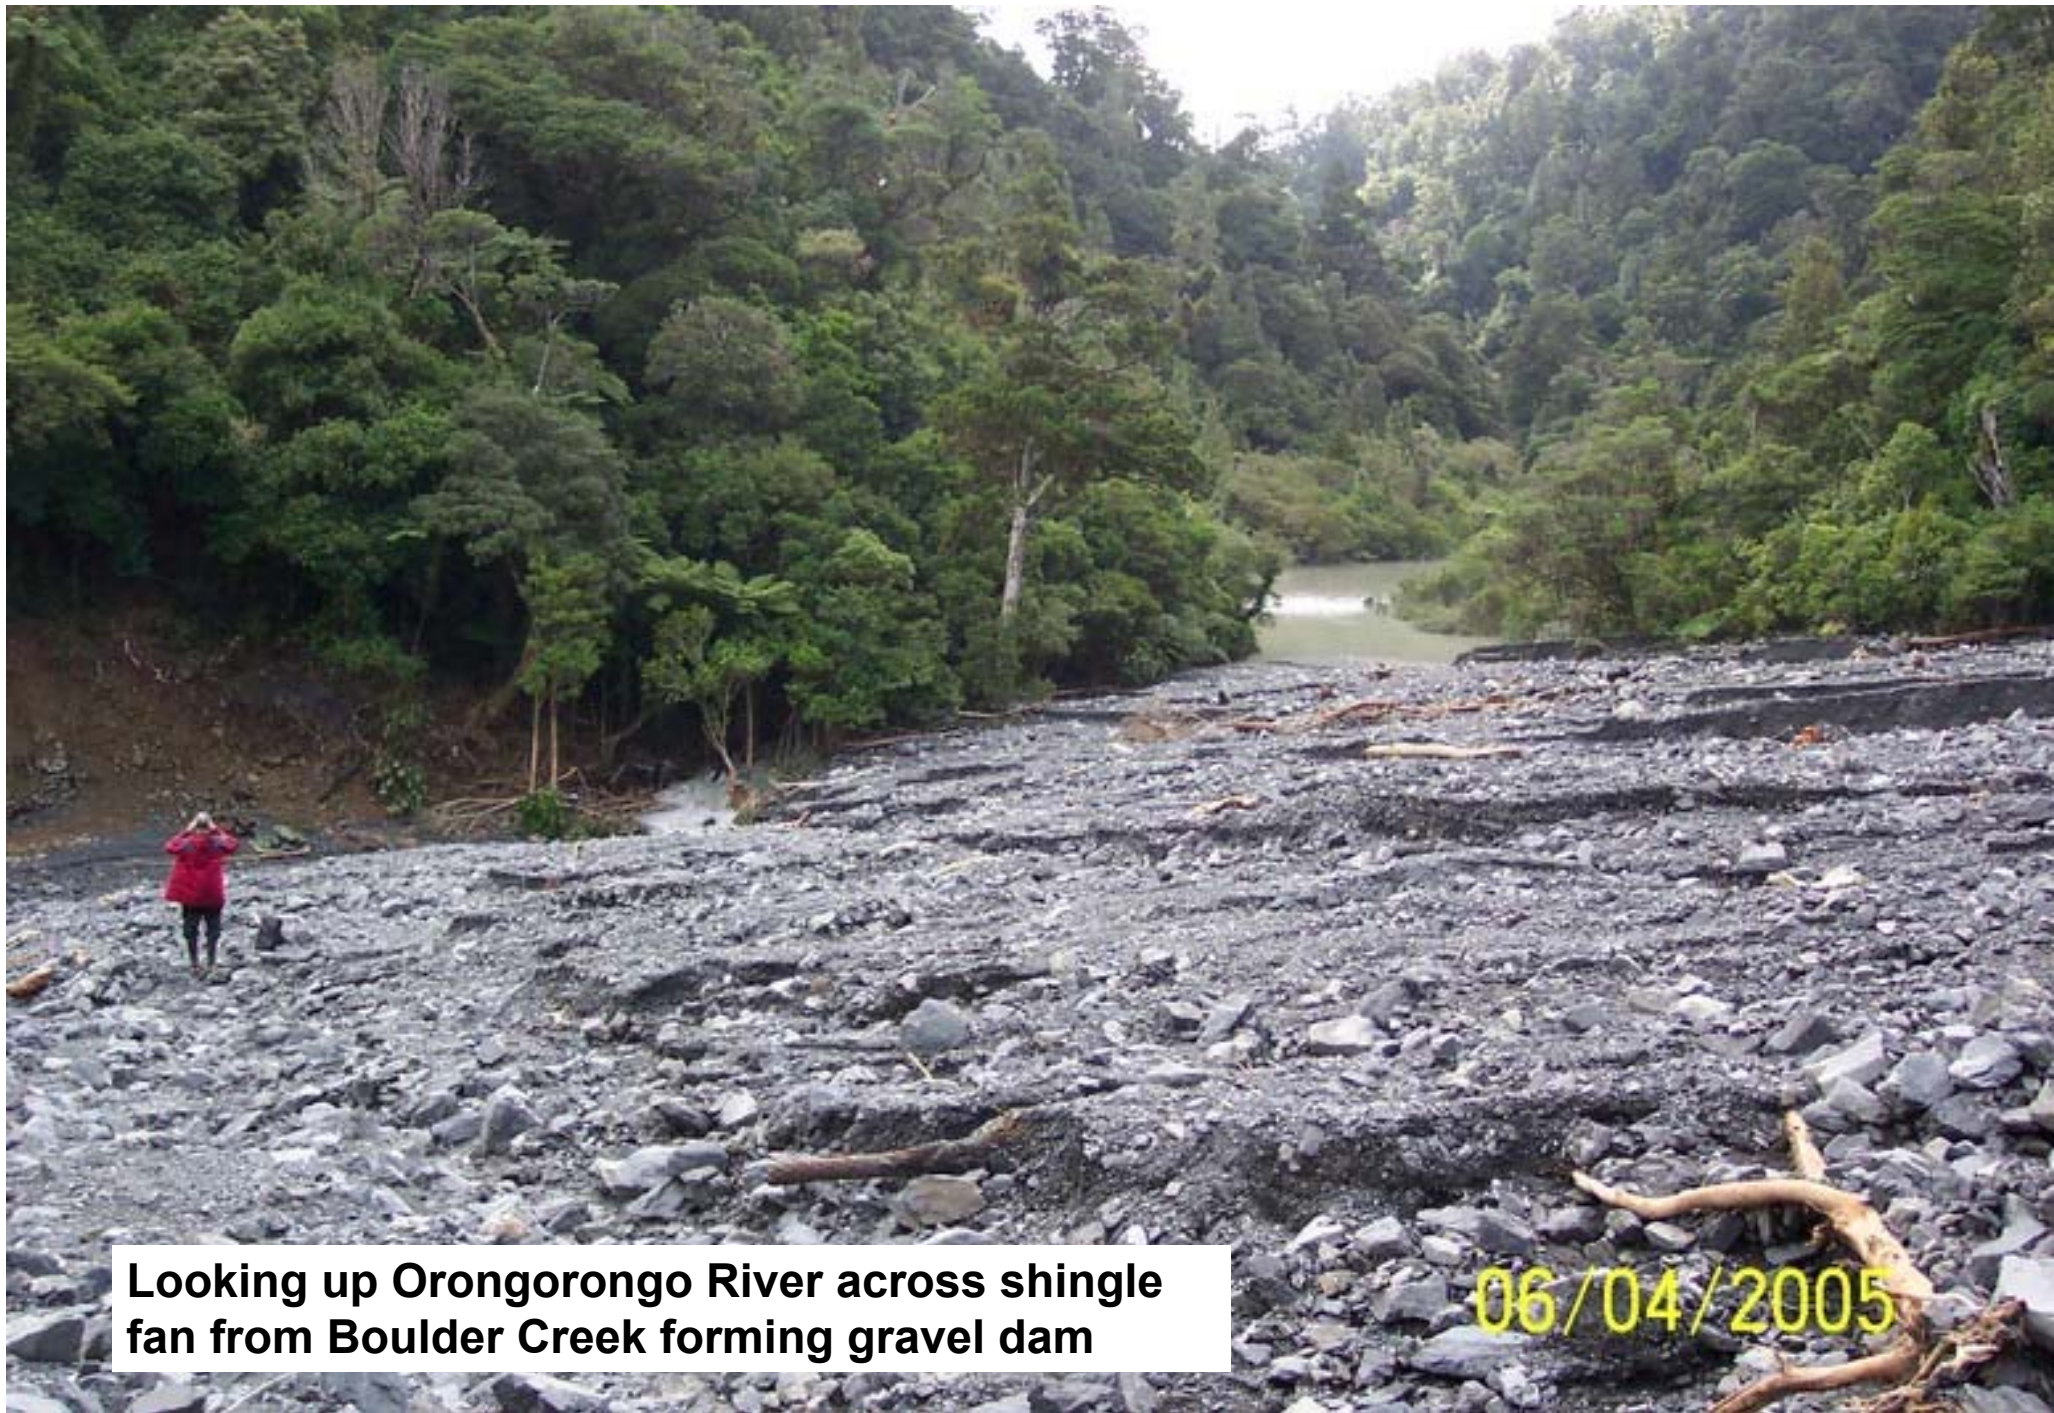
Looking up Orongorongo River across shingle fan from Boulder Creek forming gravel dam

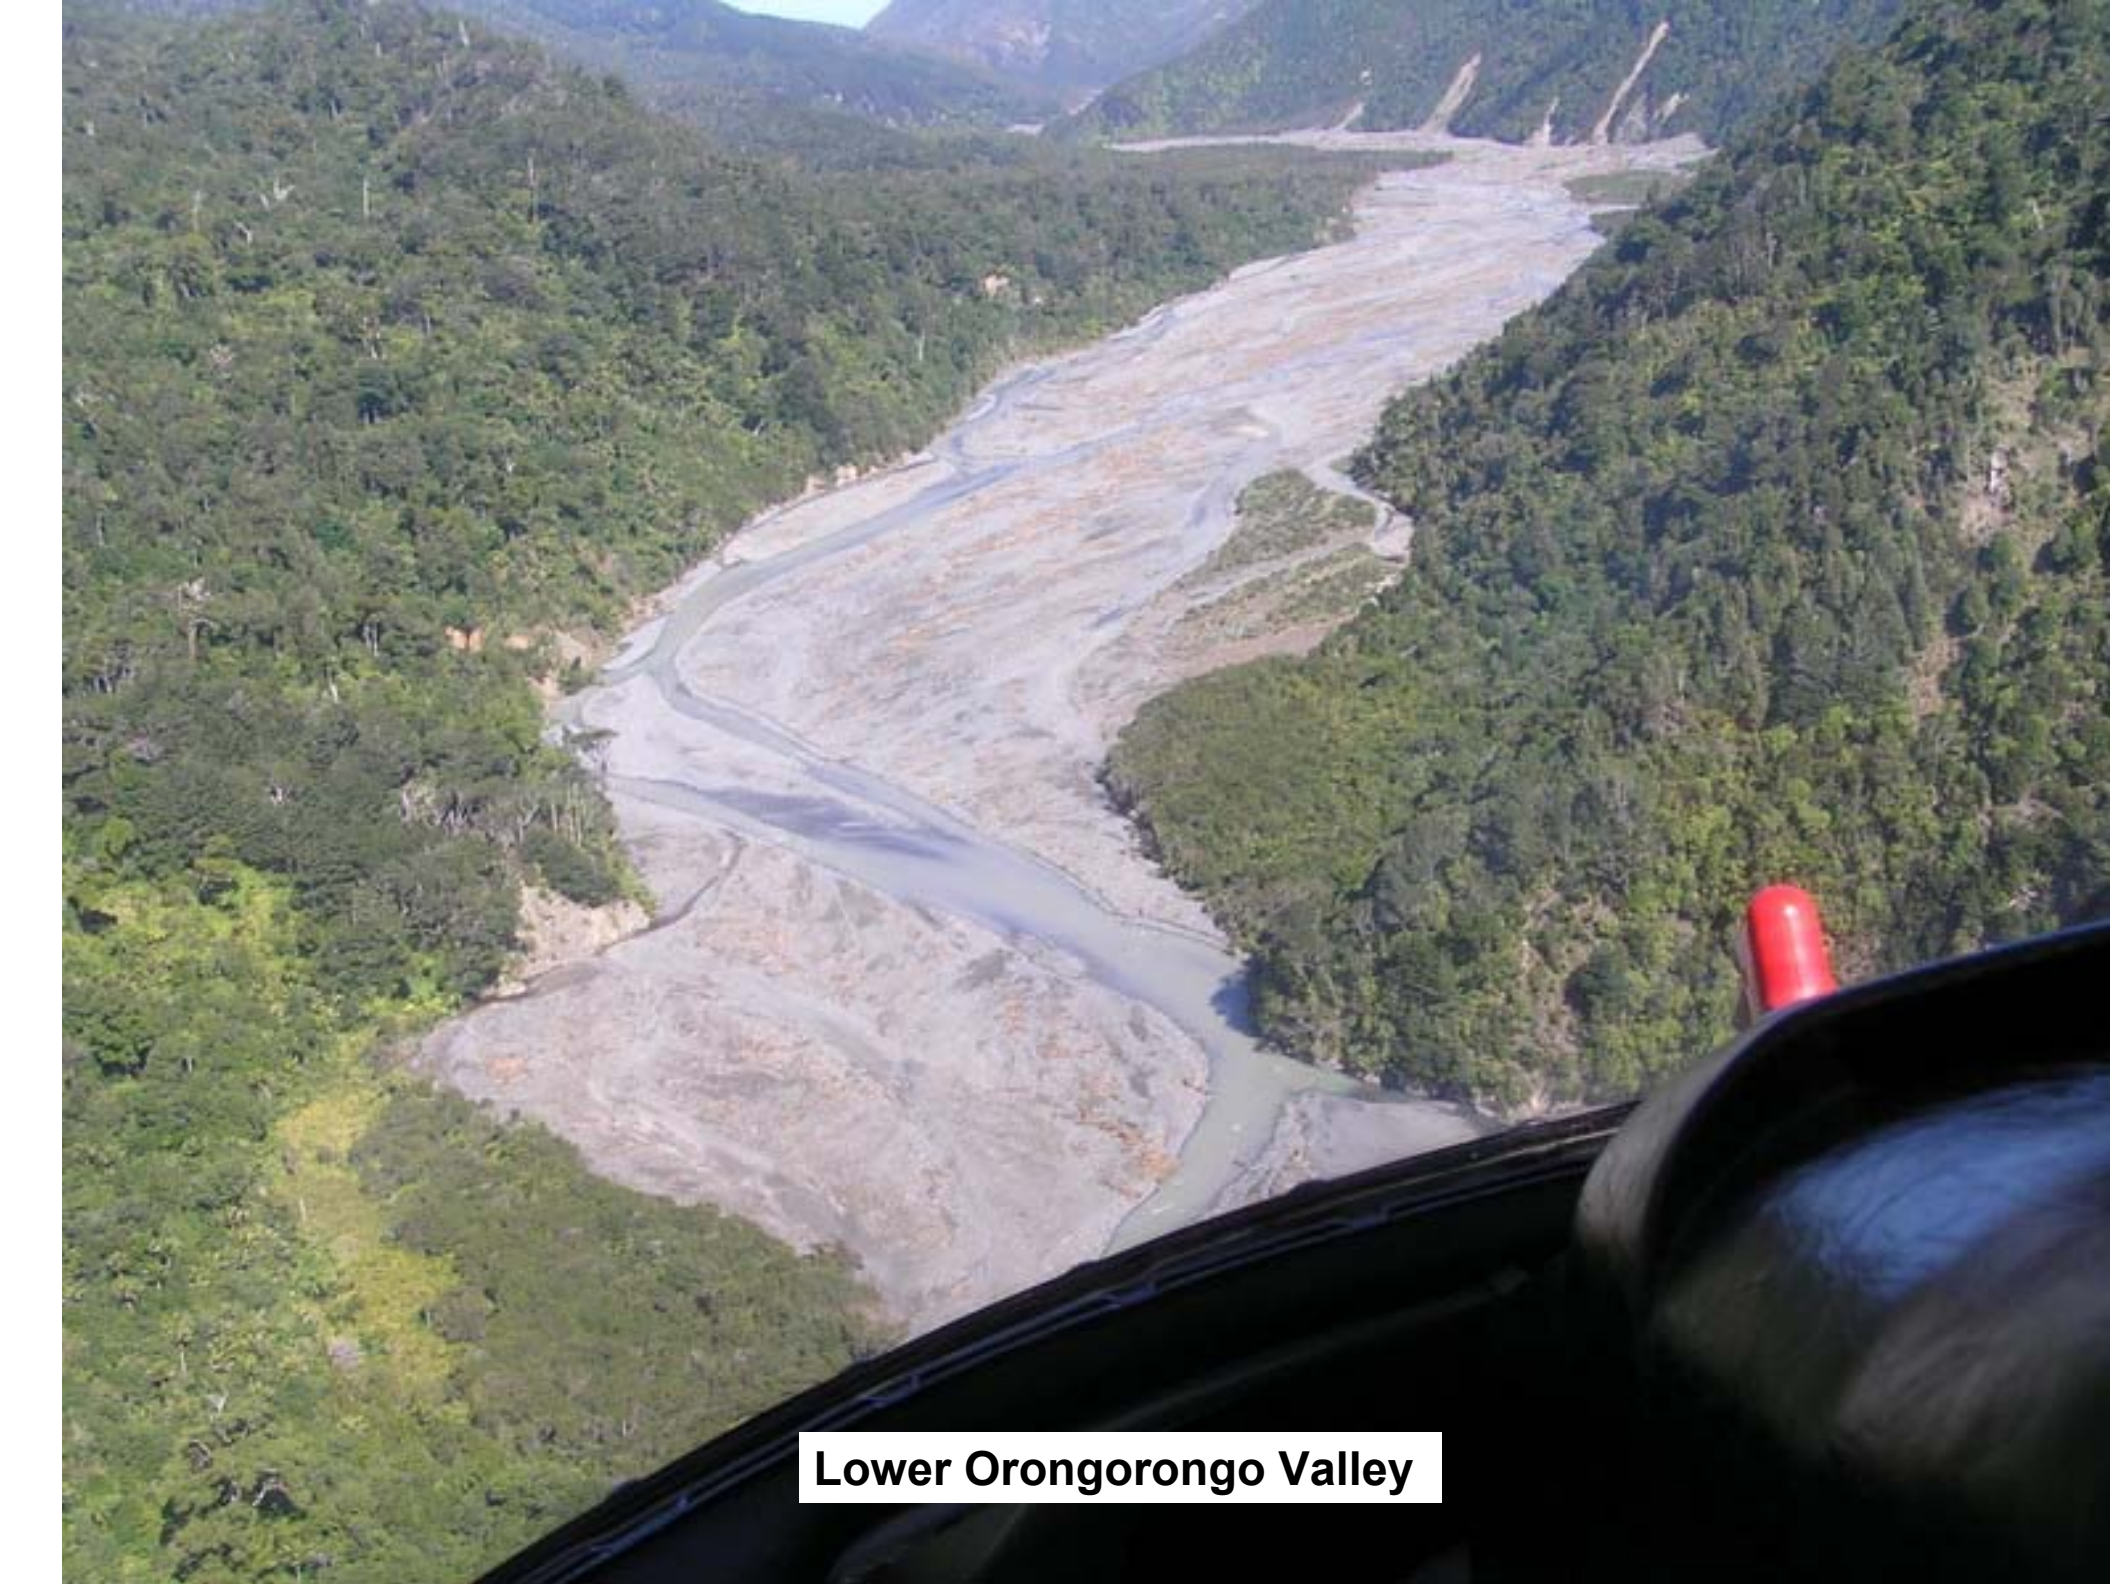
**Lower Orongorongo Valley**
