**Orongorongo tunnel portal and scoured out creek**

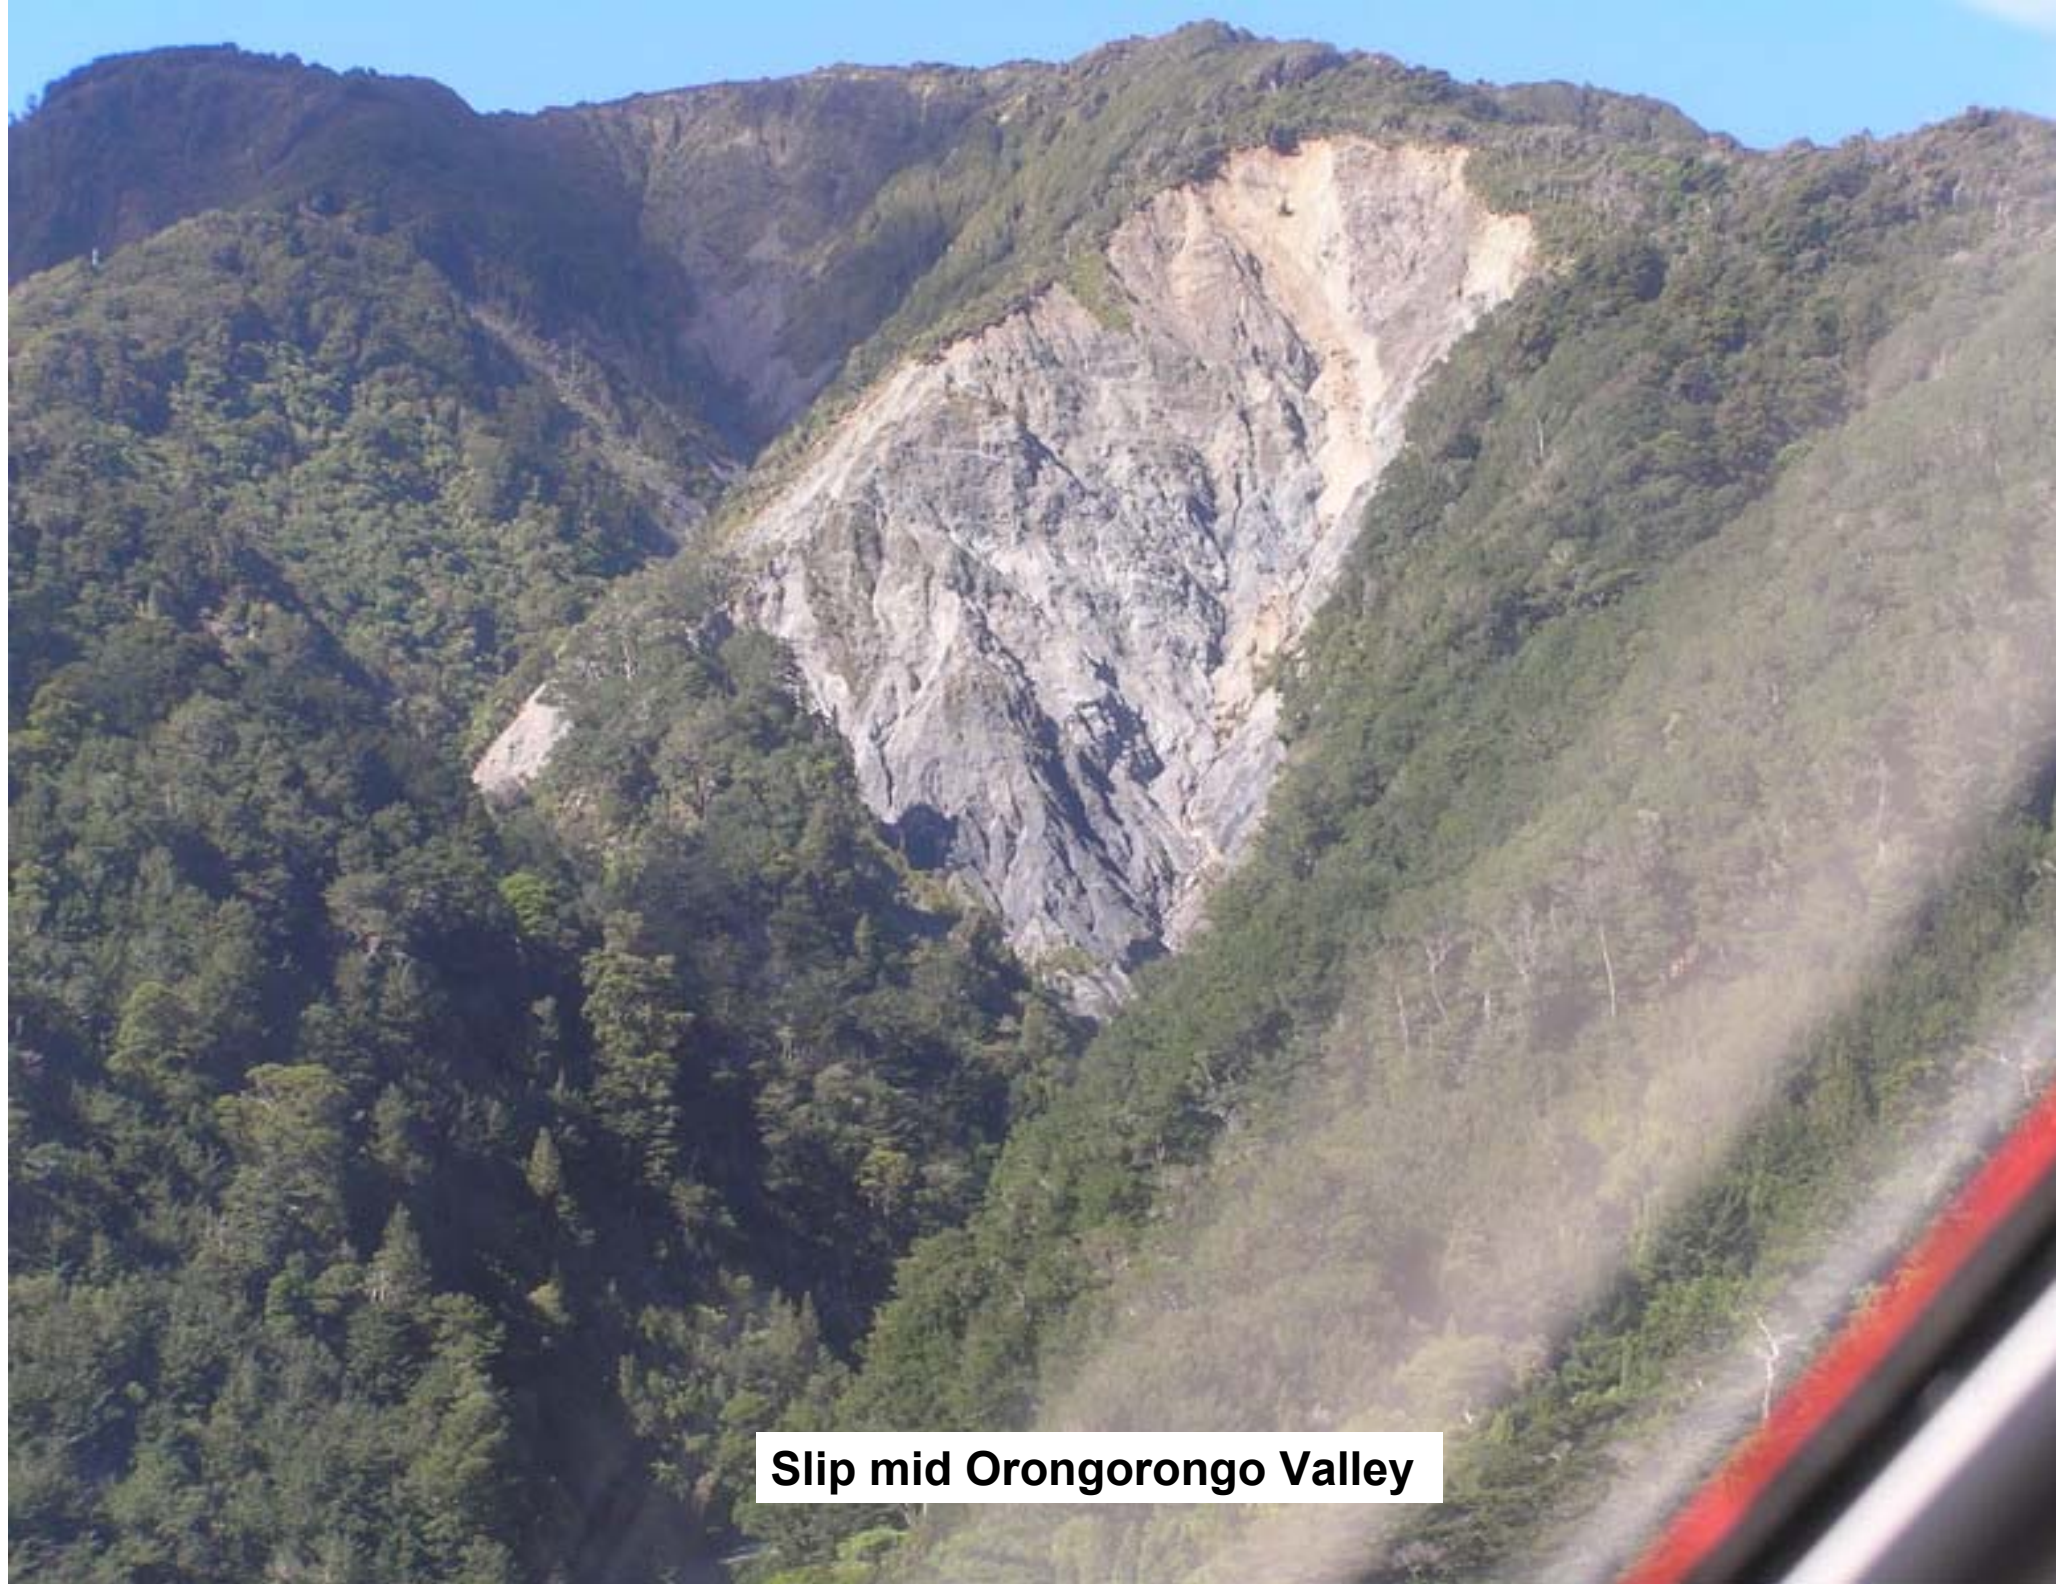
**Slip mid Orongorongo Valley**
