# **Hutt River Maoribank Erosion Study – Stage 1 Risk Assessment**

## ***Executive Summary***

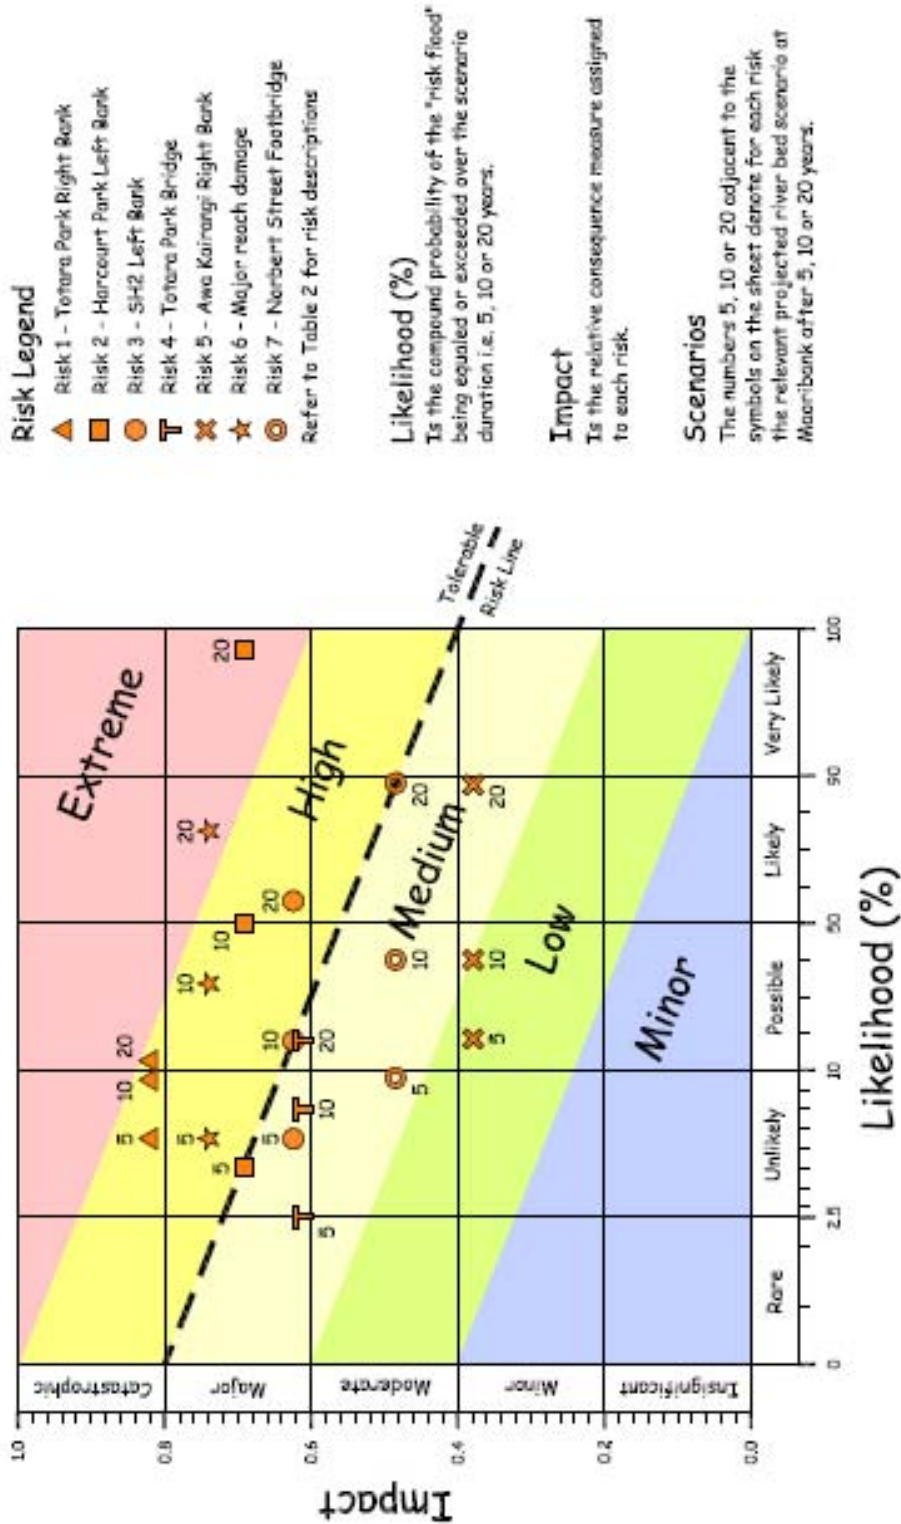
Presentation of Current and Projected Risks  
Figure 2

The outcomes of the risk analysis, after the technical and other information is assigned to each risk for the 5, 10 and 20 year riverbed scenarios, are shown on Figure 2.

The four Maoribank risks that fall above the tolerable risk line in the HIGH to EXTREME category are:

- Risk 1 - Totara Park RB Stopbank Failure
- Risk 6 – Major RB and LB Reach Damage
- Risk 2 – Harcourt Area LB Erosion
- Risk 3 – State Highway 2 LB Erosion (in the 20 year scenario)

Three of the four risks that fall in the HIGH to EXTREME category and above the tolerable risk line are those that are all or in part located upstream of the Maoribank Bend bed rock outcrop. If Risks 1 and 2 were controlled to an acceptable level, Risk 6 would fall to a risk category below the tolerable risk line.
