# **MAFBNZ Investigation of Compliance and Monitoring of the Scion GM Field Test.**

11 February 2008

Report prepared by:  
Kathryn Hurr  
Operations, Border Standards Group  
MAF Biosecurity New Zealand

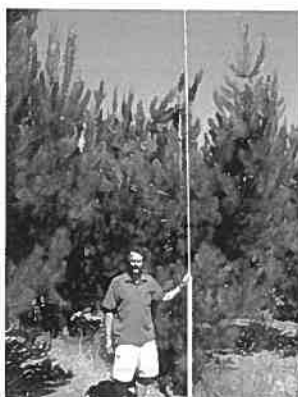
The height of all GM pine trees was verified on January 16 2008 as ranging between 4.5m and 4.8m, as measured against a fiberglass telescopic measuring pole. Topping is scheduled again within the next month to reduce the summer growth which the trees have put on since October.

Photo 1: The telescopic measuring pole used to measure the height of GM pine trees.

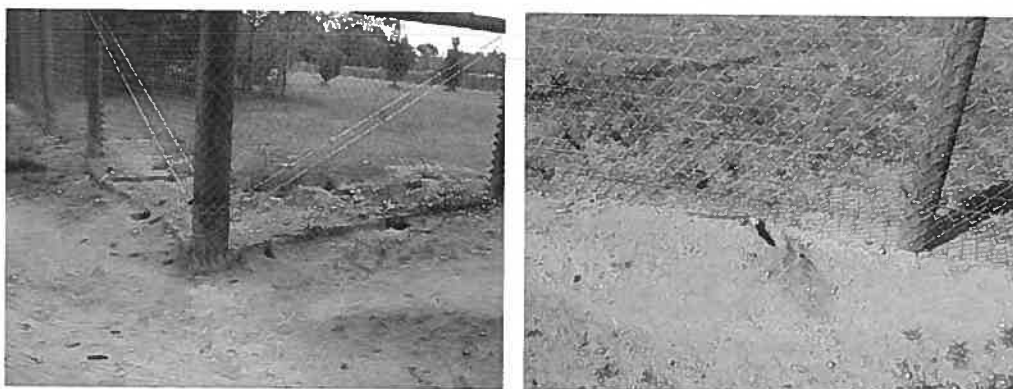
An inspection of the fence was undertaken to look for “holes in and under the fence”. No holes were found in the fence, apart from the access point created by protestors in January, which was repaired immediately the Police had concluded their site investigation. There was no evidence of extensive, deep burrowing in the ground in front of, or inside the fence, which could compromise the security of the site. Photographs were supplied to MAFBNZ by Steffan Browning of Soil & Health, which showed deeper holes in the ground in front of the wire netting fence, reportedly taken in November 2007. These are not typical of the rabbit holes observed during the site investigation in January, or depicted in photographs 2 and 3 (also provided by Steffan Browning). MAF is still investigating the cause of these holes, and has not ruled out the possibility these were man-made for publicity purposes.

Many rabbit scratchings and shallow holes were evident around the fence perimeter (see photographs below), and within the field test site. These were estimated variously to be 5-15cm deep.

Photos 2, 3: Rabbit holes and scratchings, typical of those seen during the site investigation.

Following the break-in incident, Scion are looking at various options to upgrade the security fence to improve the restricted access requirement.
