Report 03.146
Date 18 March 2003
File B/09/02/02

Committee Utility Services
Author Keith Woolley Asset Engineer

Possible Kaitoke Water Main Diversion - State Highway 2 to State Highway 58

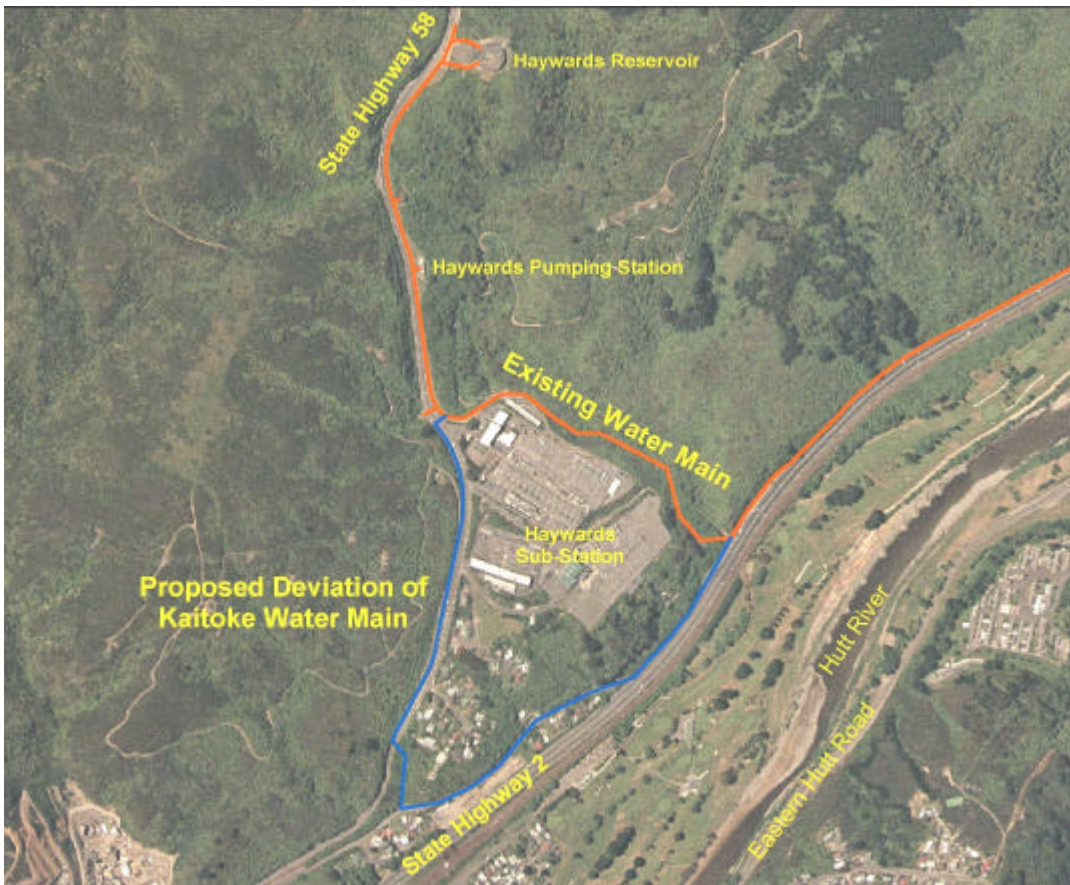
An alternative route following SH58 has been investigated and \$1.8 million programmed in the draft capital works programme in 04/05 to construct a new water main along this route. The existing water main alignment and proposed diversion are shown in Figure 1.

Figure 1 : Existing and proposed diversion of the Kaitoke Main.

A 1500 metre water main diversion, as shown in Figure 1 between SH2 and SH58 has been investigated. \$1.8 million is allocated in the draft capital works programme in 2004/05 to construct the diversion. The proposed water main route continues south of Old Haywards Hill Road along SH2 and McDougall Grove, west along a short section of walkway then up a steep slope at the head of a gully and north along the uphill side of SH58 to join with the existing main at the top of the Old Haywards Hill Road.

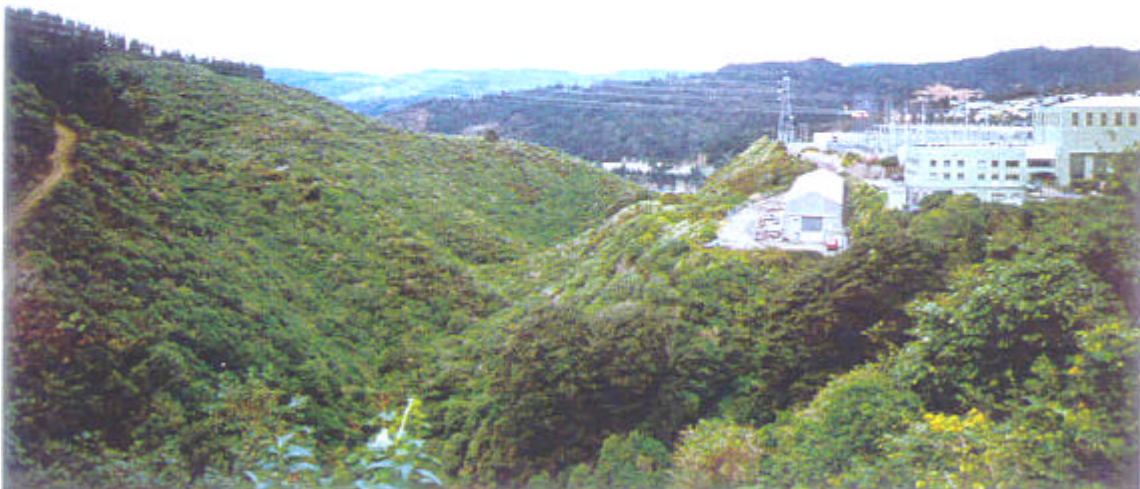
Figure 2 : Steep terrain along Old Haywards Hill Road portion of Water Main (on hillside below Haywards substation).

The Old Haywards Hill Road runs across steep weathered greywacke rock terrain. Gullies have been formed by preferential erosion in the rock, and some gullies have been partially filled in with eroded material (colluvium). Colluvium has also been deposited on slopes at some locations. Weathering of the greywacke rock has also occurred.

The colluvium is more susceptible to instability than the parent rock. Where the colluvium predominates, a number of slips have occurred below the road indicating these areas are marginally stable. A rise in water level after prolonged rainfall may be sufficient to cause instability at these locations, with or without seismic loads.

The major hazard to the existing watermain is landslides resulting from seismic shaking acceleration, which will result in damage to, or complete loss of, the water main, and severely limit access to effect repairs.

The diversion of the pipeline between SH2 and SH58 should be constructed as soon as practicable. It should be noted that the diversion does not completely eliminate the risk of damage to the water main and emergency materials and appropriate emergency planning measures are to be put in place.
