JUNE 2005

CCA and Formaldehyde Monitoring at Railway Crescent, Masterton

Perry Davy
Air Quality Scientist

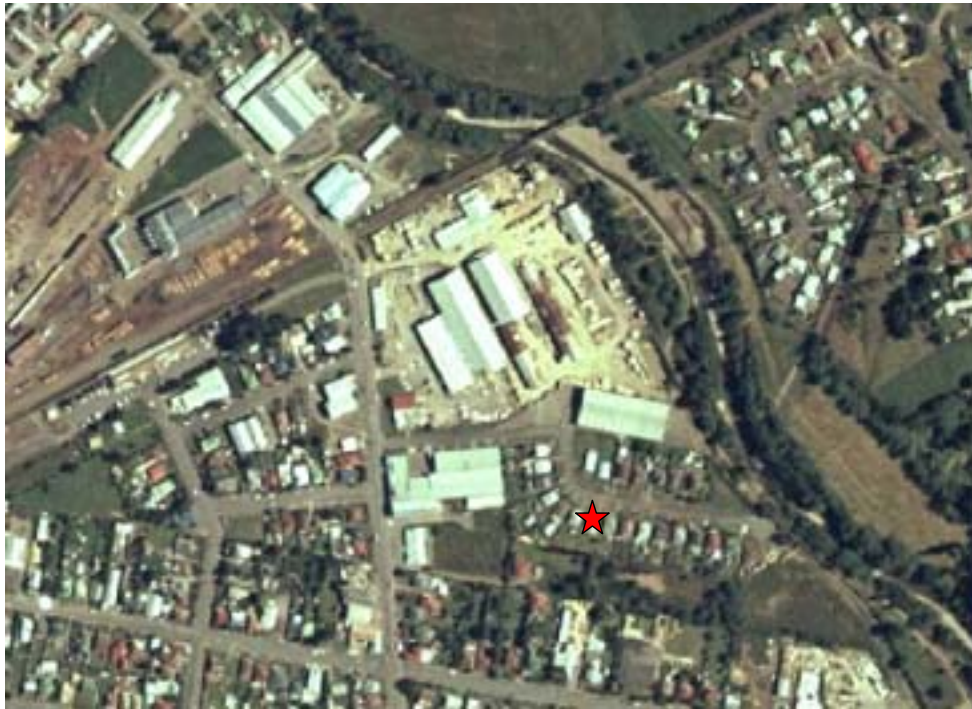
The samplers were set up in the front yard of a residential property on Railway Crescent, Masterton. The monitoring site was approximately 100 metres to the southeast of the timber mill's wood drying kilns. Figure 1 shows an aerial photograph of the monitoring site and Figure 2 shows the site location to the north of Masterton town centre.

Figure 1: Aerial view of monitoring site (★)

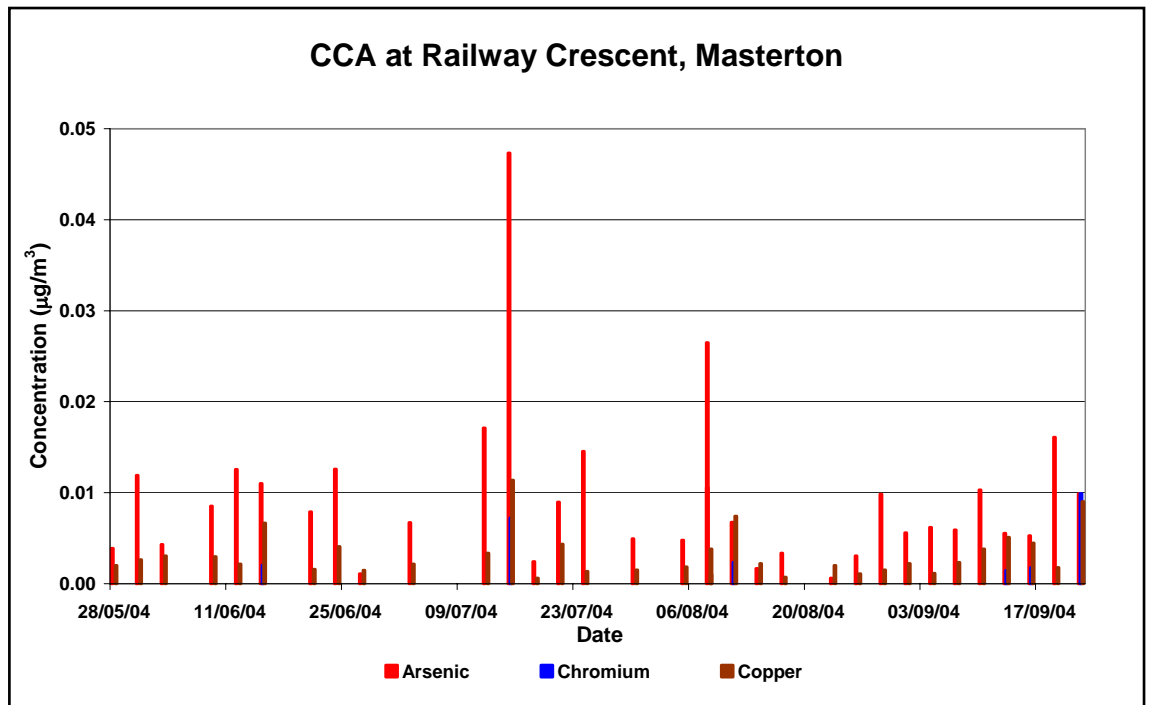
A total of 33 TSP samples were collected during the monitoring period. The results for the TSP and CCA analysis are given in Table 1 and depicted graphically in Figure 3.

Figure 3: CCA concentrations at Railway Crescent, Masterton

The analysis of TSP samples for CCA show that detectable levels of these elements were present in the air at the Railway Crescent site. However, comparison with concentrations at the Wairarapa College background air quality monitoring site show that levels of CCA at Railway Crescent are similar to CCA concentrations likely to be found elsewhere in the Masterton airshed.

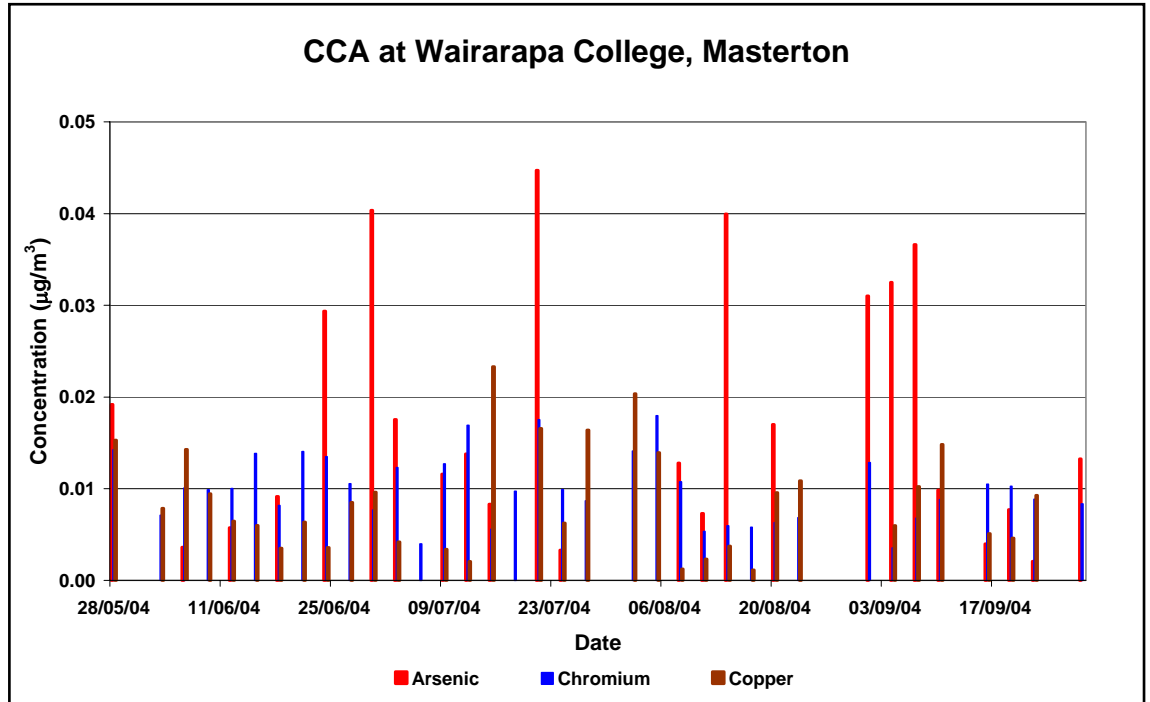
The background CCA concentrations are depicted graphically in Figure 4.

Figure 4: Background CCA concentrations at Wairarapa College, Masterton

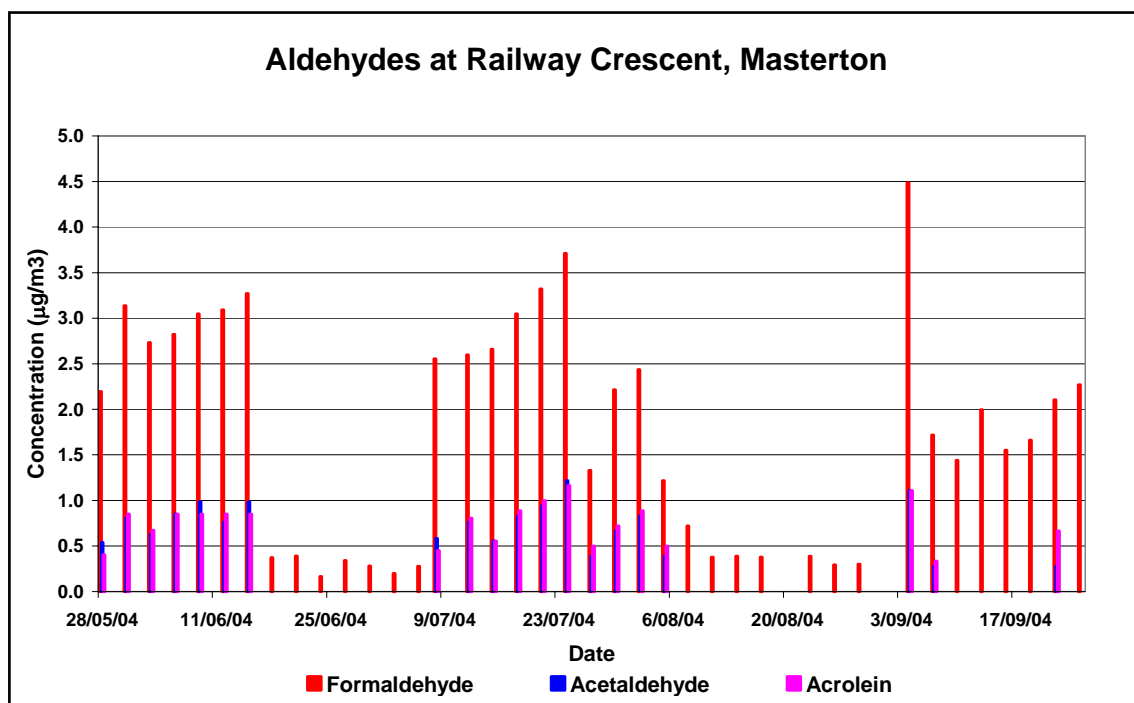
Figure 5 shows the results graphically.

Figure 5: Aldehyde concentrations at Railway Crescent, Masterton
