Will I get sick if I swim?

Suitability for recreation grades for selected marine and fresh water bathing sites in the Wellington region

Environmental Monitoring and Investigations
Greater Wellington Regional Council

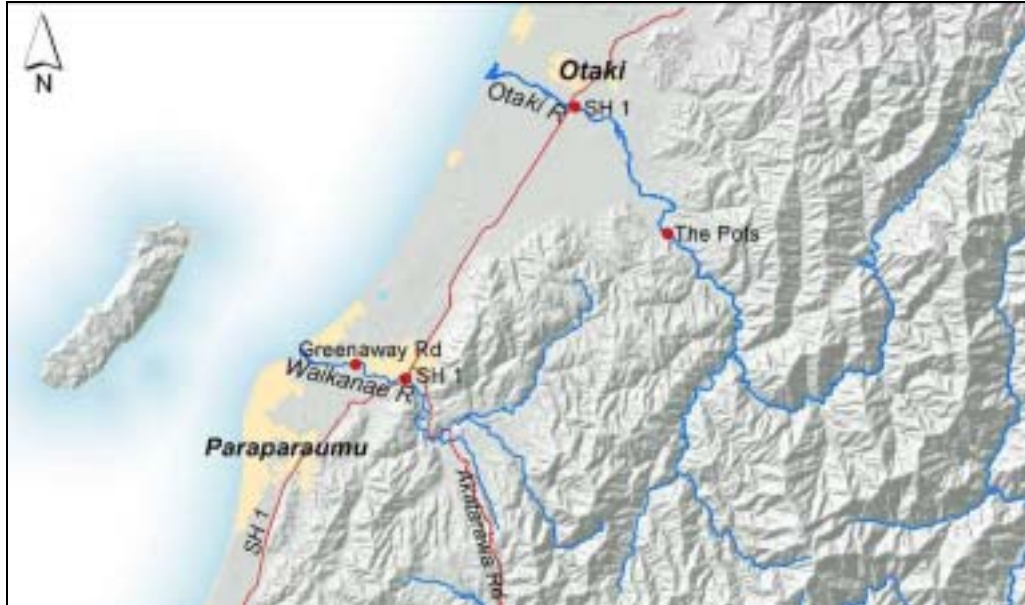
Figure 3.2: Freshwater recreational water quality monitoring sites on the Kapiti Coast.

Over the last five years, four freshwater sites have been monitored on the Kapiti Coast, two on the Otaki River and two on the Waikanae River (Figure 3.2).

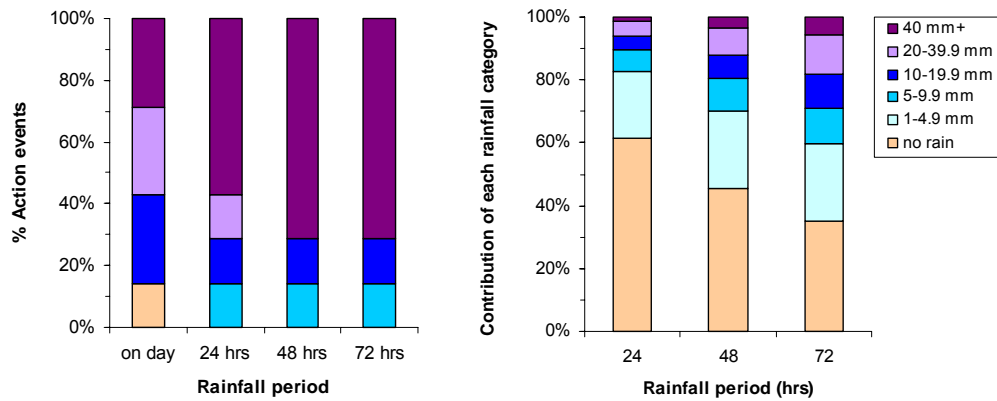
Figure 3.6: (a), left – rainfall on the day and in the hours prior to action level results (7) recorded during routine weekly sampling in the Waikanae River at Greenaway Road over the 2001-2006 summer bathing months; (b), right – frequency of rainfall events of varying amounts recorded at the Waikanae Water Treatment Plant over the 2001-2006 summer months.

Of the seven level action results recorded at each Waikanae River site over the last five summers, six coincided with more than 10 mm of rainfall (and four with more than 40 mm of rainfall) in the 24 hours prior to day of sampling (Figure 3.6a). A review of rainfall recorded in the catchment over the 2001-2006 summer sampling periods shows that more than 10 mm of rain in 24 hours could be expected on just 10 % of all 24 hour periods, with more than 40 mm of rain expected on less than 2 % of these occasions (Figure 3.6b). Therefore the heavy rain events that result in action level events do not occur very often.

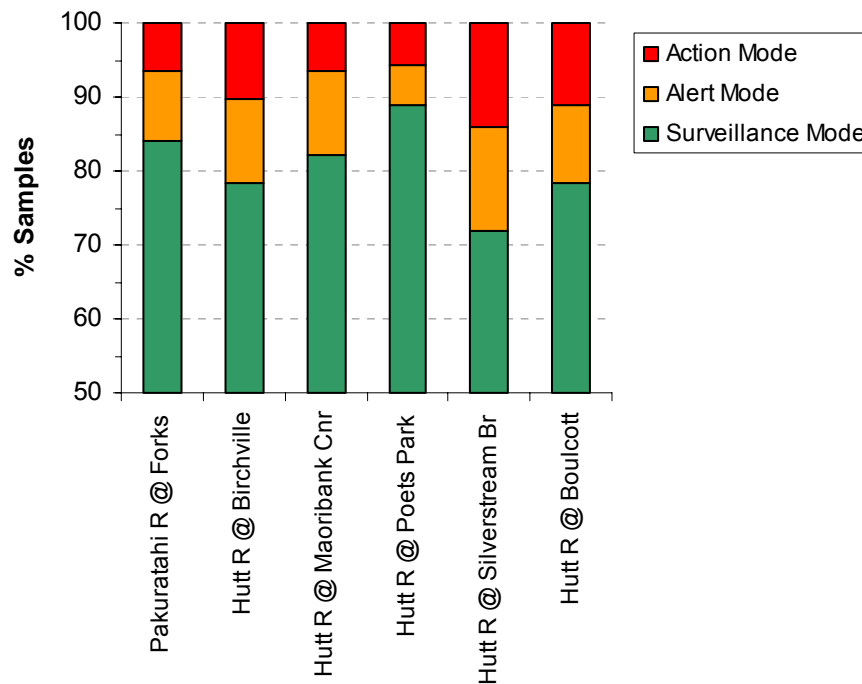
Figure 3.8: Summary of compliance with the surveillance, alert and action modes of the MfE/MoH (2003) recreational water quality guidelines, expressed as a percentage of the total number of routine sampling events undertaken over the 2001-2006 summer bathing seasons.

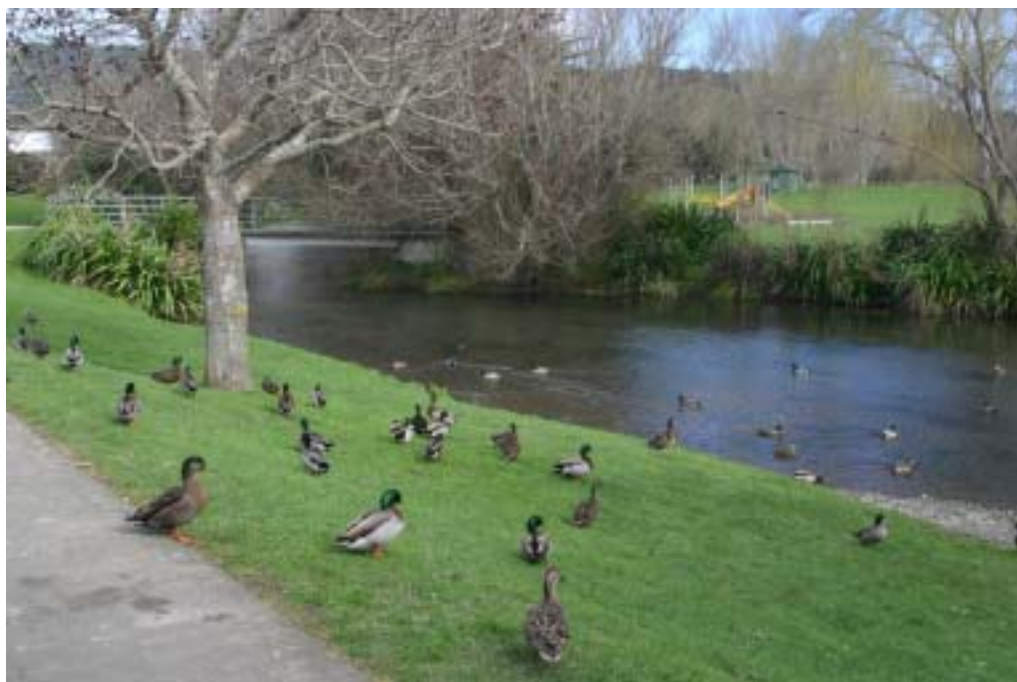
Figure 3.12: Mawaihakona Stream at Heretaunga Park.

In addition to rainfall, tributary streams are likely to impact on water quality at some of the Hutt River sites; the Akatarawa River enters the Hutt River at Birchville and the Mawaihakona Stream enters the river approximately 600 metres upstream of Silverstream. The Mawaihakona Stream may have high bacteria counts as it runs through a pond-like setting in Heretaunga Park where it attracts large numbers of waterfowl (Figure 3.12).

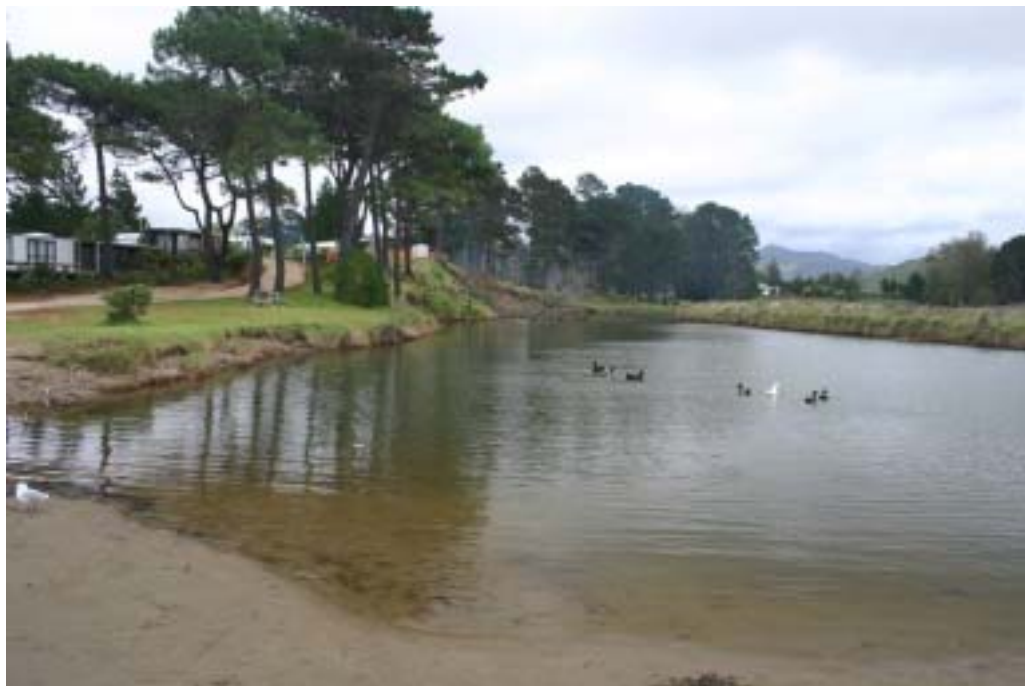
Figure 3.17: Riversdale Lagoon at Riversdale.

The Waipoua River at Colombo Road carries a high risk of microbiological contamination due to both agricultural activity in the upstream catchment and its urban location; stormwater is discharged to the river immediately upstream of the bathing site and sewer overflows have been recorded in the past (Yeats⁷, pers. comm., 2006). Riversdale Lagoon also has a high risk of microbiological contamination (Figure 3.17). The lagoon drains an agricultural catchment and has a history of poor water quality. Agricultural practices (e.g., stock access, drainage) are the likely reason for this, along with birdlife and possible seepage of septic tank and landfill leachate (Stansfield 2000).

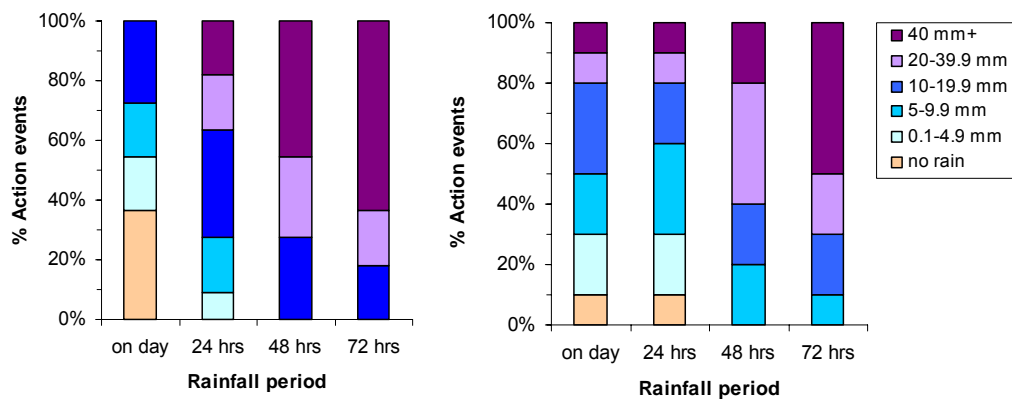
Figure 3.18: Rainfall on the day and in the hours prior to action level results recorded during routine weekly sampling in the Ruamahanga River at Te Ore Ore (left) and Waihenga over the 2001-2006 summer bathing months.

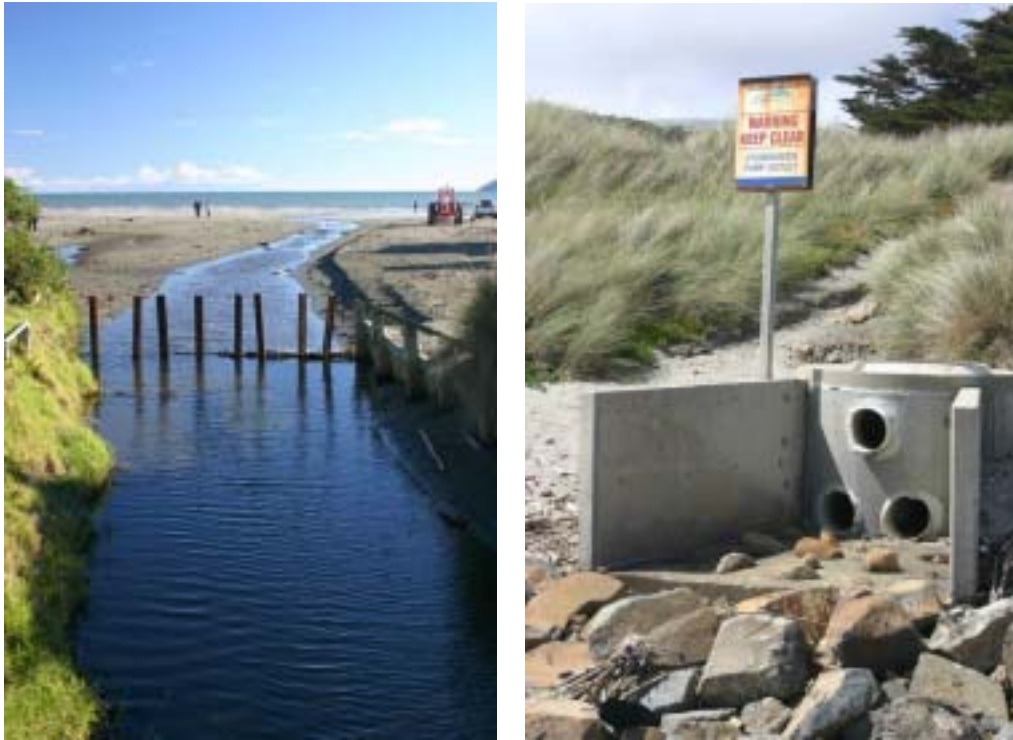
Figure 4.4: Tikotu Stream drains to Paraparaumu Beach (left) and stormwater outfalls discharge to Waikanae Beach behind the Tutere Street tennis courts.

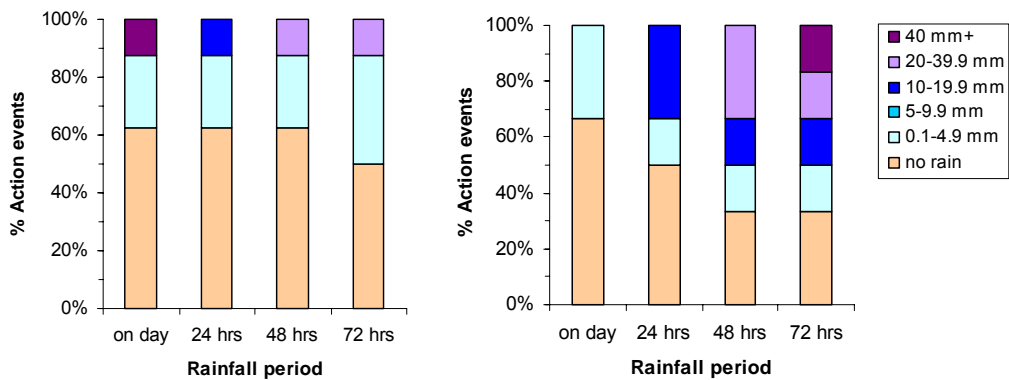
Figure 4.6: Rainfall on the day and in the hours prior to action level events recorded during routine weekly sampling along Paraparaumu Beach at Ngapotiki Street (left) and Toru Road over the 2001-2006 summer bathing period.

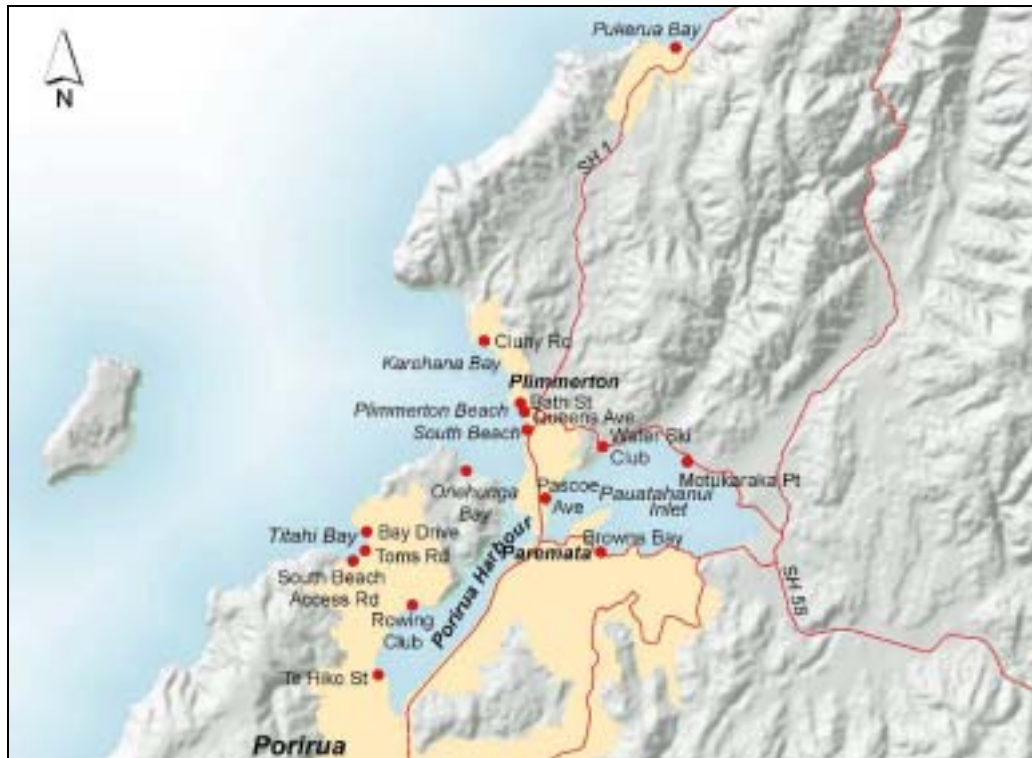
Figure 4.7: Marine recreational water quality monitoring sites in Porirua City.

Recreational water quality monitoring has been conducted at 14 marine sites in Porirua City over the last five years (Figure 4.7). An additional site – Porirua Harbour at Te Hiko Street – was monitored over 2001/2002 but was dropped after twelve of the 22 samples collected exceeded the action level of the recreational water quality guidelines (Milne 2005).

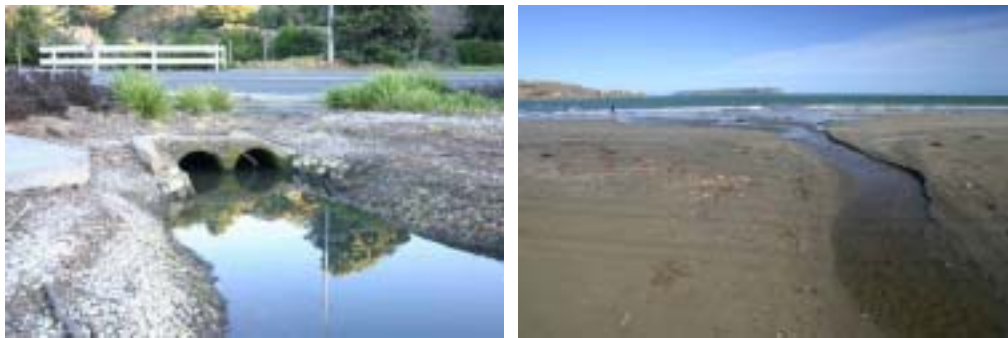
Figure 4.9: Browns Stream (left) flows into the Pauatahanui Inlet at Browns Bay and Taupo Stream discharges to Plimmerton Beach.

The majority of bathing sites carry a moderate risk of microbiological contamination due to being located in close proximity to confluences with streams or drains that receive either agricultural run-off or urban stormwater (Figure 4.9). Pukerua Bay is more remote and is considered to have a lower risk of microbiological contamination, despite the presence of a stream nearby. Refer to Appendix 3 for a complete assessment of the risk factors present at each site.

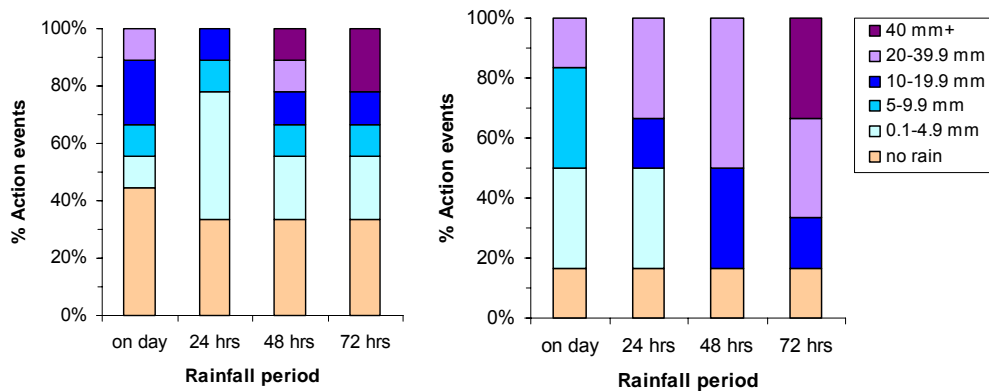
Figure 4.10: Rainfall on the day and in the hours prior to action level events recorded during routine weekly sampling in the Pauatahanui Inlet at Browns Bay (left) and the Water Ski Club over the 2001-2006 summer bathing period.

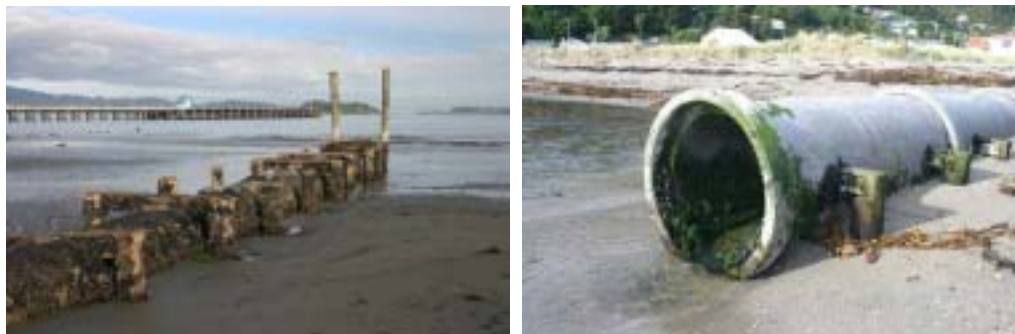
Figure 4.15: Stormwater outfalls at Petone Beach (left) and Rona Bay at the northern end of Cliff Bishop Park.

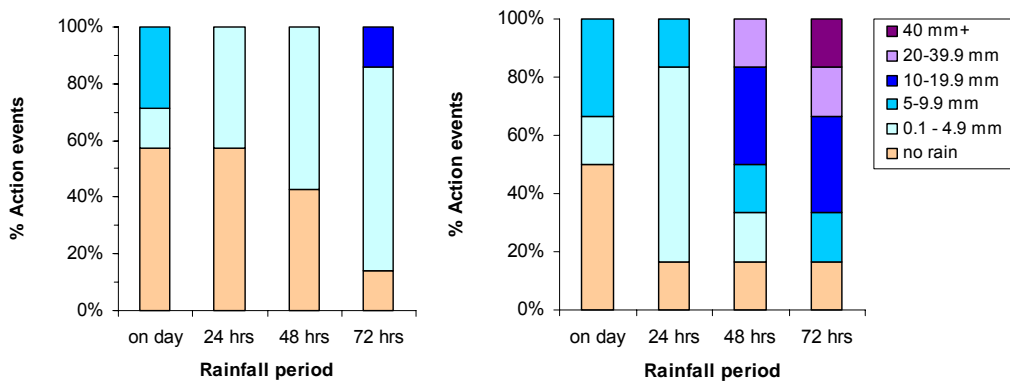
Figure 4.17: Rainfall recorded on the day and the hours prior to action level events recorded during routine weekly sampling at Petone Beach (Sydney Street) (left) and Rona Bay (Cliff Bishop Park) over the 2001-2006 summer bathing period.

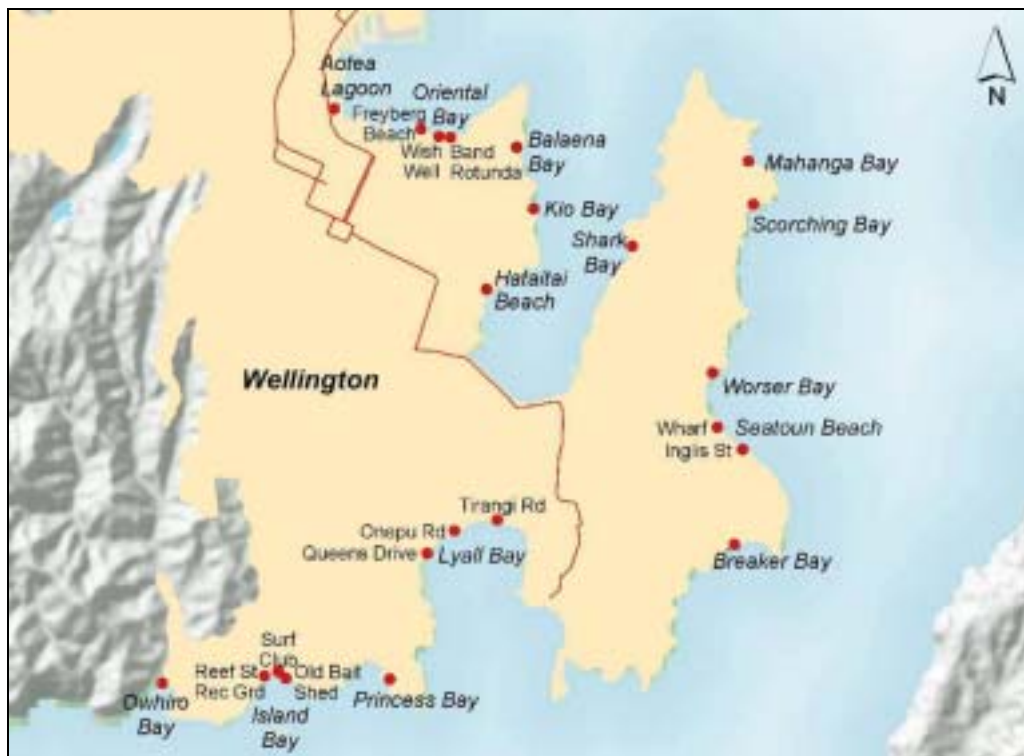
Figure 4.18: Marine recreational water quality monitoring sites in Wellington City.

Recreational water quality monitoring has been conducted at 22 marine sites in Wellington City over the last five years (Figure 4.18). There was one change in monitoring sites during this period; the Old Bait Shed at Island Bay was dropped after the 2004/2005 summer in favour of a site adjacent to Derwent Street, to the west of the Reef Street Recreation Ground. Monitoring at the Derwent Street site commenced in January 2005.

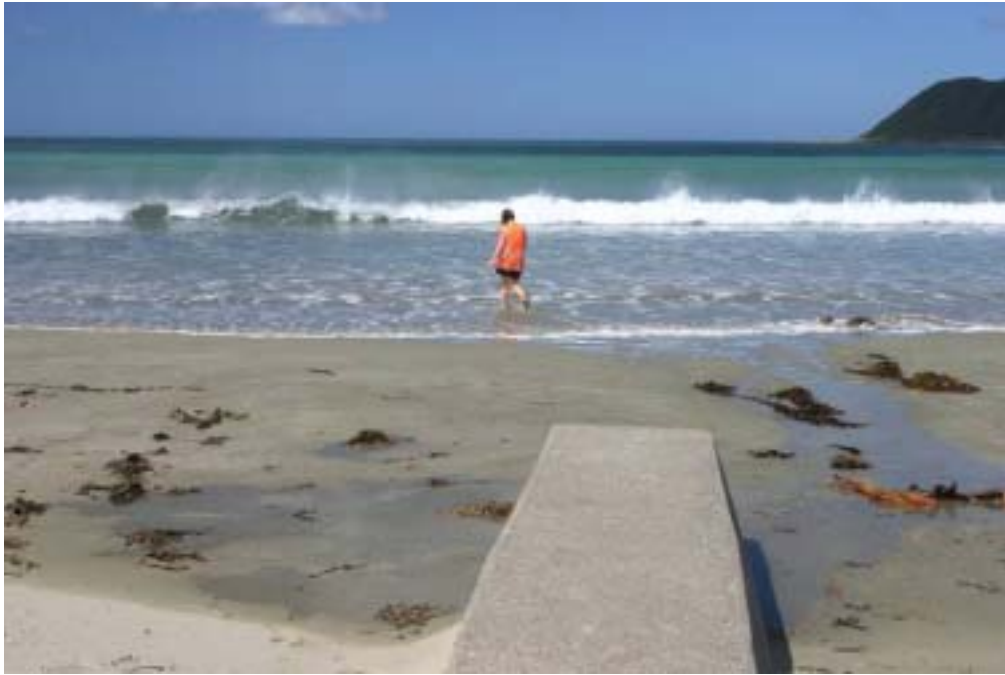
Figure 4.20: Stormwater outfall at Tirangi Road, Lyall Bay.

Sites at Aotea Lagoon, Oriental Bay, Seatoun Beach, Lyall Bay and Island Bay all have a moderate risk of microbiological contamination, reflecting their close proximity to urban stormwater outfalls (Figure 4.20). Hataitai Beach and Owhiro Bay also have a moderate risk of contamination. Faecal contamination from ducks and urban runoff pose the major risks at Hataitai Beach, although decaying leaf litter from nearby pohutukawa trees may also play a role (Wood¹⁴, pers. comm., 2006). Owhiro Stream, an urban stream draining a mix of residential and industrial land use, discharges to Owhiro Bay and has a long history of elevated faecal bacteria counts (Figure 4.21).

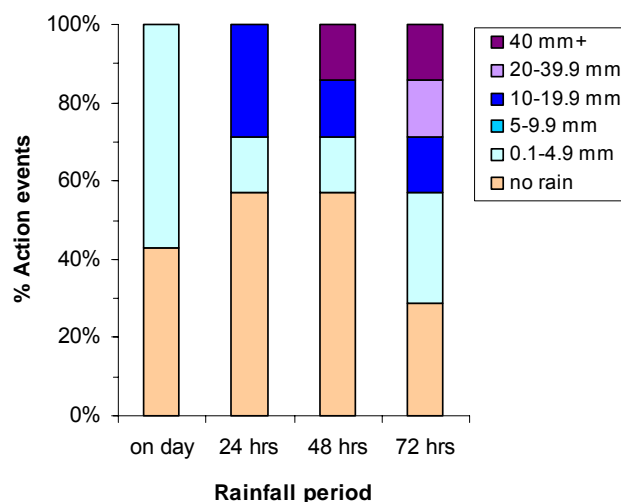
Figure 4.22: Rainfall recorded on the day and the hours prior to action level events recorded during routine weekly sampling at Oriental Bay (Wishing Well) over the 2001-2006 summer bathing period.

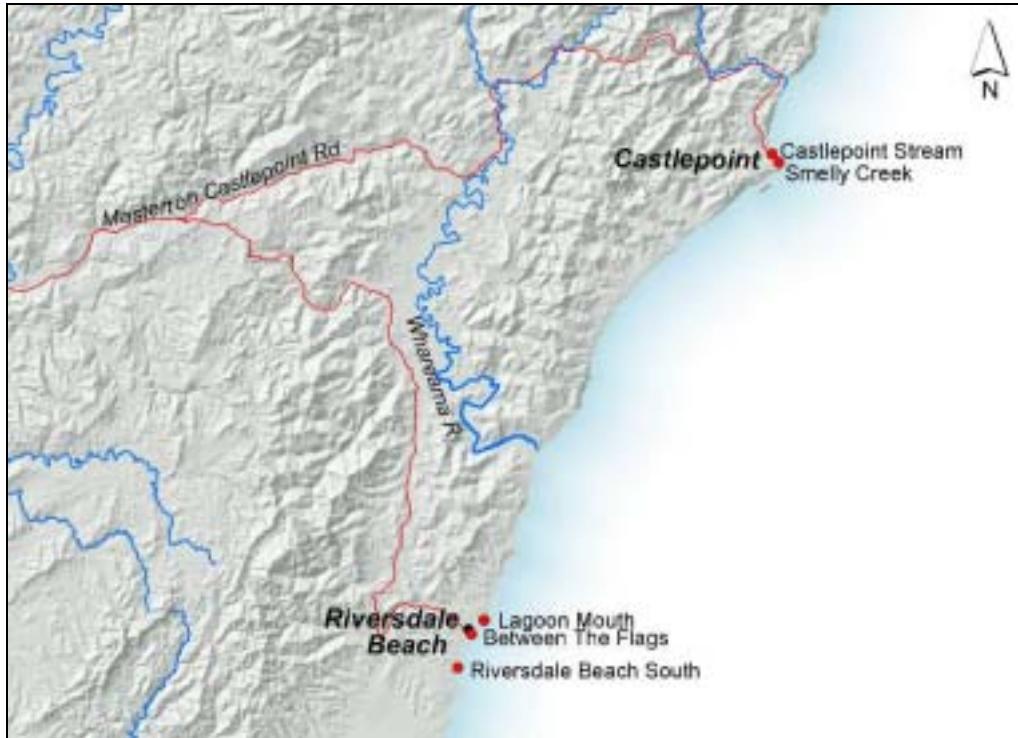
Figure 4.23: Marine recreational water quality monitoring sites in the Wairarapa.

Marine recreational water quality monitoring is conducted at two sandy beaches in the Wairarapa; Riversdale and Castlepoint. Five sites have been monitored along these two beaches over the last five years (Figure 4.23).

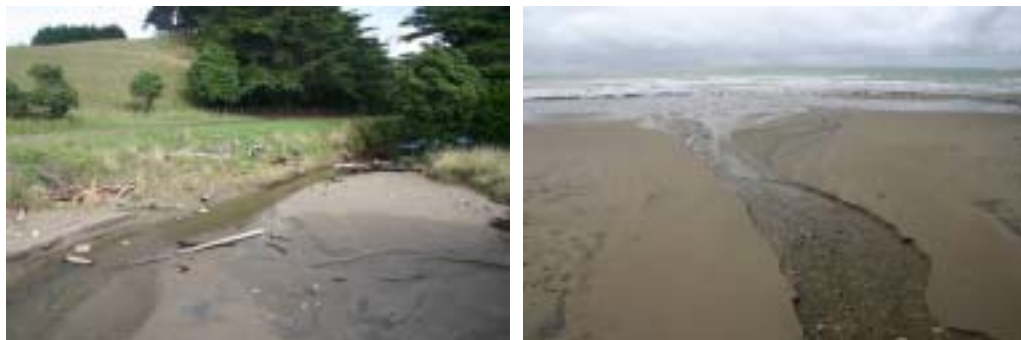
Figure 4.25: Castlepoint Stream and Castlepoint Beach.

The Castlepoint Beach sites have a moderate risk of microbiological contamination, as they are located adjacent to the outflows from Castlepoint Stream (Figure 4.25) and Smelly Creek. Both of these streams drain predominantly agricultural catchments, with the former also receiving treated wastewater from the Castlepoint township during the winter months.
