Hulls Creek – water quality and ecology

Environmental Monitoring and Investigations Department

GW/EMI-T-07/219

August 2007

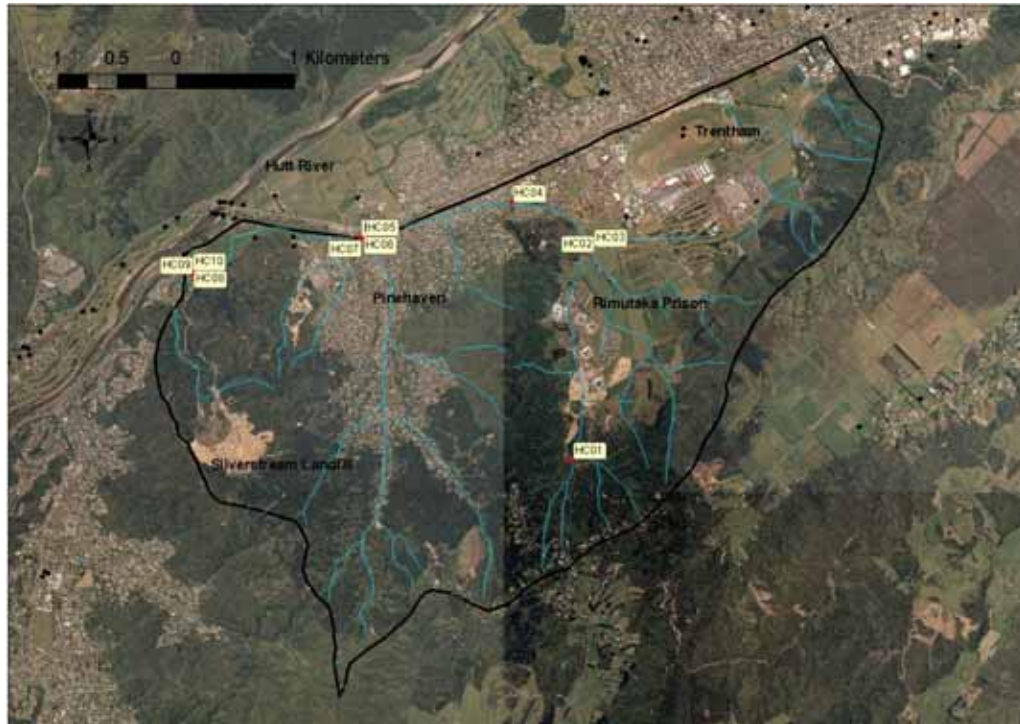
The Hulls Creek catchment is made up of low lying hills in the Blue Mountains, Pinehaven, and Trentham/Wallaceville areas and low gradient areas around Heretaunga and Silverstream (Figure 2.1).

Figure 2.1: Map of the Hulls Creek catchment showing the 2006/07 water sampling sites

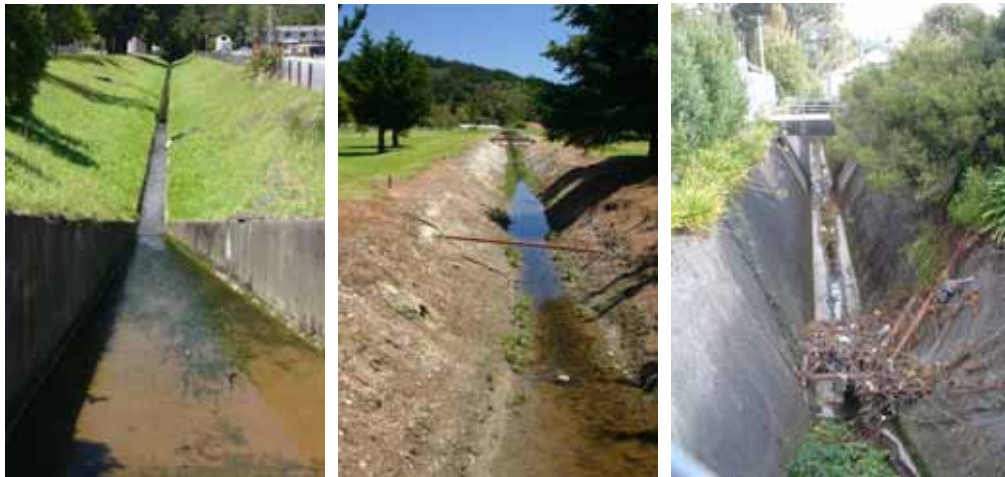
Pastoral and urban landuse in the upper and middle reaches of the Hulls Creek catchment has resulted in significant channel modification in many places. Much of the northern tributary and part of the main Hulls Creek channel between the northern tributary confluence and the former Central Institute for Technology (CIT) site have been integrated into Upper Hutt City Council's stormwater network and are often referred to as the Heretaunga Drain. These reaches have been straightened and are concrete lined over much of their length (Figure 2.2). In urban areas some parts of Hulls Creek and its

Figure 2.2: Examples of channel modification in Hulls Creek at the former Central Institute of Technology (CIT) site (left), the Trentham Camp golf course (middle) and in the northern tributary downstream of the former General Motors site (right)

- A high proportion of stream reaches in urban areas of the Hulls Creek catchment is heavily modified through straightening, concrete lining and in some cases piping (refer to Figure 2.2, Section 2.1). This modification has resulted in significant degradation of invertebrate and fish habitat in these reaches.

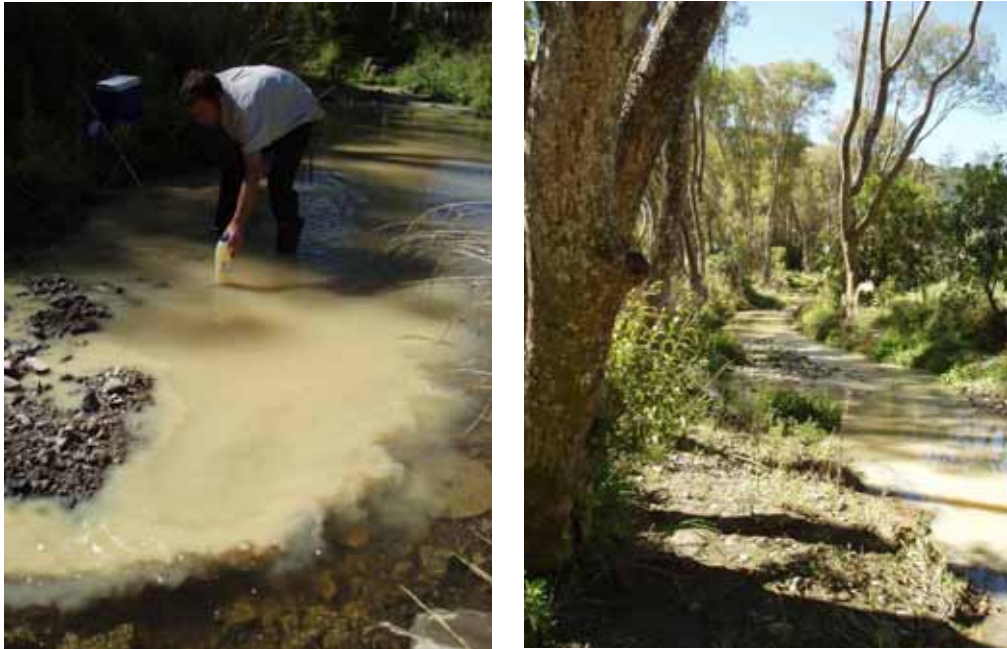
There have been several instances of non-compliant discharges from the Silverstream Landfill stormwater sediment retention ponds to Tip Stream. One such incident, on 27 January 2006, resulted in large amounts of sediment entering Tip Stream, Hulls Creek and the Hutt River (Table 2.3, Figure 2.3). High concentrations of aluminium, copper and iron were also associated with this particular discharge. It is likely that these metals were bound to sediment particles in the stormwater sediment retention pond given the circumstances of the discharge event.

Figure 2.3: Turbid water at the confluence of Tip Stream with Hulls Creek (left) and in Hulls Creek downstream of Tip Stream (right) following an unauthorised discharge from the Silverstream Landfill stormwater sediment retention ponds, 27 January 2006

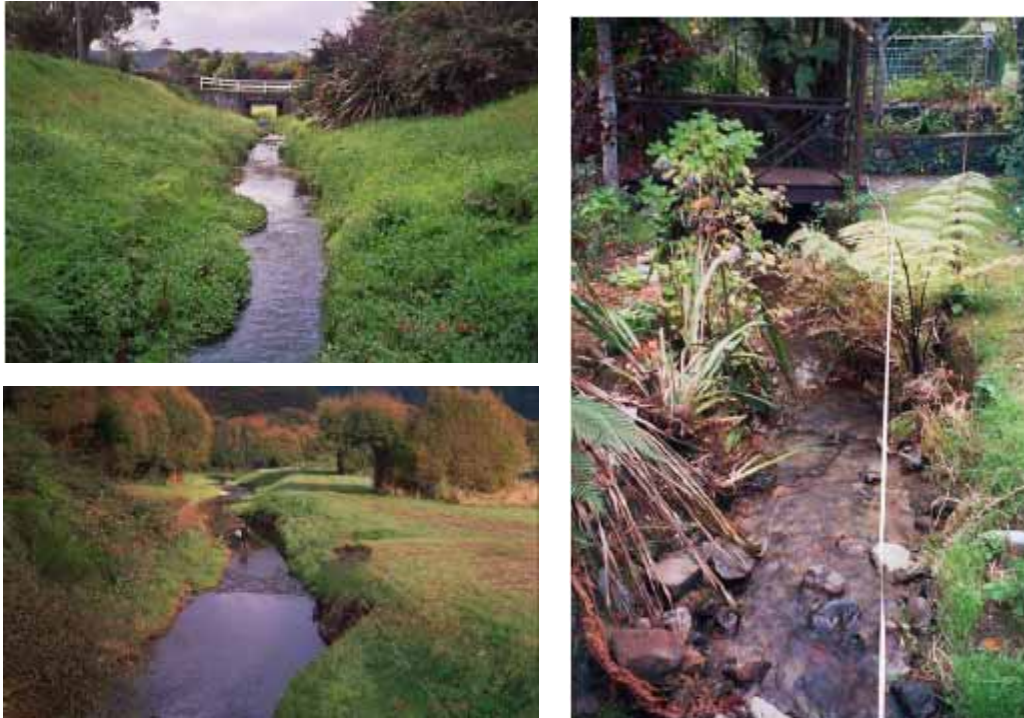
In contrast to the upper Pinehaven Stream site, where channel shading was estimated to be 64%, both sites on Hulls Creek had little or no channel shading (Figure 2.4). There was 100% periphyton cover at all three sites and macrophytes covered 72% of the channel at the upper Hulls Creek site.

Figure 2.4: Sites in the Hulls Creek catchment assessed as part of Kingett Mitchell's (2005) urban stream study – upper Hulls Creek (top left), lower Hulls Creek (bottom left), and upper Pinehaven Stream (right)

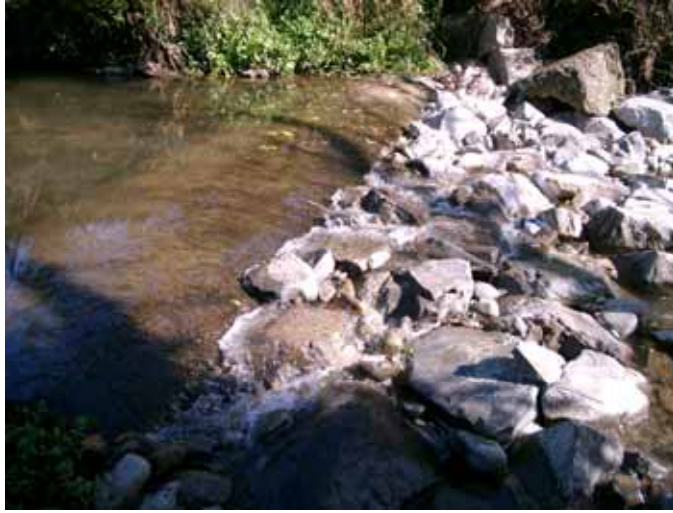
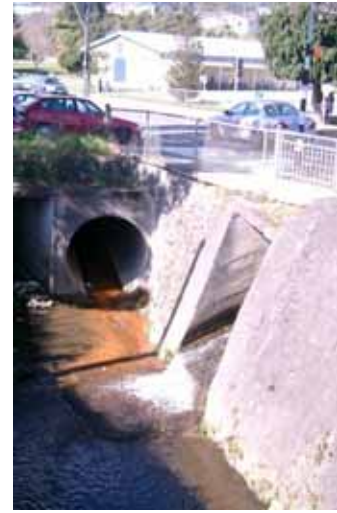
In conjunction with the Silverstream Care Group, Greater Wellington constructed a fish pass over this weir in August 2007 (Figure 2.5). Fish monitoring will be carried out to assess any changes in the Hulls Creek fish community that the fish pass may bring about.

Another barrier to fish passage in the Hulls Creek catchment is the drop of approximately half a metre at the confluence of the Pinehaven Stream with Hulls Creek. This barrier, combined with the piping of approximately 300m of the Pinehaven Stream upstream of the confluence, is likely to be limiting fish access to high quality habitat in the upper reaches of the catchment.

Figure 2.5: Fish pass constructed at the weir downstream of Eastern Hutt Road (left) and a possible barrier to fish passage at the confluence of the Pinehaven Stream with Hulls Creek (right)

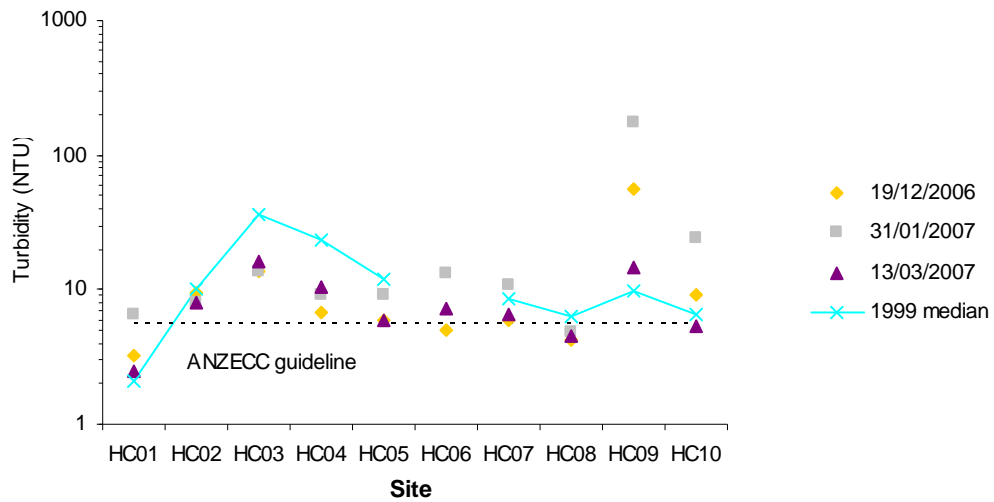
Turbidity levels exceeded the ANZECC (2000) default trigger value of 5.6 NTU on 22 of 30 sampling points. Turbidity levels were highest in Tip Stream with a maximum of 174 NTU recorded in January. The median turbidity recorded across all sites was 8.04 NTU. Comparison with measurements taken in 1999 suggests little change in turbidity levels in Hulls Creek in the last eight years (Figure 3.1).

Figure 3.1: Turbidity measurements from water sampling in Hulls Creek on three occasions over 2006/07 and median results from eight sampling occasions at nine sites over 1998/99 (from Berry 1999). Note the logarithmic scale on the y-axis.

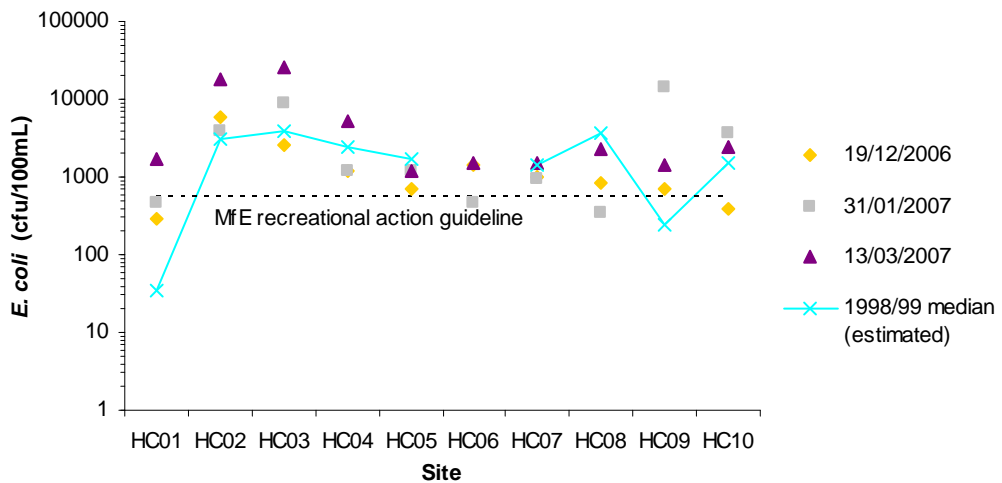
E. coli counts in Hulls Creek ranged between 290 cfu/100mL and 26,000 cfu/100mL. The median *E. coli* count from all sites was 1,400 cfu/100mL. All but five of the 30 samples taken from Hulls Creek were above the action mode of the MfE/MoH (2003) recreational water quality guidelines (550 cfu/100mL), indicating that the creek is unsafe for contact recreation (Figure 3.2). In general the highest *E. coli* counts were found in the upper catchment.

Figure 3.2: *E. coli* counts in Hulls Creek measured on three occasions in 2006/07 and median results from eight sampling occasions at nine sites in 1998/99 (from Berry 1999). Median *E. coli* counts from 1998/99 were estimated by applying the USEPA ratio to faecal coliform data. Note the logarithmic scale on the y-axis.

E. coli data collected for this study cannot be directly compared to 1999 faecal coliform data. However, using the USEPA relationship between these two indicators (the USEPA estimates that out of 200 faecal coliforms 126 will be *E. coli* (<http://www.mfe.govt.nz/issues/water/water-quality-faqs.html#question4>)) to estimate *E. coli* levels from 1999 faecal coliform data it appears that there has been little change faecal bacteria levels since 1999 (Figure 3.2).

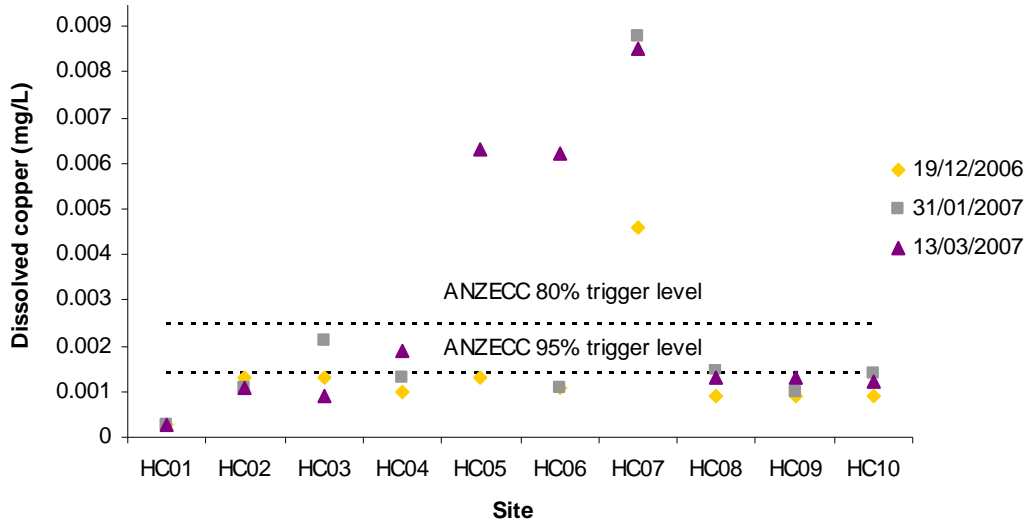
Figure 3.3: Dissolved copper concentrations recorded on three sampling occasions between December 2006 and February 2007 inclusive

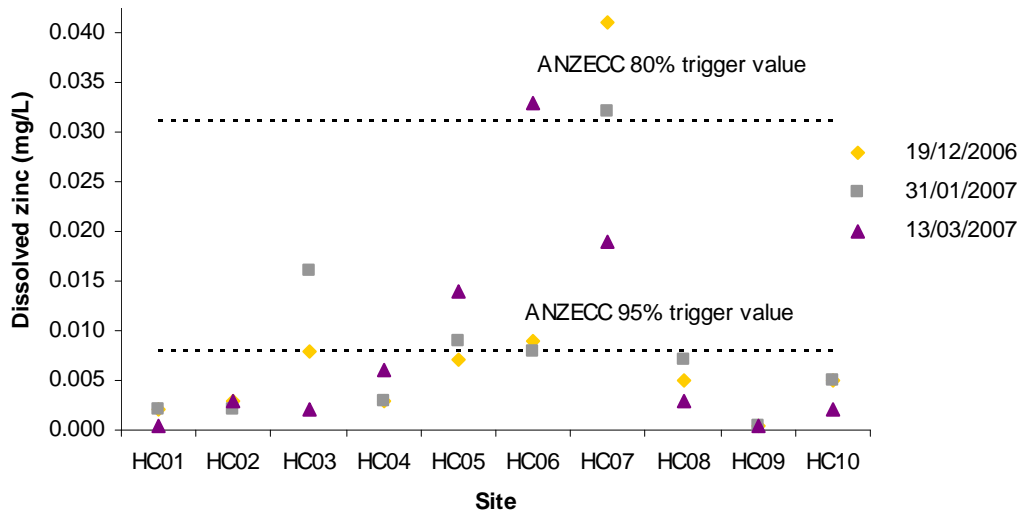
protection threshold. Dissolved zinc concentrations were highest in the lower Pinehaven Stream and immediately downstream of its confluence with Hulls Creek.

Figure 3.4: Dissolved zinc concentrations recorded on three sampling occasions between December 2006 and February 2007 inclusive

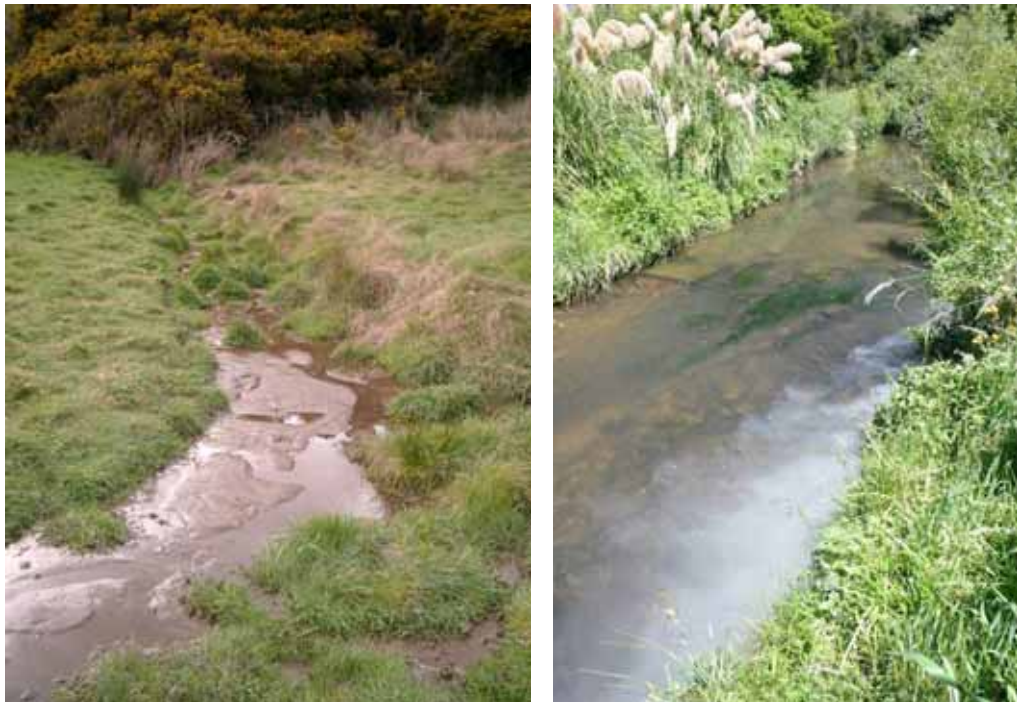
Figure 4.1: Heavy siltation in a branch of the northern Hulls Creek tributary (left) and turbid water entering Hulls Creek below Tip Stream (right)

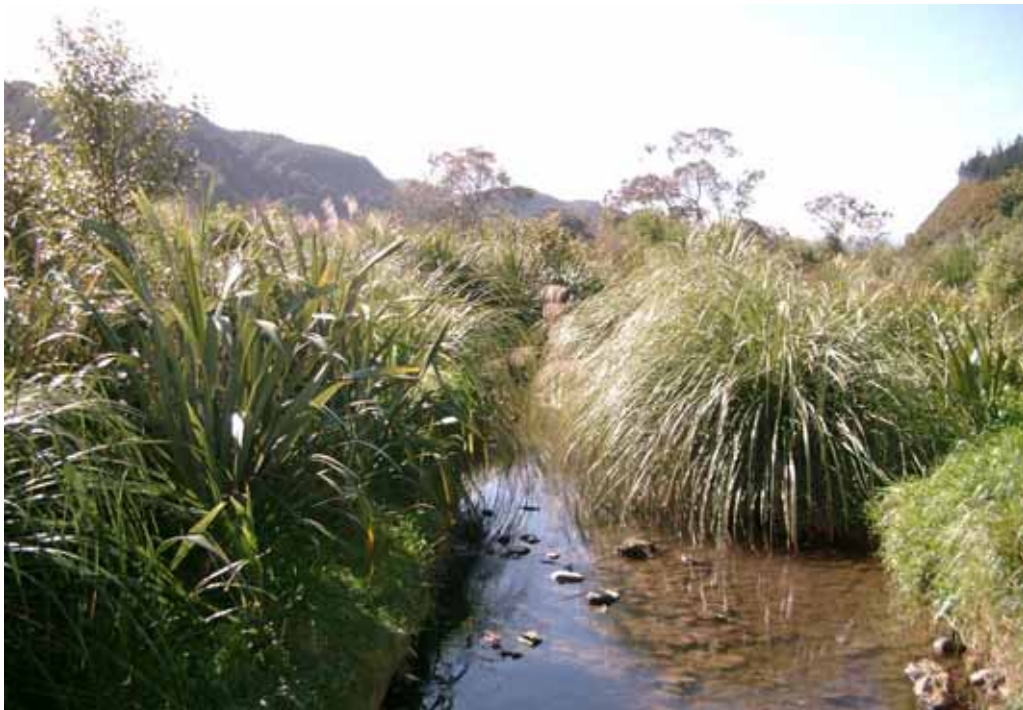
The Silverstream Care Group, a Forest and Bird led group with financial assistance from Greater Wellington and the Ministry for the Environment's Sustainable Management Fund, is currently undertaking restoration work in the lower Hulls Creek catchment. So far this work has involved willow removal, riparian planting (Figure 4.2), weed control and rubbish removal from 700m of Hulls Creek in the lower catchment (Richard Romijn, Greater Wellington, pers. comm.). The care group has also recently constructed a fish pass at the weir located downstream of Eastern Hutt Road (refer Figure 2.5, Section 2.3.4). The riparian rehabilitation work has resulted in significant improvement in riparian and instream habitat in the lower reaches of Hulls Creek and together with removal of fish barriers may result in improved fish diversity in these reaches. This work may also improve the likelihood of fish reaching high quality habitats found in some upper catchment reaches.

Figure 4.2: A reach of lower Hulls Creek where riparian rehabilitation work has been undertaken by the Silverstream Care Group
