Report 07.38
Date 30 January 2007
File ENV/17/02/01

Committee Environment
Author Tim Strange, Pollution Control Officer

Pollution Control Report for the period 27 October 2006 to 19 January 2007

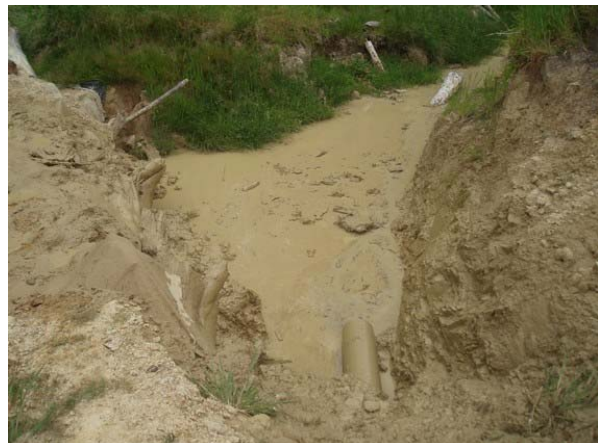
Pollution Control Officers investigated a discharge of sediment laden water from earthworks at the Silverwood Block in Whitby. The discharge caused significant discolouration of a neighbouring wetland and Pauatahanui Inlet. Pollution Control and Consents and Compliance teams are investigating the cause of this incident.

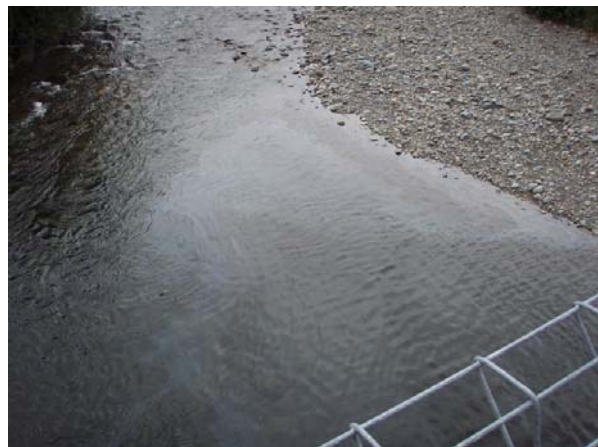
Approximately 5000L of diesel was discharged into the Akatarawa River on New Years Eve following vandalism of a bulk storage tank at Akatarawa Saw Mills. The discharge caused a significant plume in the Akatarawa River for the following 24 hours. Pollution Control are working with the saw mill to improve security of the tank to prevent reoccurrence.

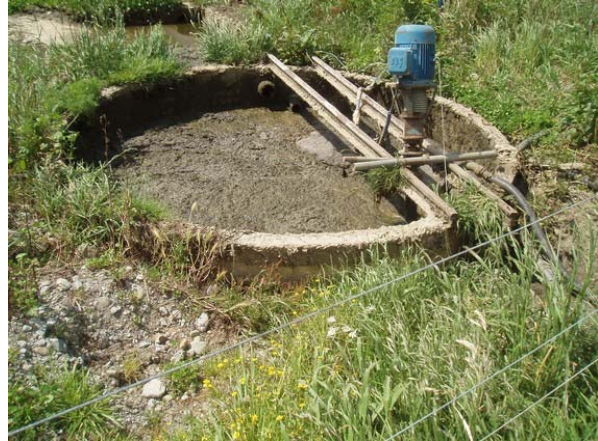
Inspection of a dairy farm in the Wairarapa discovered dairy shed effluent overflowing from the effluent sump to a stream contaminating the drinking water supply for cattle on neighbouring properties.

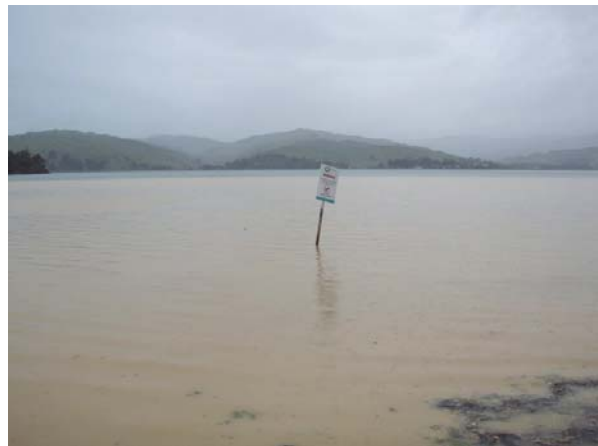
Sediment was discharged to Browns Bay during rainfall from the Staithes Drive subdivision in Whitby. The ongoing discharge of sediment to Browns Bay from this subdivision is likely to cause a large amount of deposition of sediment in the Bay smothering marine species.

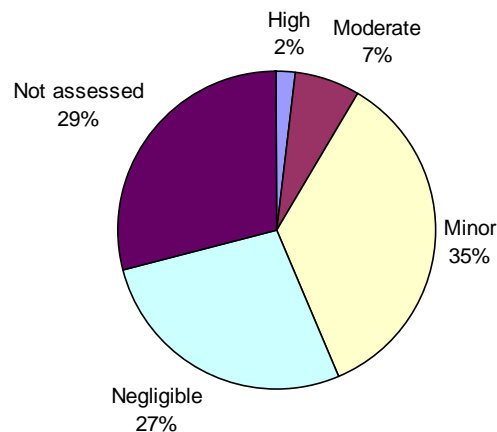
Figure 2: Incident Significance for period 27 October 2006 to 19 January 2007

The incidents are assessed for significance as determined by the severity, duration and extent of environment effects. This ranking is used to track incident trends. The majority of incidents attended were considered to have minor adverse affects. The incidents categorised as “not assessed” are those where officers did not attend the scene, or where officers were unable to assess the severity, duration and extent of environmental effects.
