Air quality 2007/08

Groundwater 2007/08

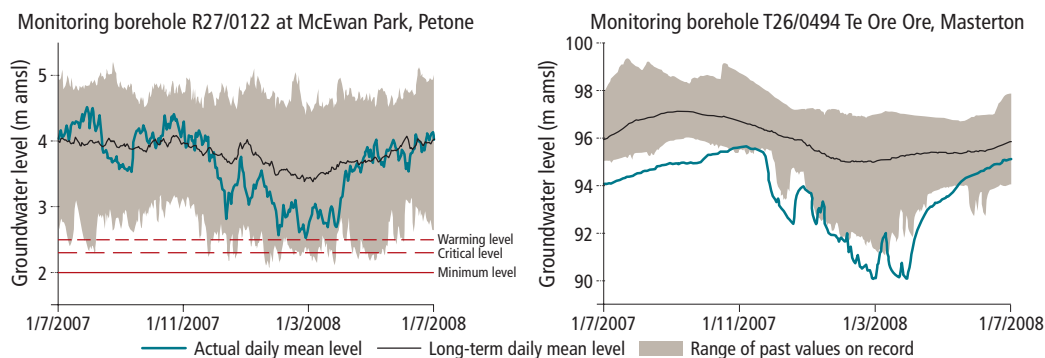
Groundwater levels at the Petone foreshore from the confined Waiwhetu aquifer (left) show the effects of above average groundwater pumping for public water supply throughout the summer months. Groundwater levels were maintained above the warning level set in the aquifer to safeguard against the effects of saline intrusion. The relatively dry year and long-term low groundwater levels are evident in the Te Ore Ore monitoring borehole near Masterton (right). Long term minimum levels were recorded throughout much of the year due to reduced recharge and groundwater abstraction in the aquifer. Groundwater levels can be seen to recover back towards average levels in May and June 2008 when it was very wet.

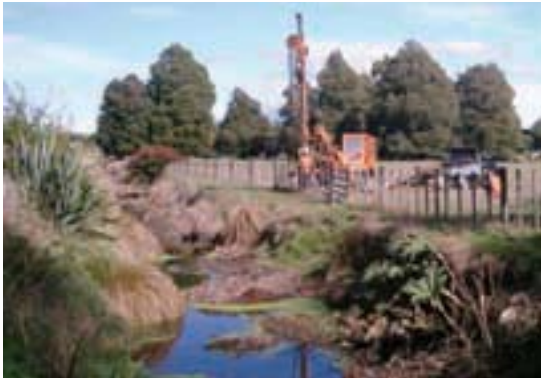
Construction of a new shallow monitoring borehole in Te Ore Ore as part of the Wairarapa groundwater investigation. This borehole, and ten others constructed across the valley, will support existing monitoring sites to help us understand the complex hydrogeological systems in the Wairarapa. At this particular monitoring site, we hope to further explore the link between the Te Ore Ore aquifer and the Poterau Spring seen in the foreground.

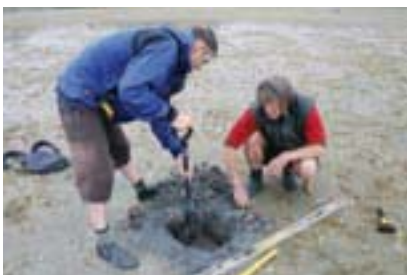
Burying sediment plates in the Porirua Harbour. The depth to each sediment plate will be measured each year, allowing us to determine the rate of sedimentation.

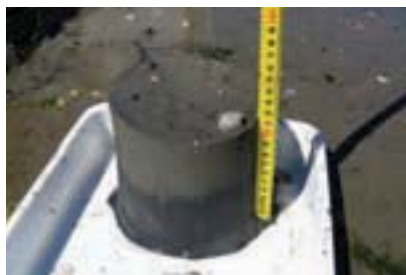
Measuring the depth of oxygenated sediment in a sediment core sample from the Porirua Harbour. The greater the depth of oxygenated sediment, the better the conditions for plant and animal life in the sediment.

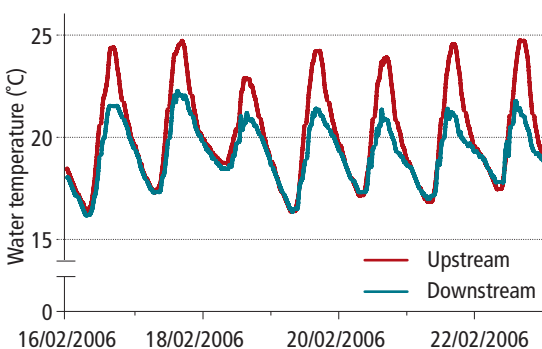
Daily variation in water temperatures upstream and downstream of a planted reach of the Enaki Stream, Carterton, for a week during February 2006. Maximum water temperatures are generally two to three degrees cooler in the planted section (downstream) than the unplanted section (upstream). This is important as many fish and stream invertebrate species can't tolerate warm water.

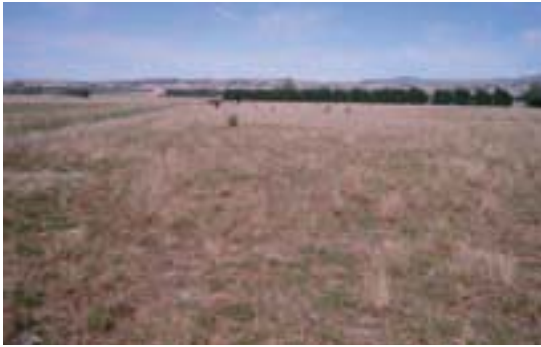
One of the soil quality monitoring sites – a drystock farm in the Wairarapa. At each site, samples (taken from a depth of 0-10cm) are tested for various parameters and the results compared with the optimum range for the soil type. The soil at this site was compacted but nutrient levels were satisfactory.

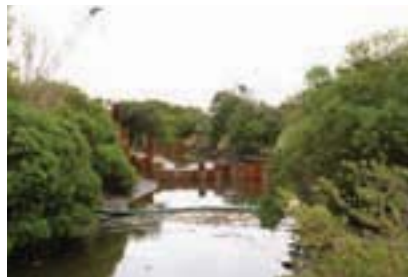
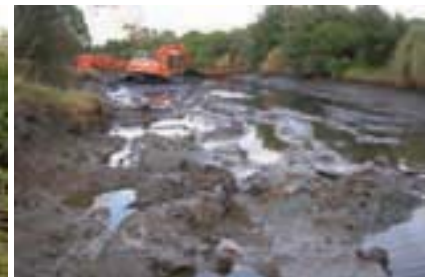
Contamination in this section of the Waiwhetu Stream in Lower Hutt was successfully cleaned up earlier this year. The stream was divided into two cells using sheet piles (left). The cells were then de-watered before the contaminated sediment was excavated from the upstream cell (right) and disposed of to landfill. The next stage of this project will be to remove the contaminants from the remainder of the stream.

A successful trial clean-up of a section of the stream was completed in March 2008. The clean-up method involved dividing an 80 metre length of the stream into two cells by driving sheet piles into the bed. The cells were then dewatered and the contaminated sediment excavated from the upstream cell. In all, 423 tonnes of contaminated sediment was safely taken to the Silverstream Landfill for disposal. The clean-up of the full 800 metre reach of the stream is planned to commence in March 2009. This work is being jointly funded by Greater Wellington, Hutt City Council and the Ministry for the Environment's Contaminated Sites Remediation Fund.
