HUTT RIVER ESTUARY BRIDGE

**Sediment extraction from the Hutt River Mouth
and foundation stability of Estuary Bridge**

Prepared for Greater Wellington

Date: October 2010
Reference: 3-50861.00
Status: FINAL

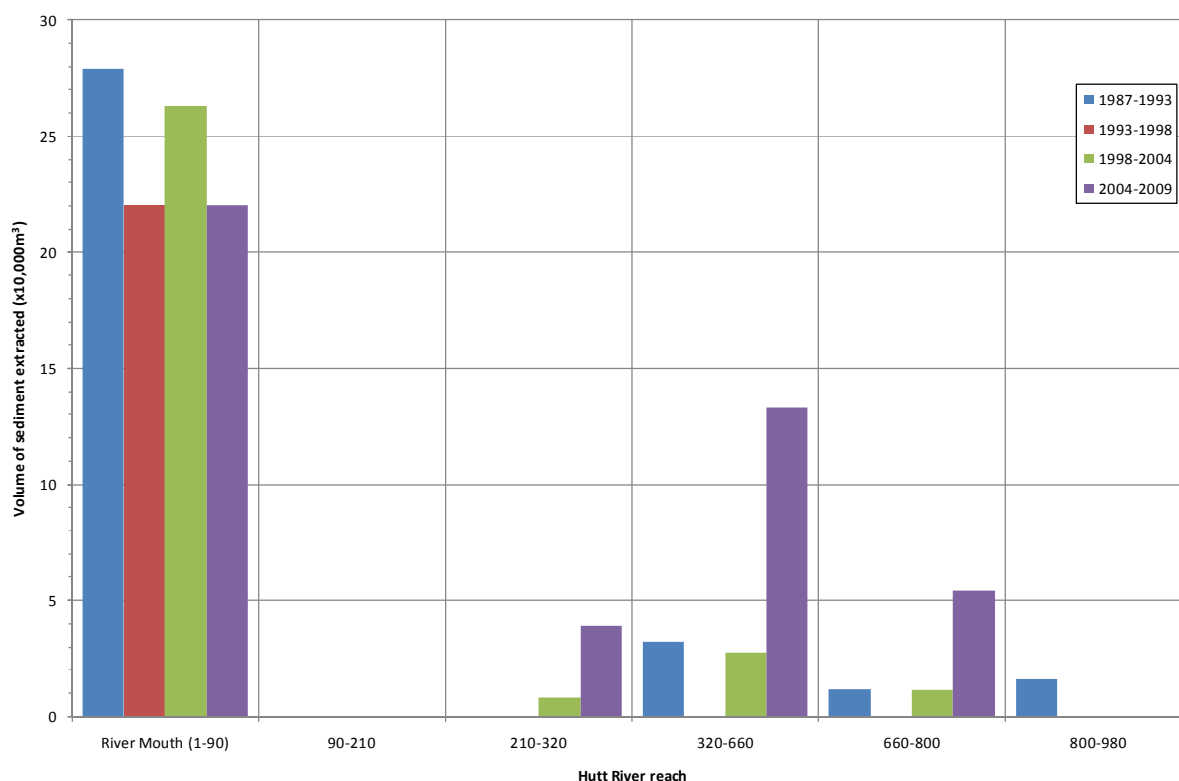
Figure 3.1: Sediment extraction volumes from Hutt River between 1987 and 2009.

Data obtained from GWRC (refer Table 3.1 and Figure 3.1) show that between 1987 and 2009 sediment was extracted at the river mouth and upstream of cross-section 210 (situated at the Ava Rail Bridge). Extraction has therefore occurred well upstream of the Estuary Bridge. The annualised sediment extraction returns have been adjusted to match the periods between cross-section surveys.

The data in Table 3.1 and Figure 3.1 show that extraction volumes from the river mouth have been relatively constant. However, the extraction volumes upstream of the river mouth have varied both in amount and in location. Between 1992 and 2000 the extraction of gravel material from the river upstream of the mouth was suspended to allow the bed to recover. In the 2004-2009 inter-survey period the extraction volume upstream of the river mouth increased significantly.

Table 3.1: Sediment extraction volumes from the Hutt River between 1987 and 2009.

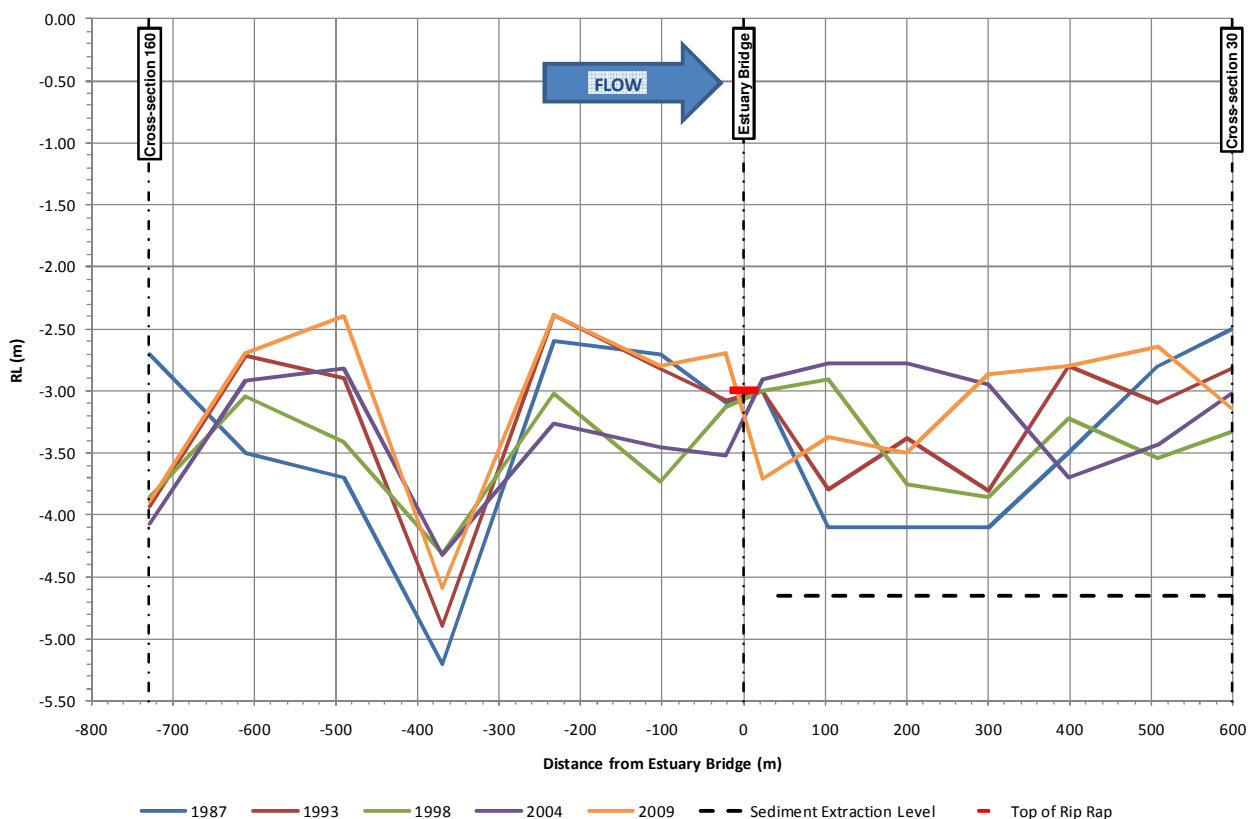
Figure 3.2 Variation in minimum bed level between 1987 and 2009.

One way to analyse the trends reflected in the cross-sections is to look at the *minimum* bed level on each cross-section. From Figure 3.2 it can be seen that in the last inter-survey period the bed appears to have aggraded upstream of the bridge. No such clear distinction can be made relating to the channel downstream of the bridge. The bed downstream of the bridge, however, has remained above the sediment extraction level limit. The variability shown in the cross-sections could be because of the extraction of sediment in the river mouth varying in location over time. Over the first 300m downstream of the bridge the bed level appears to be below the top of the rock rip-rap aprons round the piers. These reduced bed levels are, however, localised and do not compromise the stability of the bridge. While these low bed levels do not represent an immediate cause for concern, this situation should be considered when setting conditions on any new resource consent relating to sediment extraction from the river mouth.

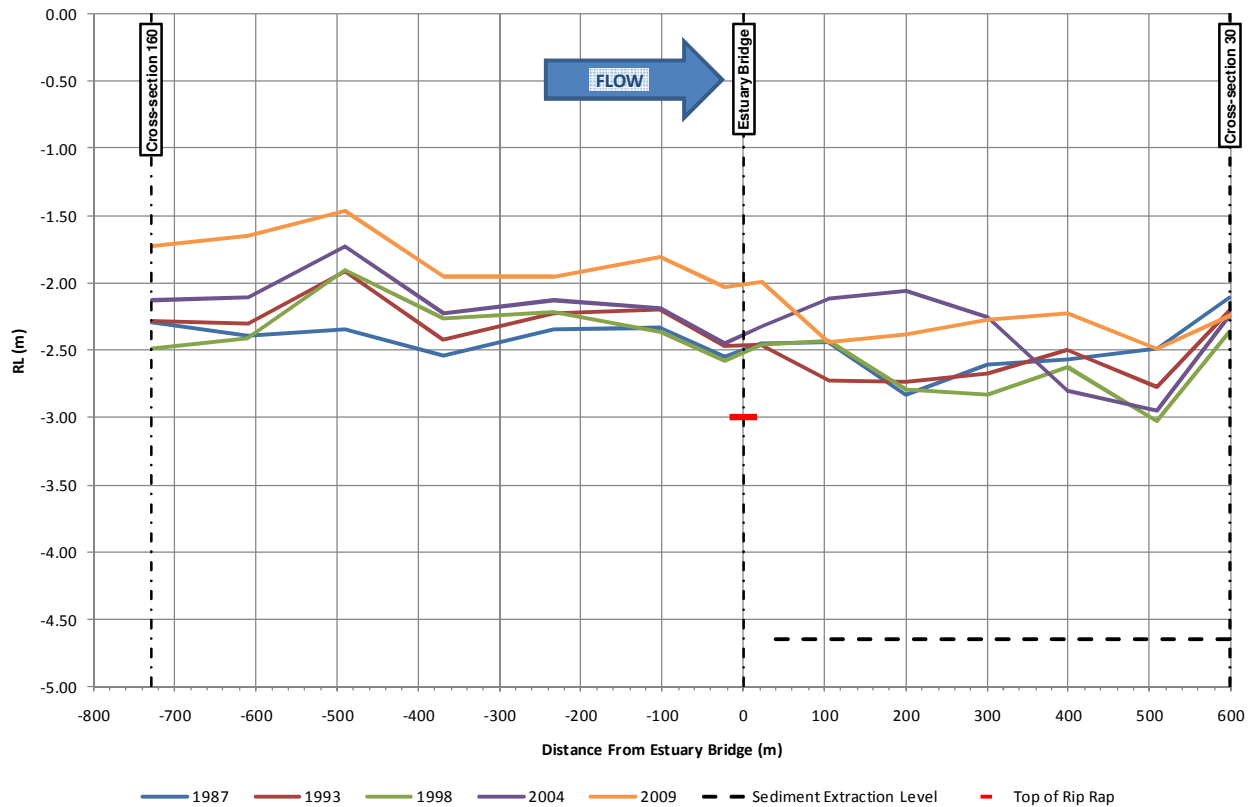
Figure 3.3 Variation in Hutt River mean bed level between 1987 and 2009.

A better way to assess changes in the cross-sections over time, and with respect to each other, is by comparing the mean bed levels. Figure 3.3 shows the variation of the mean bed level along the reach considered. In general, the mean bed level remains above the top of

the rock rip-rap and the sediment extraction level. Furthermore, the bed of the Hutt River has aggraded since the 2004 survey, except for a reach between 50 and 300m downstream of the bridge. This is most likely as a result of sediment extraction being carried out over this section during that period.

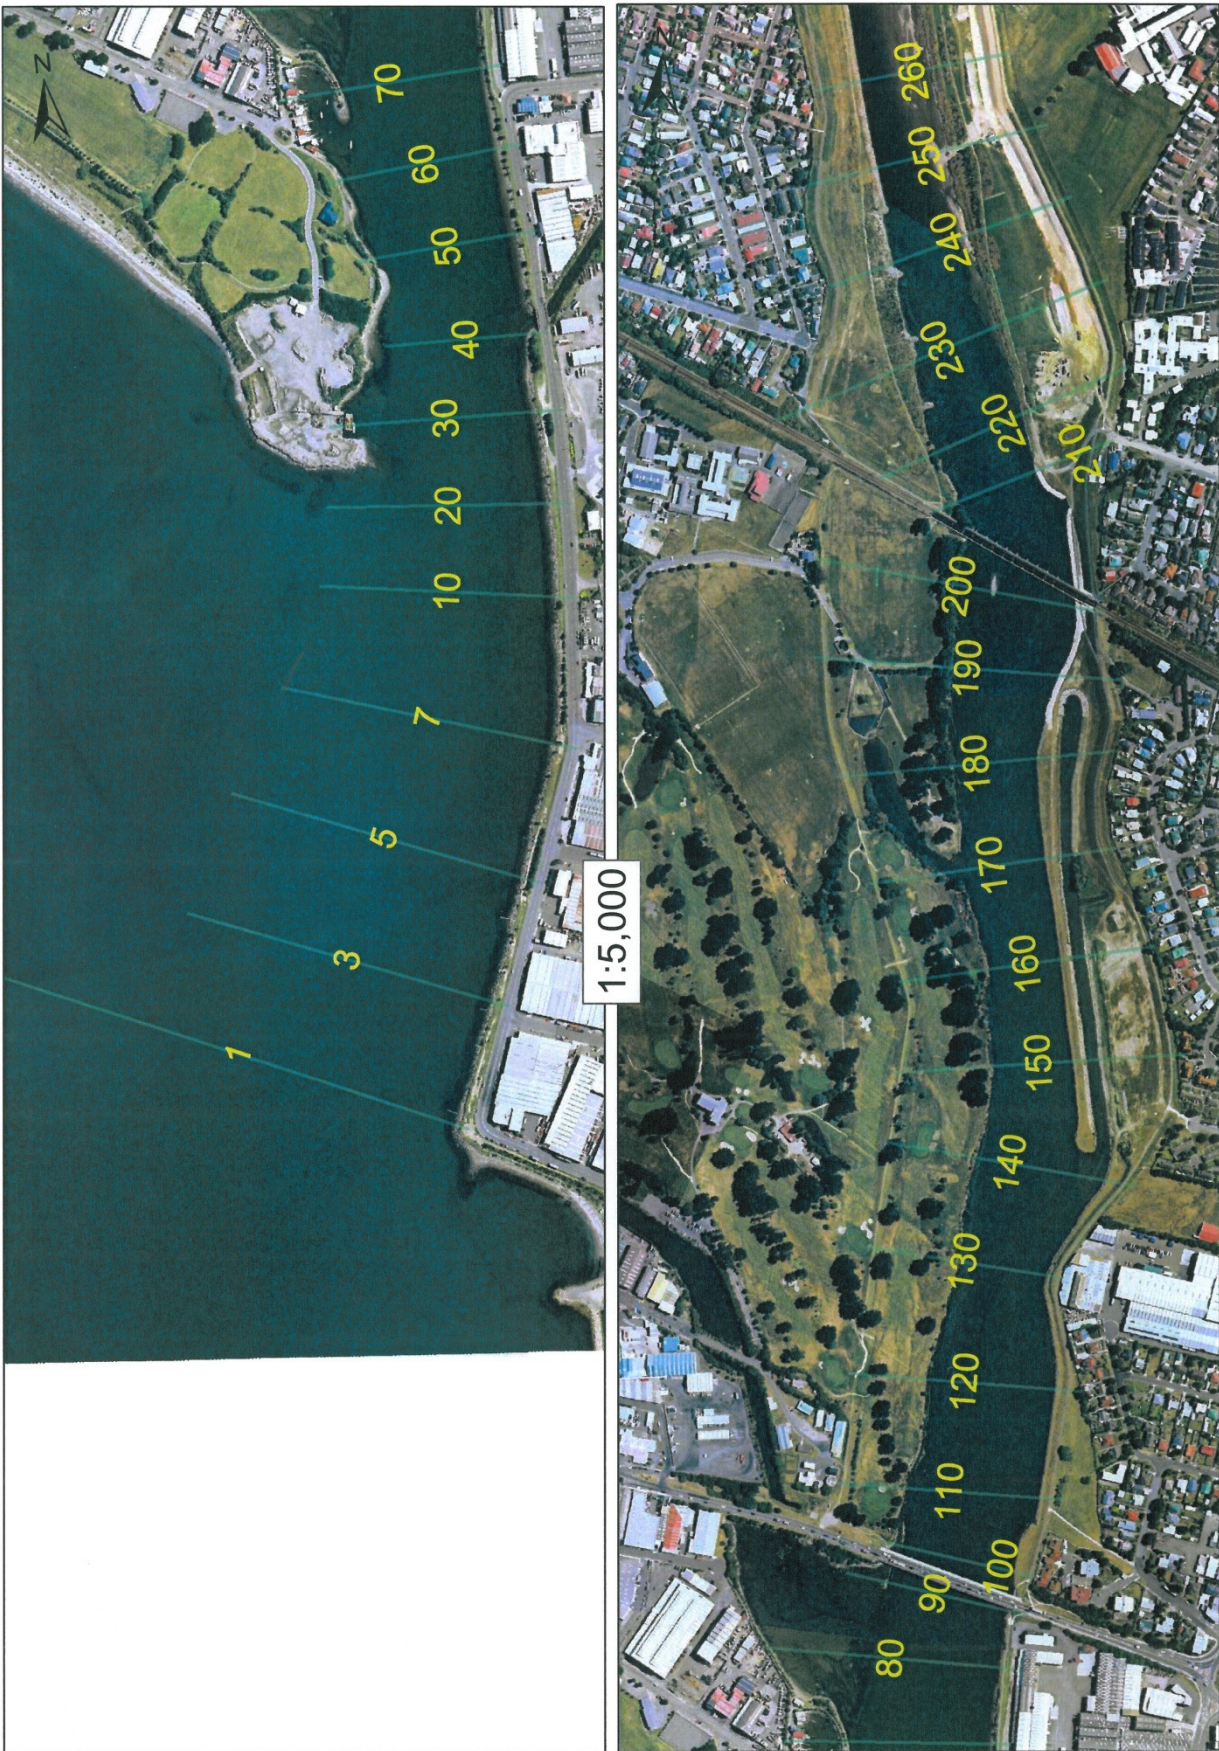
**Appendix A – Aerial photographs showing cross-sections along
the Hutt River in the vicinity of the Estuary Bridge**

Cross-section 30 is coincident with the end of Winstone Aggregates Ltd sand mining plant located on the right bank of the river mouth (refer to aerial photographs in Appendix A). Cross-section 1 is coincident with the end of the Seaview reclamation on the left bank of the Hutt River mouth. Sediment deposition occurs over the reach between these cross-sections and some of this material is actively mined by Winstones.

The impact of sediment extraction on bed levels near the Estuary Bridge was assessed by examining changes in cross-sections both upstream and downstream of the bridge. The study reach is 1327m long and extends between cross-sections 30 and 160. This reach extends 730m upstream and 600m downstream of the bridge.

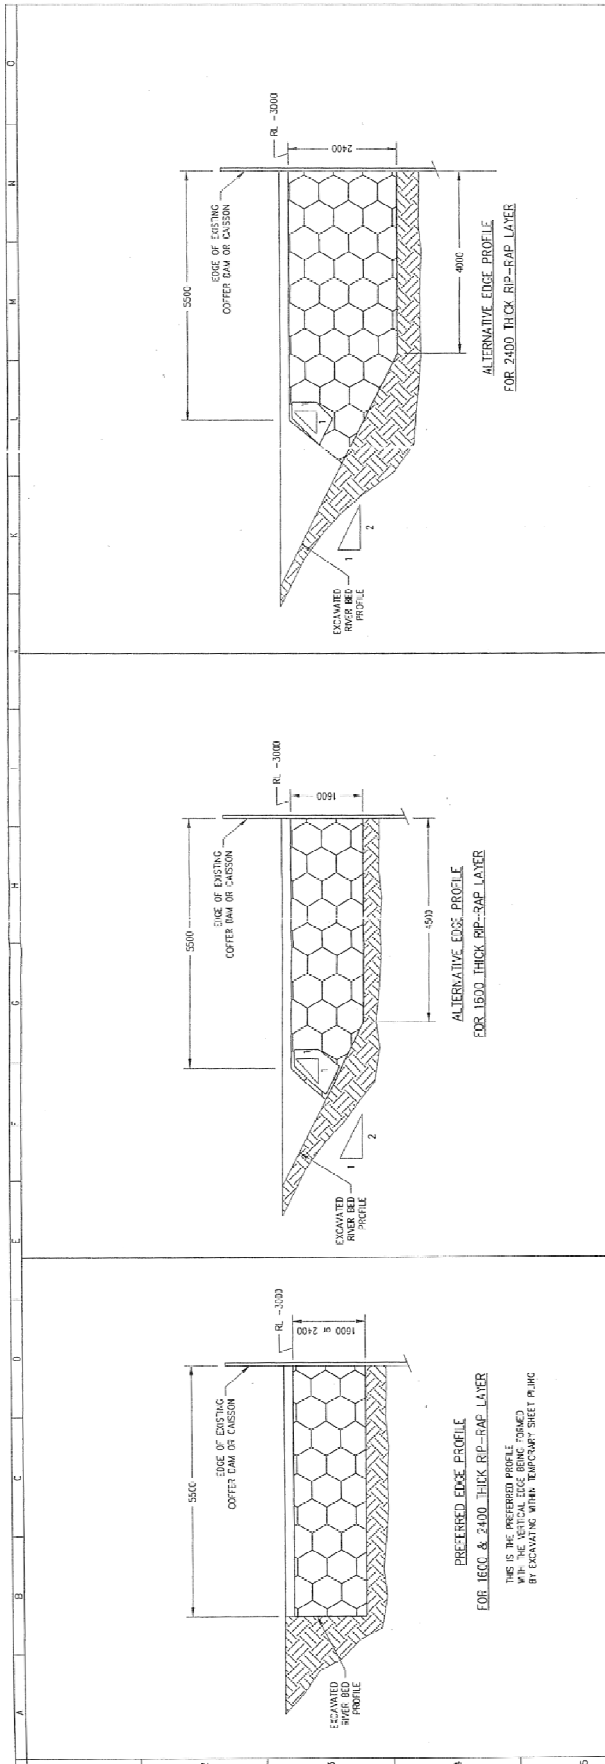
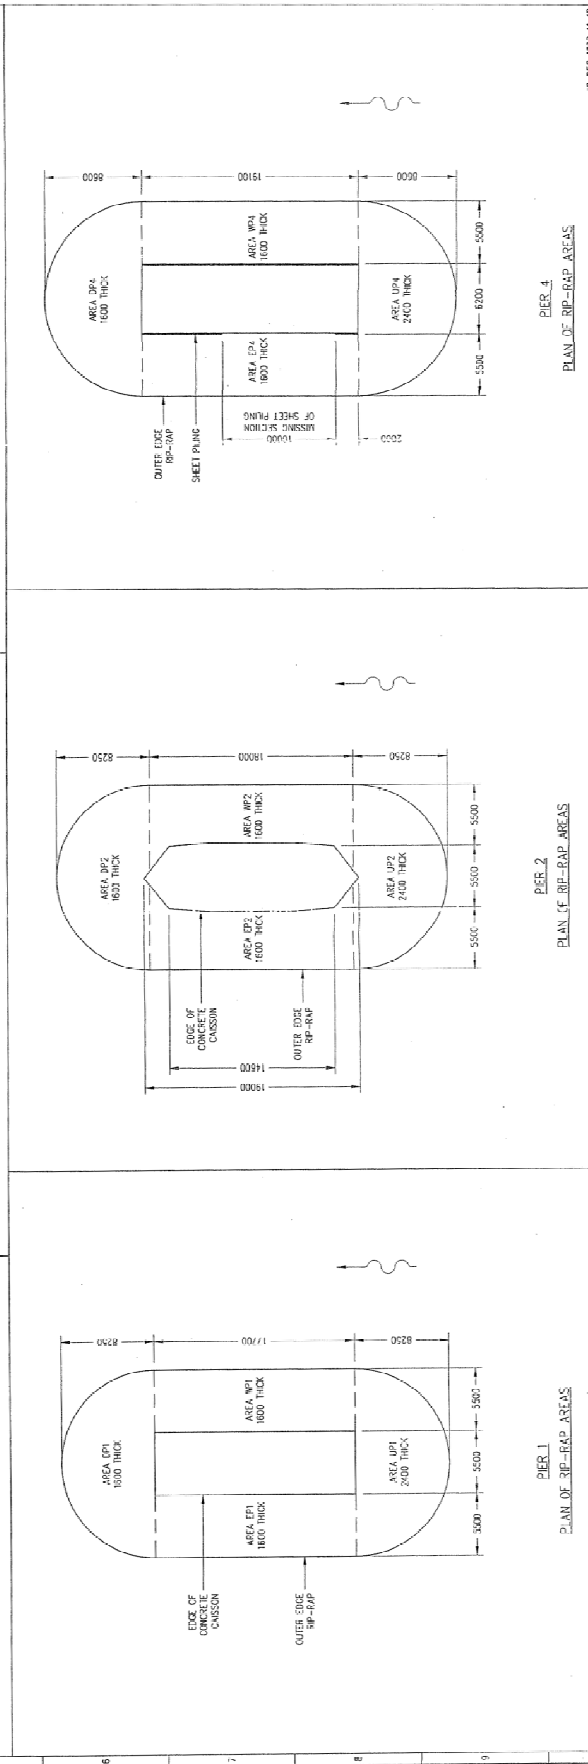
**Appendix C – Drawings of Hutt River Estuary Bridge including
scour protection works**

In 1998 Hutt City placed rock rip-rap scour protection aprons around three of the four piers of the Estuary Bridge (Hutt City Council, 1998). Drawings detail the existing foundations of the bridge and the scour protection. Copies of the relevant drawings have been included in Appendix C.

The construction drawings of the bridge (Hutt City Council, 1998) show that Piers 1, 2 and 4 have been provided with a rip-rap apron with a top level at RL -3.0m. Each of the aprons extends up to 18.15m downstream of the centre-line of the bridge. The drawings also show that the foundation of each of the piers extends to well below the sediment extraction limit of RL -4.65m. The shallowest foundations are those of Piers 3 and 4 at RL -8.84m

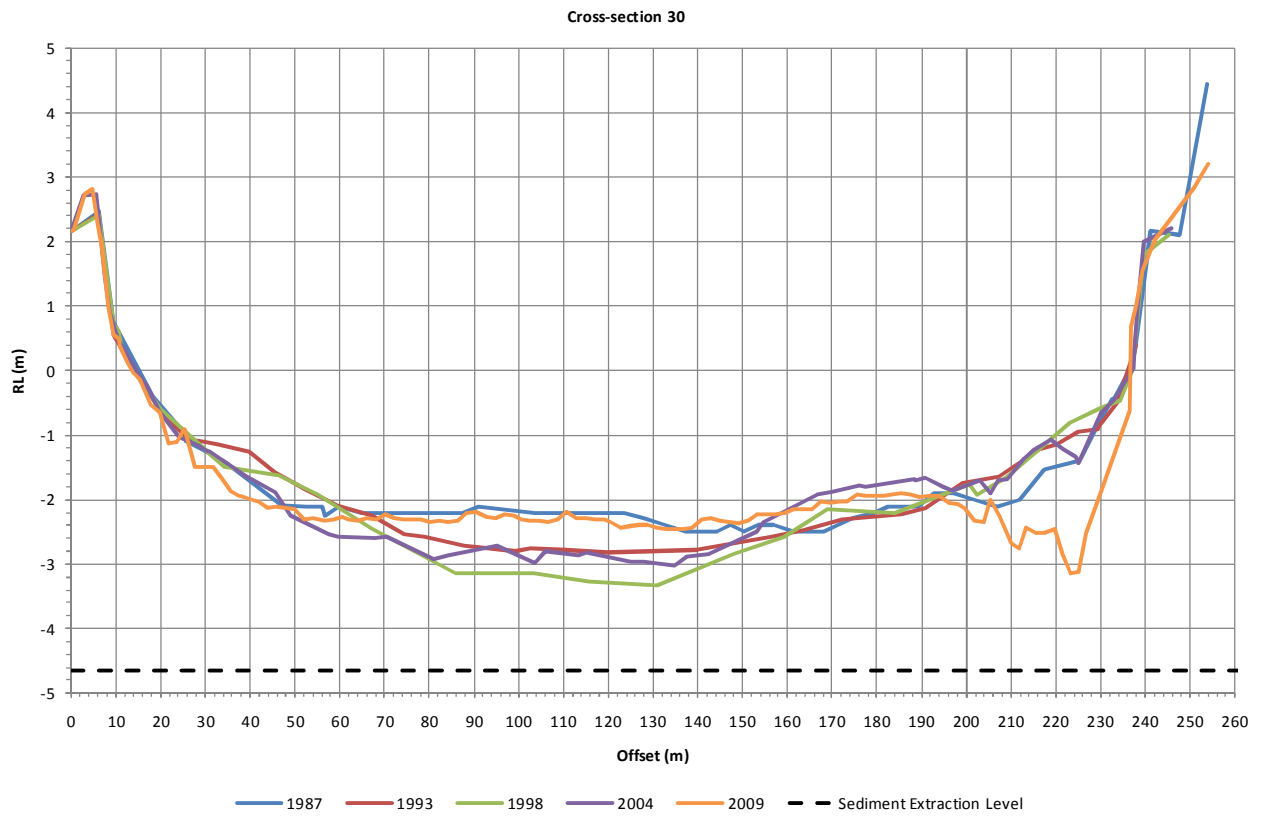
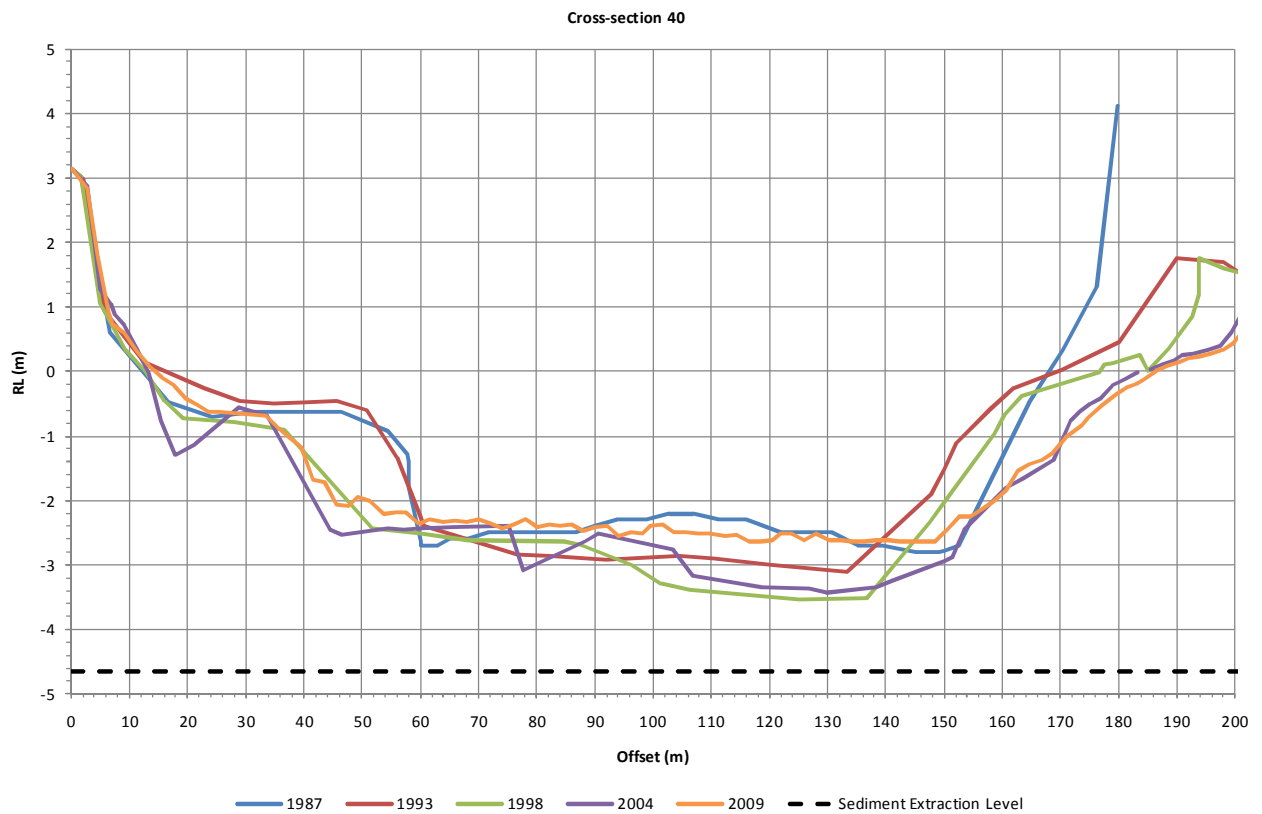
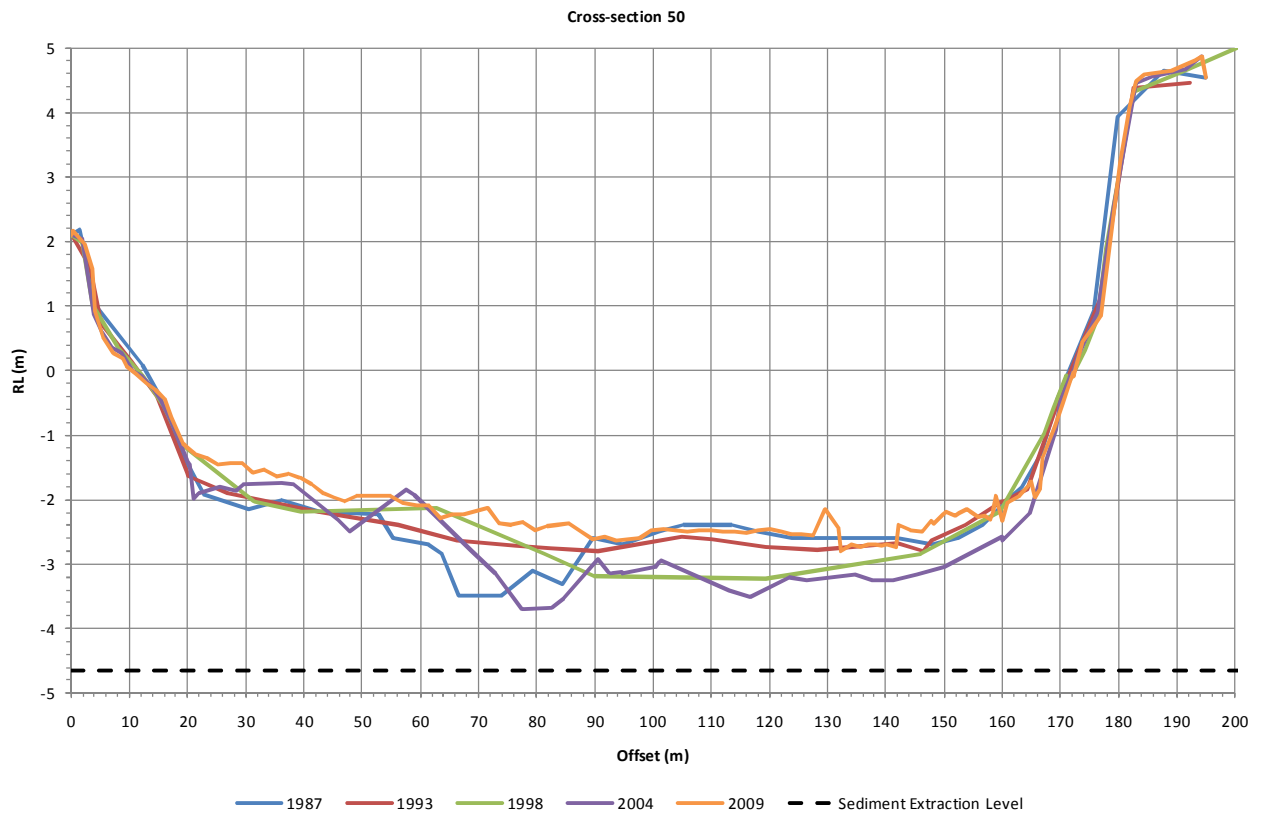
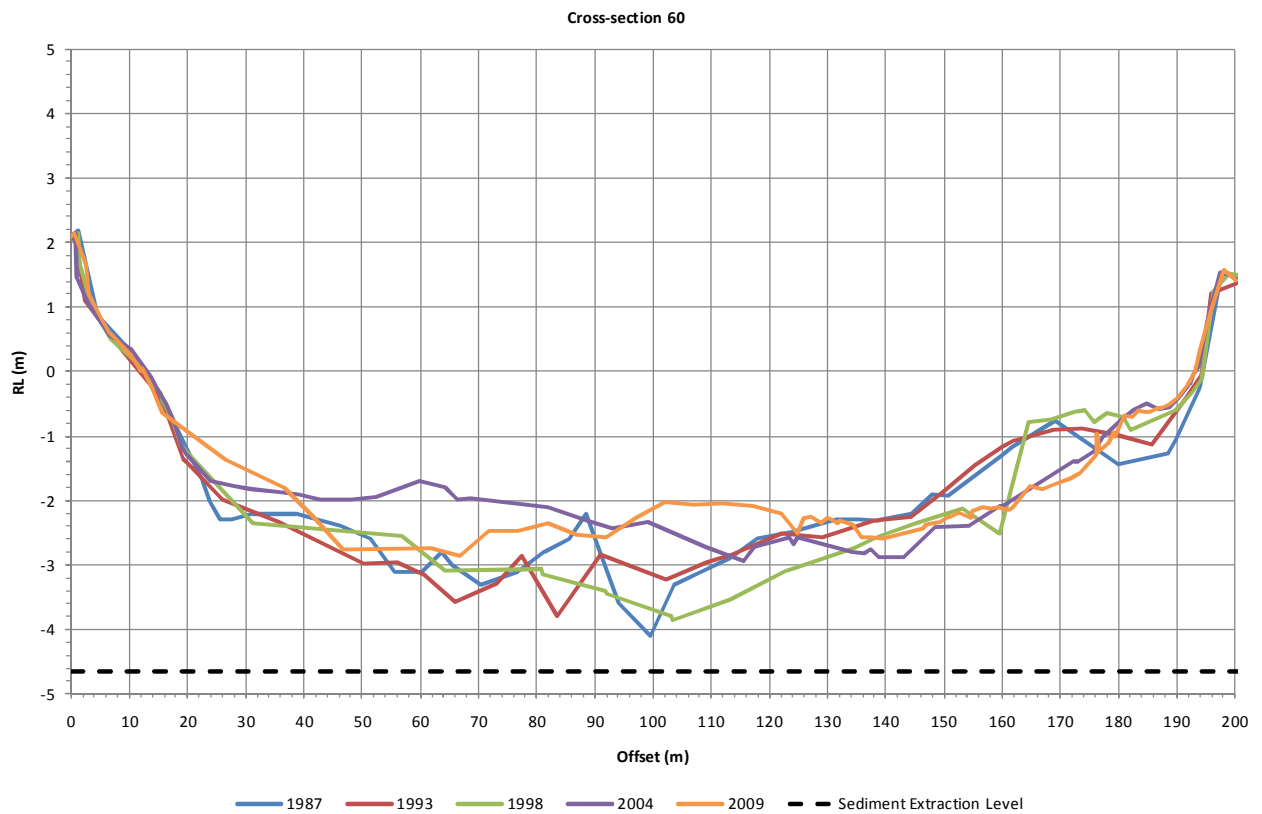
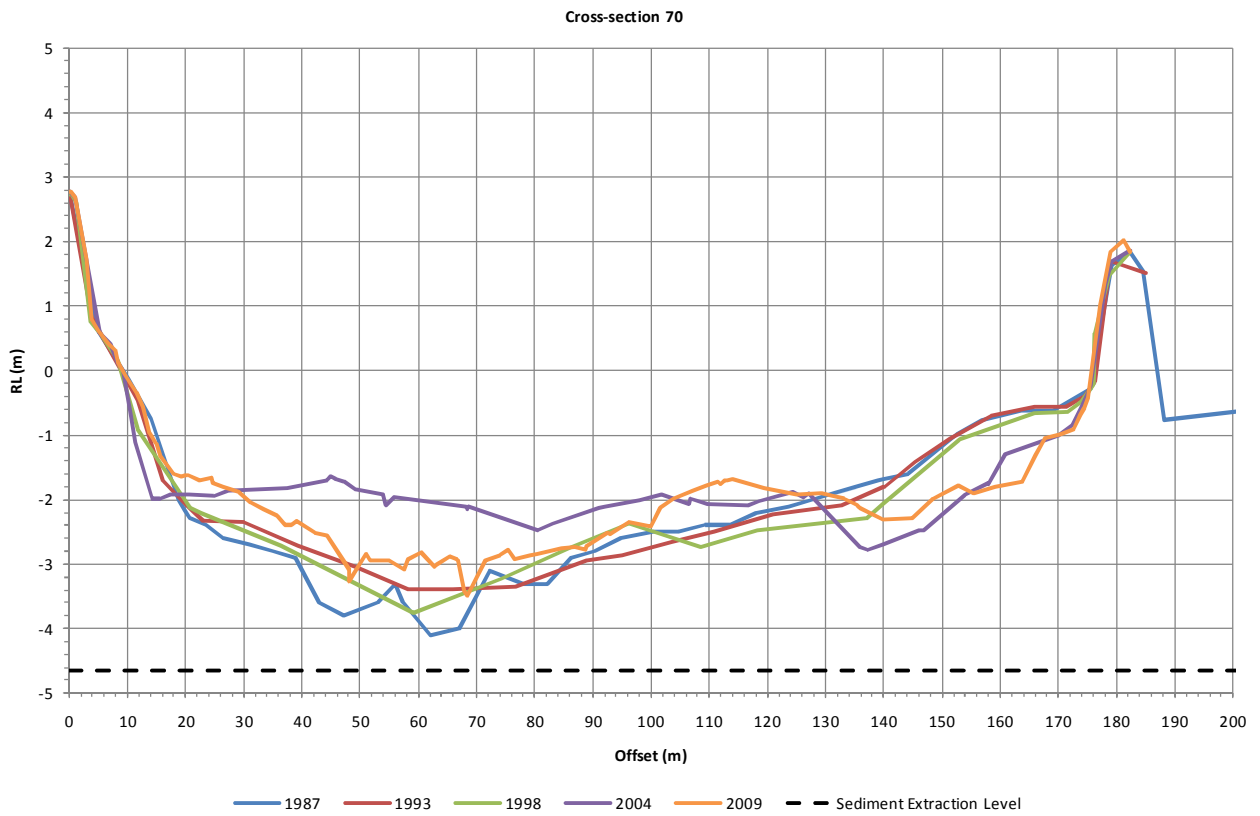
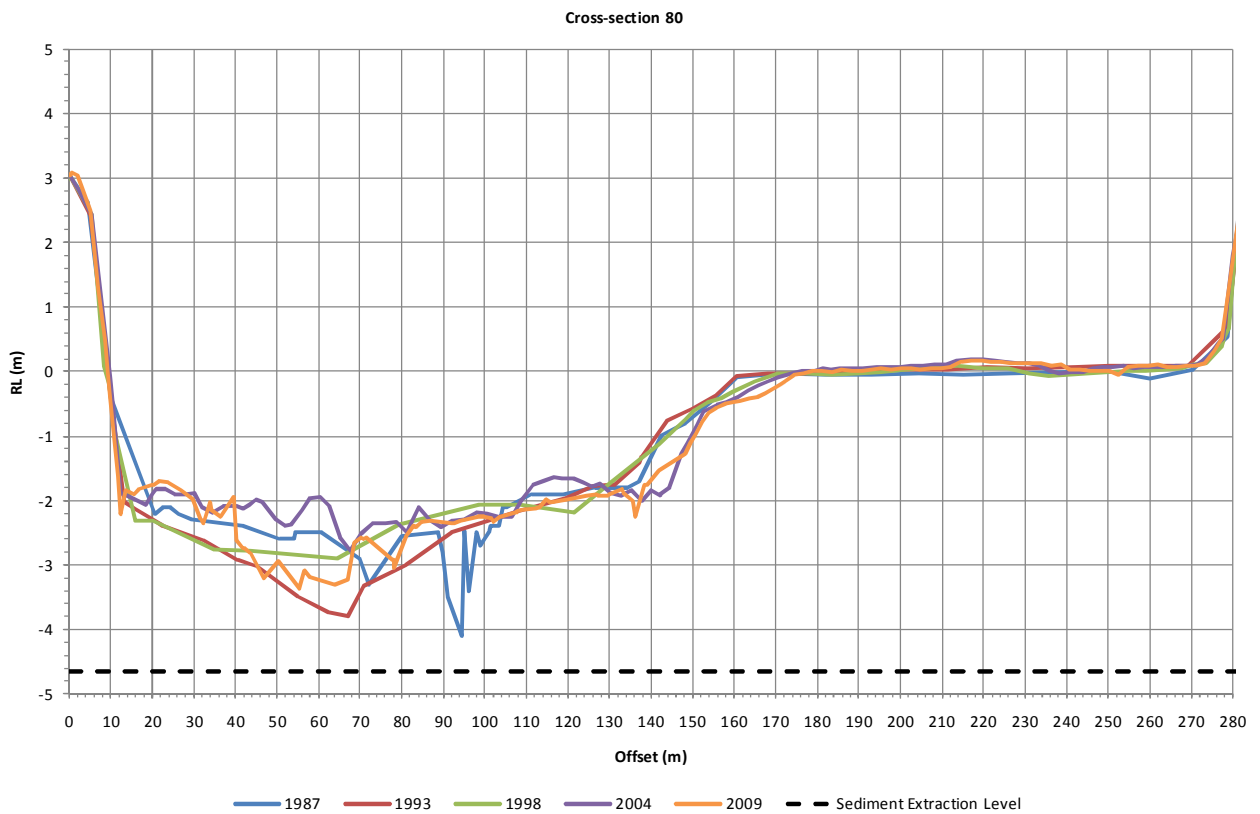
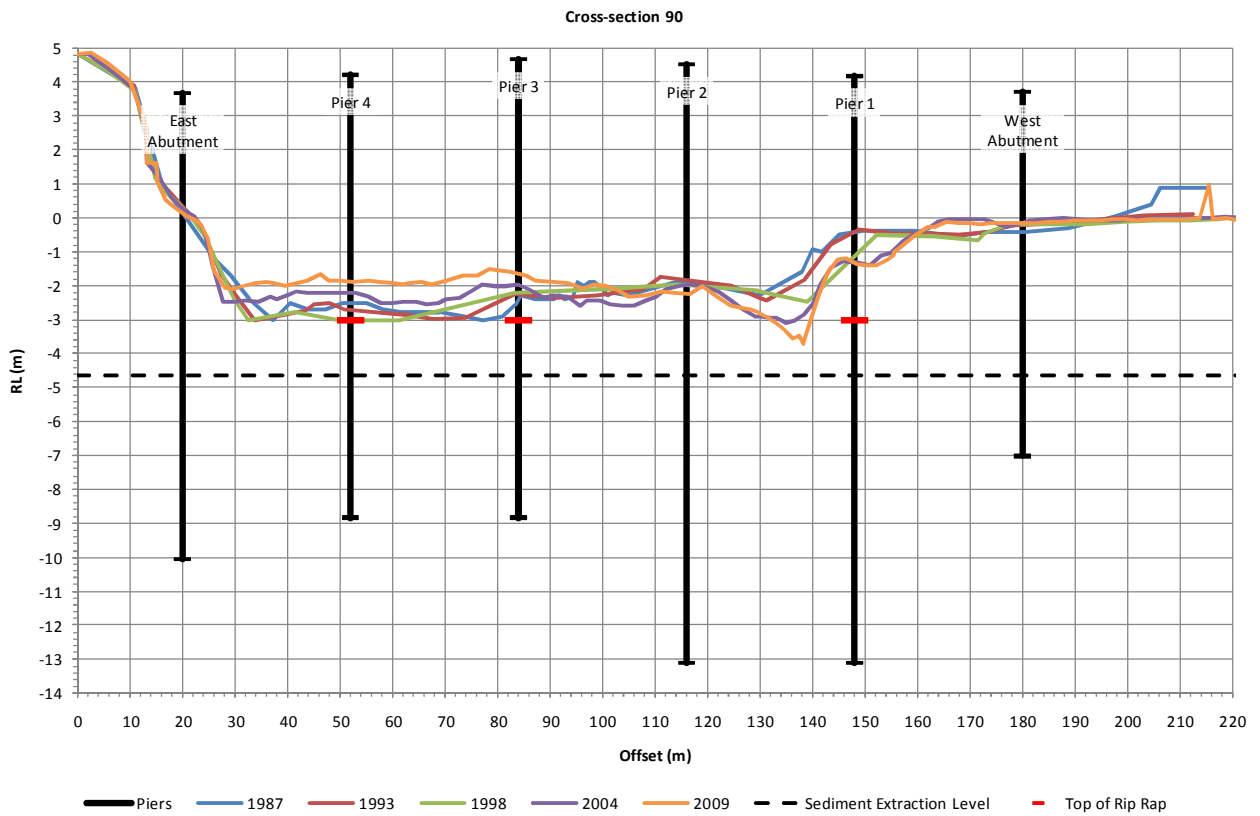
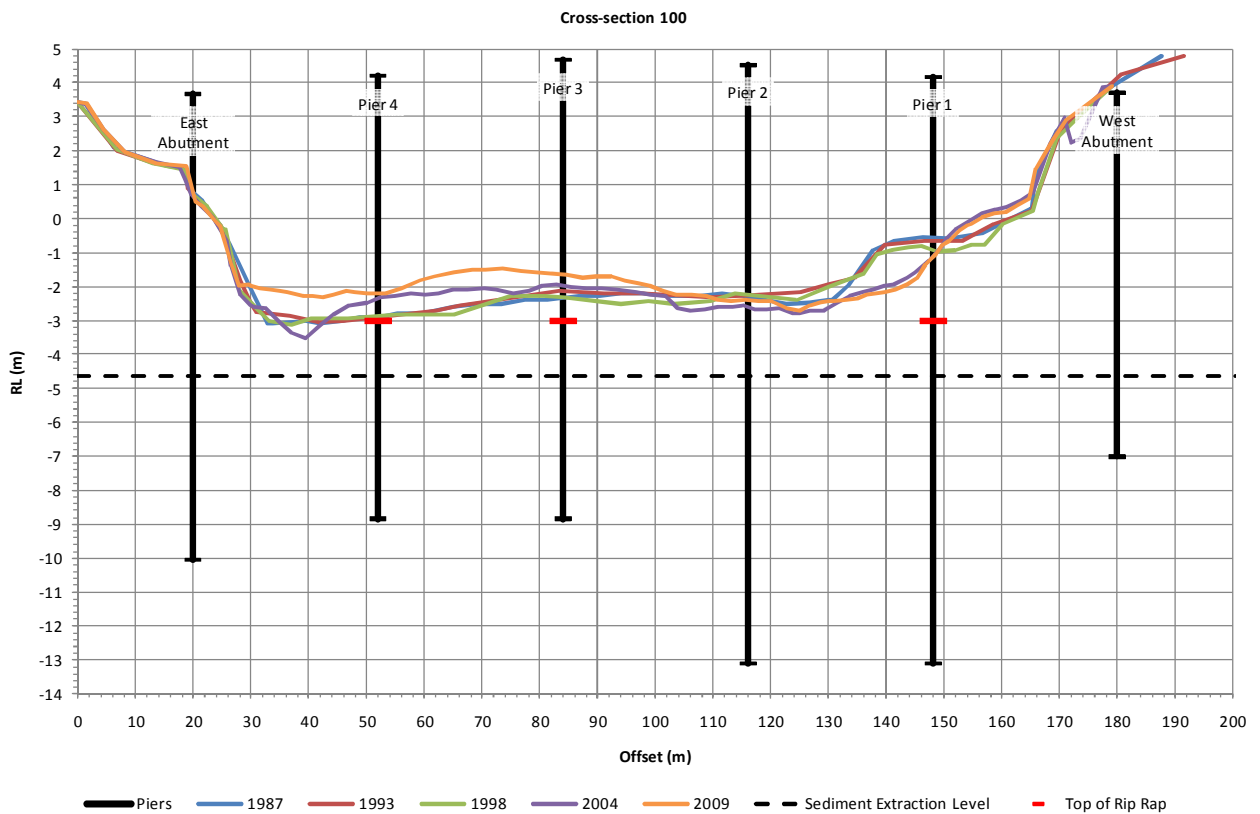
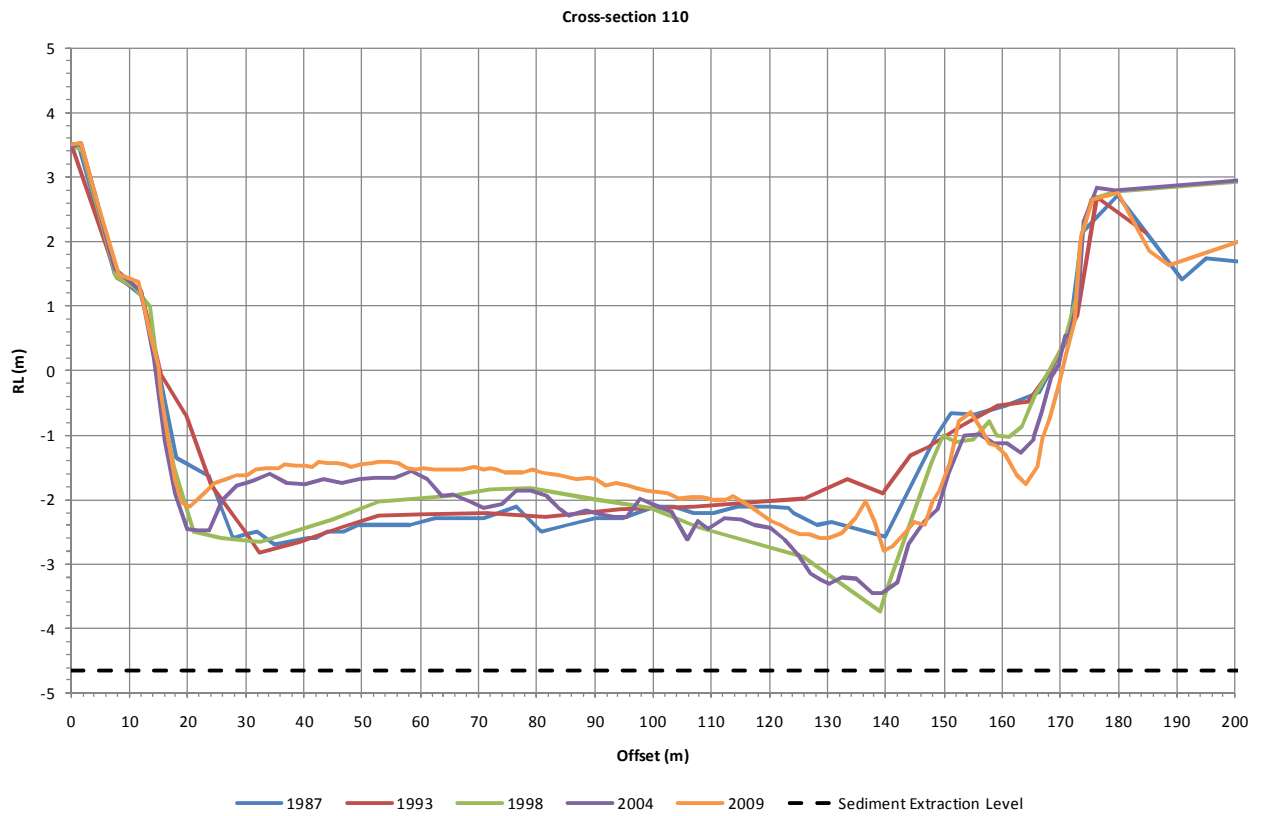
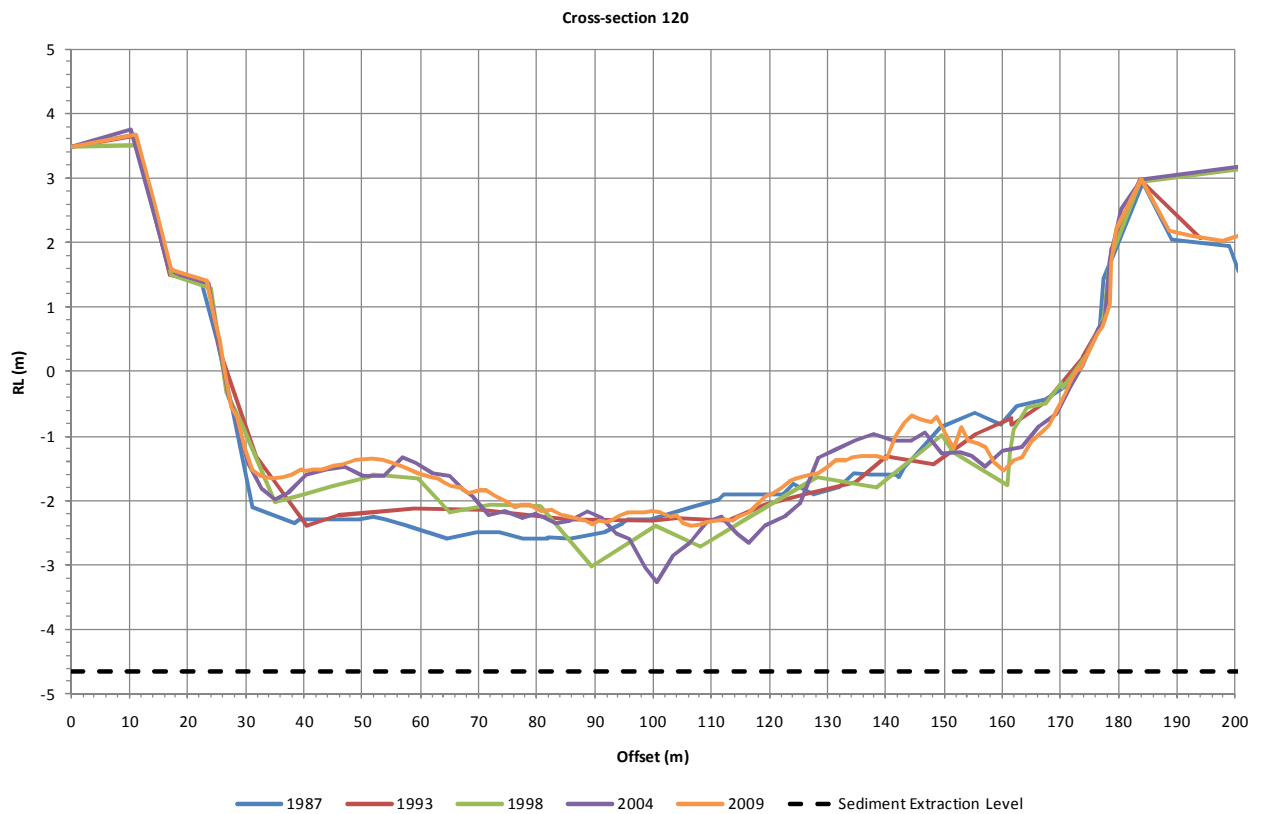
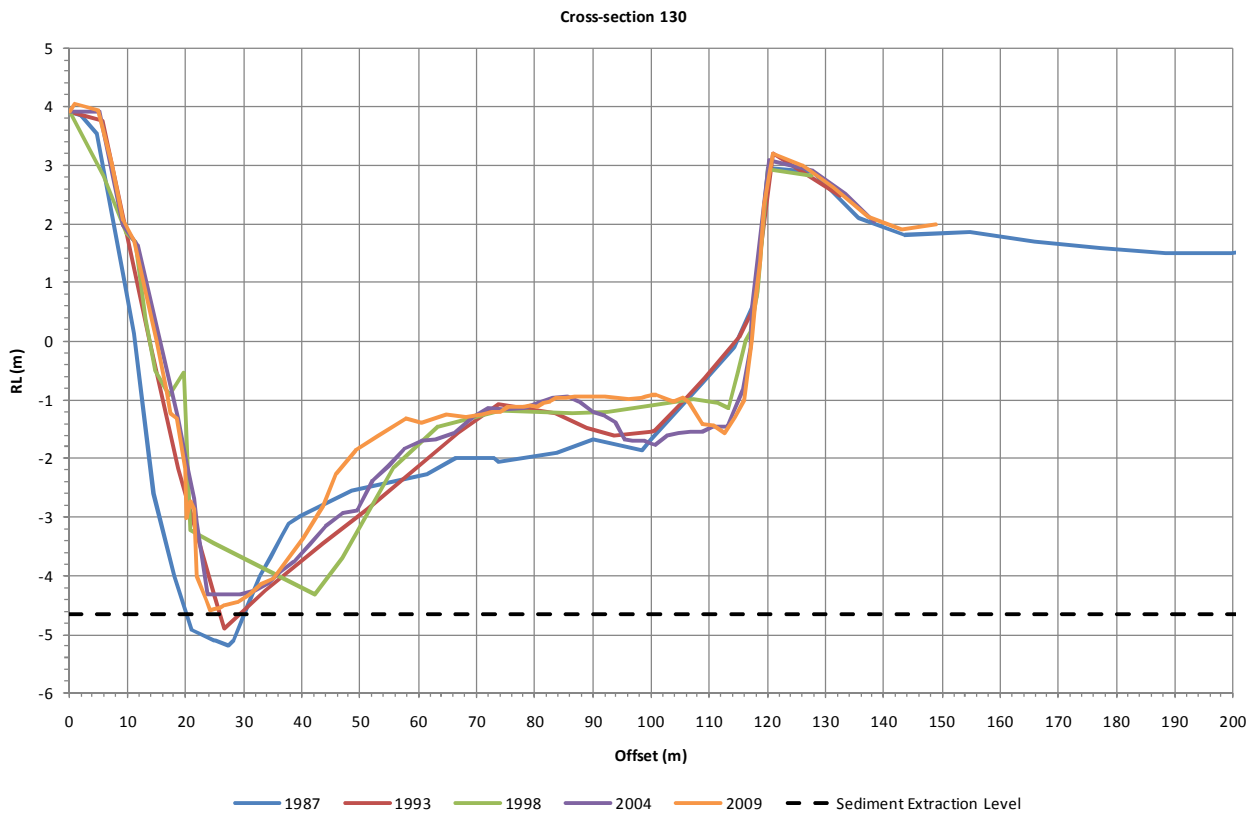
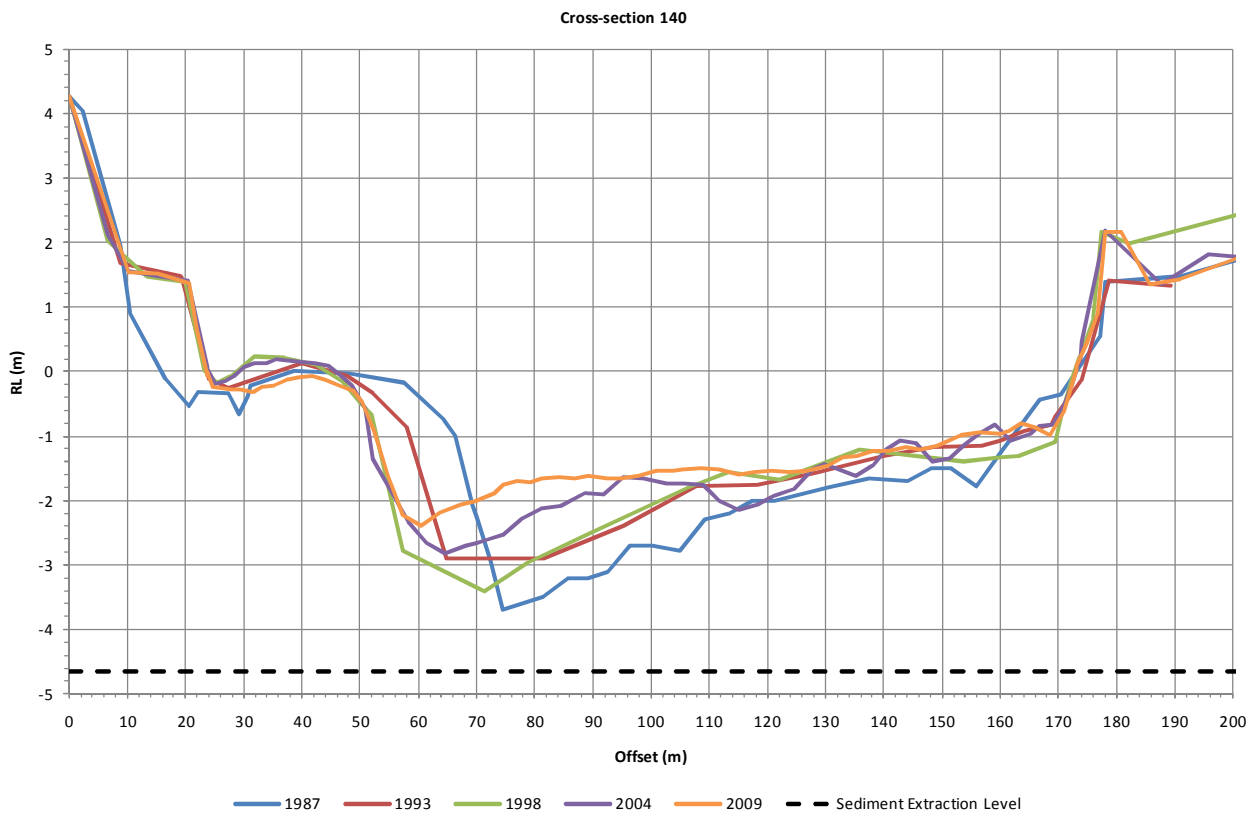
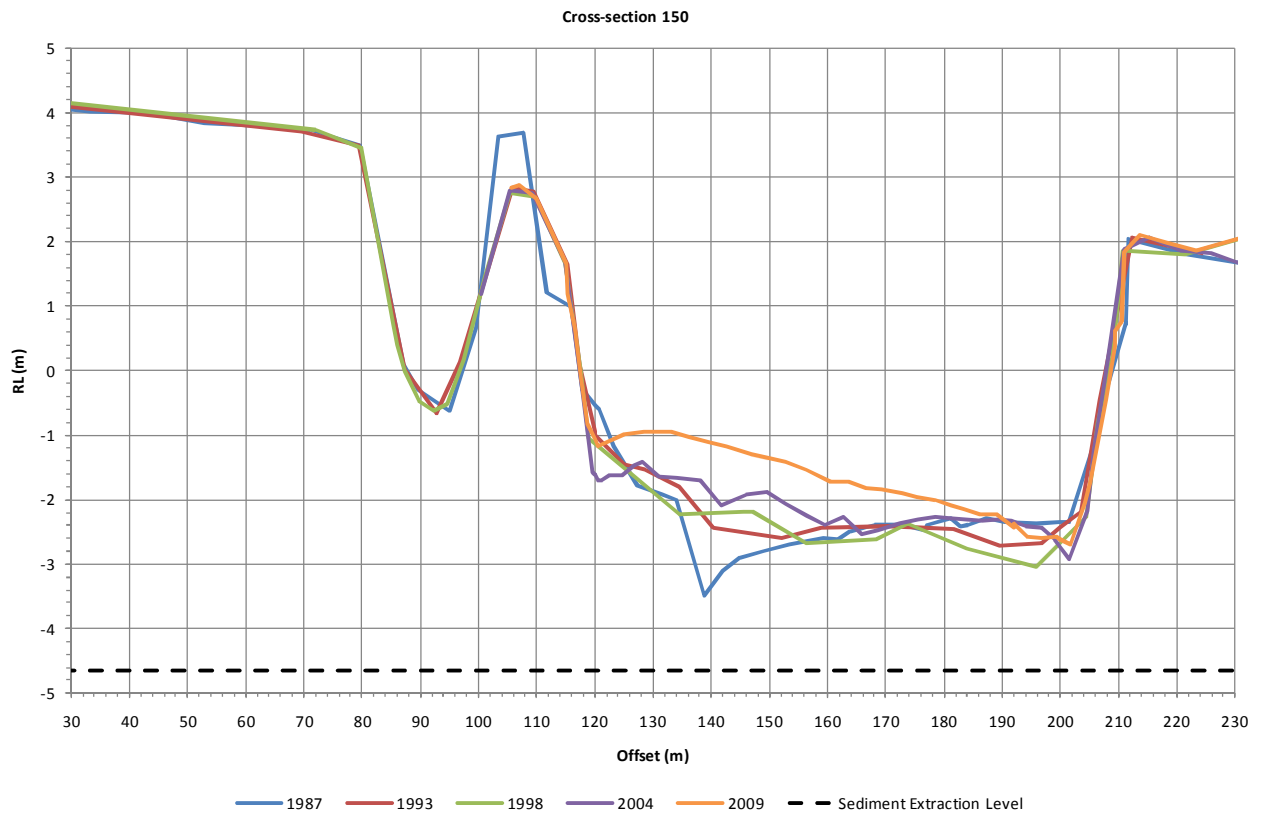
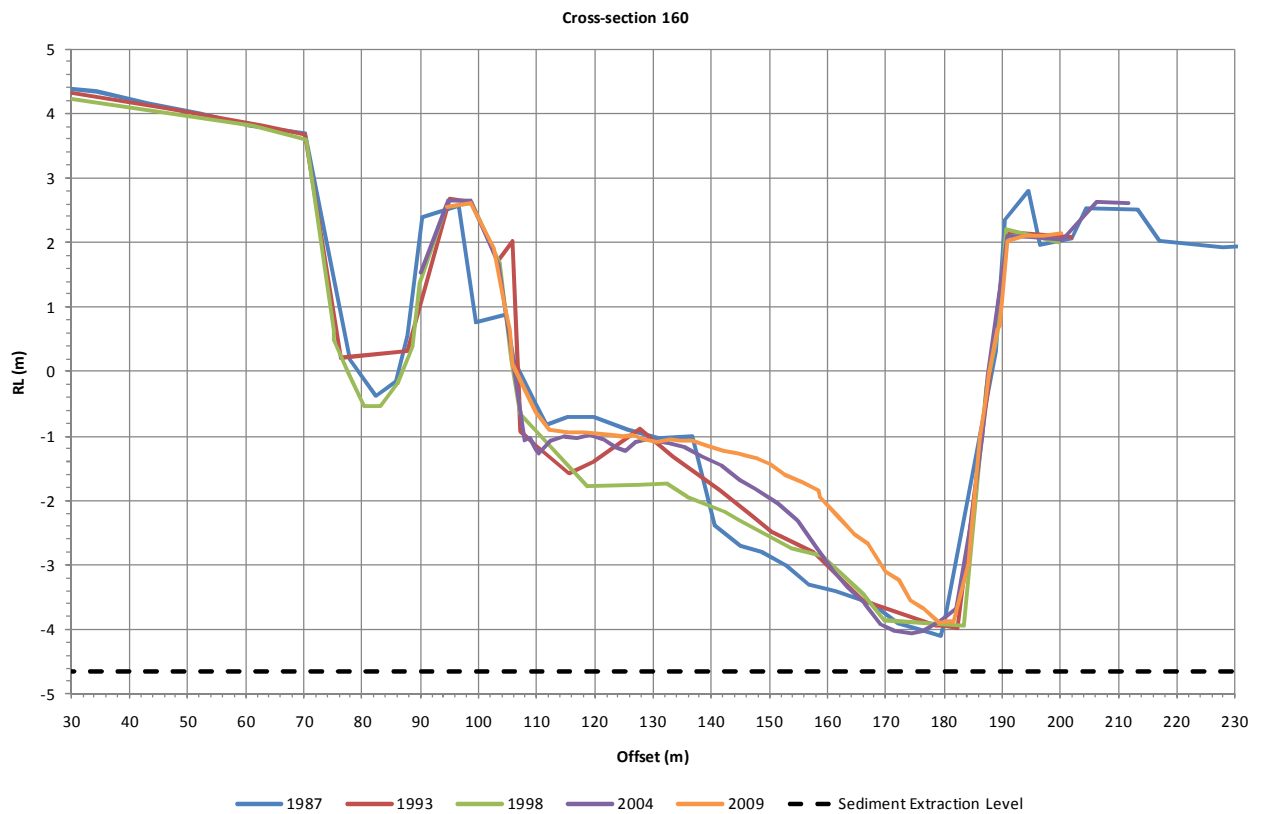
Appendix D – Hutt River cross-sections 30 to 160

(Based on data provided by GWRC)

The Greater Wellington Regional Council (GWRC) regularly surveys cross-sections at 313 locations along the lower 33.5km of the Hutt River. The data from these surveys are used to analyse trends in bed-material movement, and bed aggradation and degradation along the river. The results of these analyses are used to guide policy on gravel extraction and general river management.
