**WESTERN RIVER SCHEMES**

**THE NATURAL CHARACTER OF THE RIVERS**

**AND AN ASSESSMENT OF NATURAL CHARACTER**

**FOR SCHEME MONITORING**

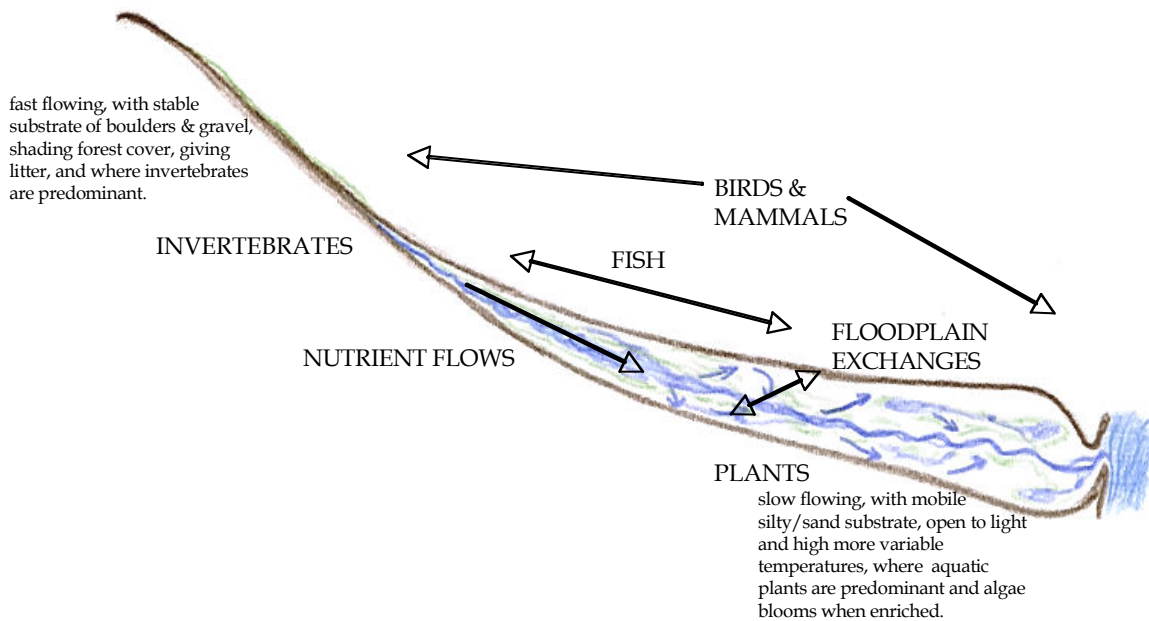
## ECOLOGICAL PROFILE – Along a River

**Biological activity adds layer on layer of interconnected processes, which give rise to very complex and dynamic river systems of inter-dependent ecosystems and physical exchange systems.**

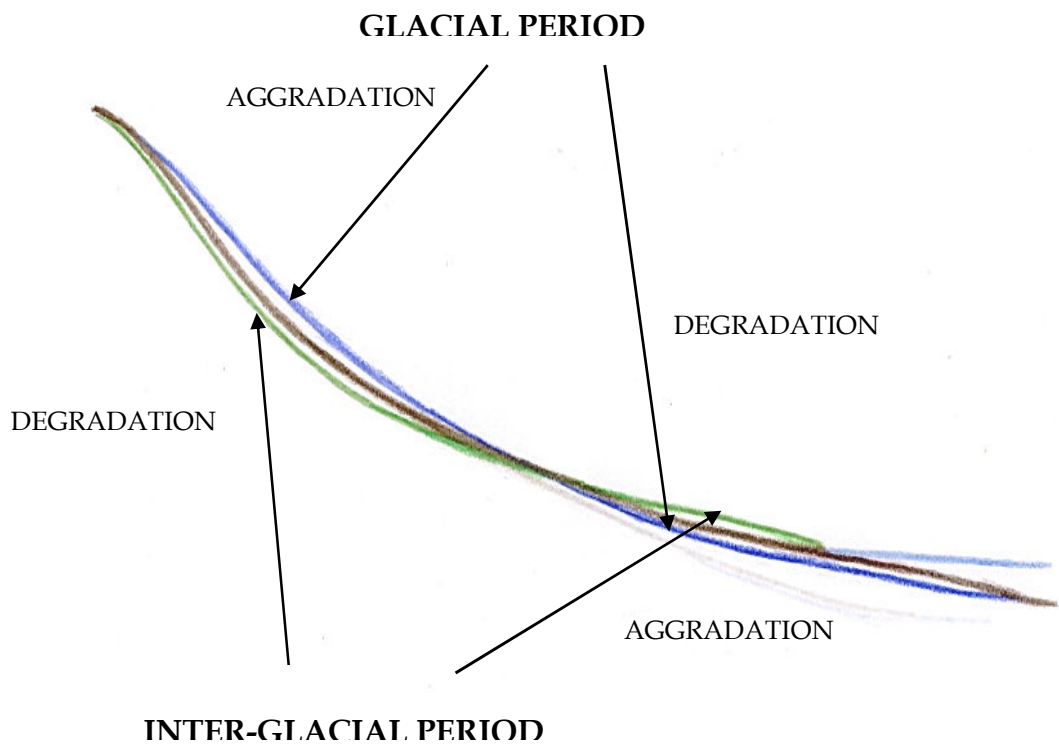
### Sediment transport and channel effects from Glacial to Interglacial periods

These climatic changes have given rise to alternating periods of aggradation and degradation. In glacial periods there is a high sediment supply from the steep catchment land with valley infilling, but channel entrenchment on the plains down to a lower and further out coastline. In the shorter interglacial times the forest cover reduces catchment erosion, but more intense rainstorms degrade the rivers into the valley fill. At the same time, the higher sea level gives rise to aggradation and plains building at the coast, with coastline aggradation or wave attack retreat, as a new coastline forms.

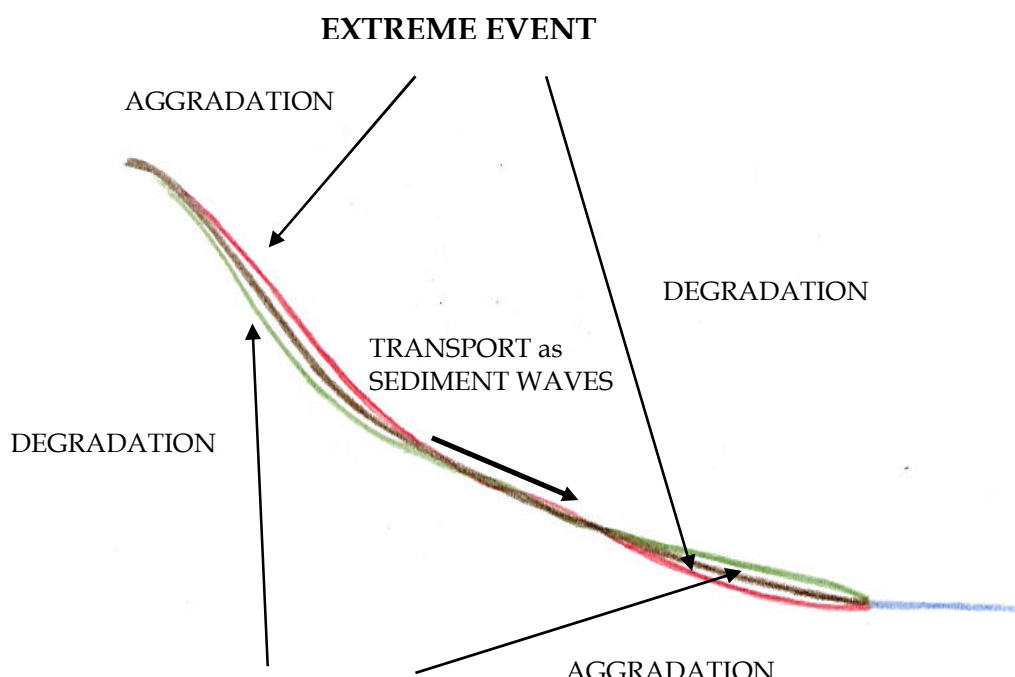
### Sediment transport and channel effects between Common and Extreme floods

There is a similar effect from floods under present conditions, with the variations in catchment erosion and sediment movement between common and more extreme flood events giving rise to a down river pulse of sediment. In large storm events there is a high sediment input from the steeper upper catchment, and a flushing out of the lower reaches by the large flood flows. In more common flood events the upper catchment input is re-worked down the system and the lower reaches re-built.

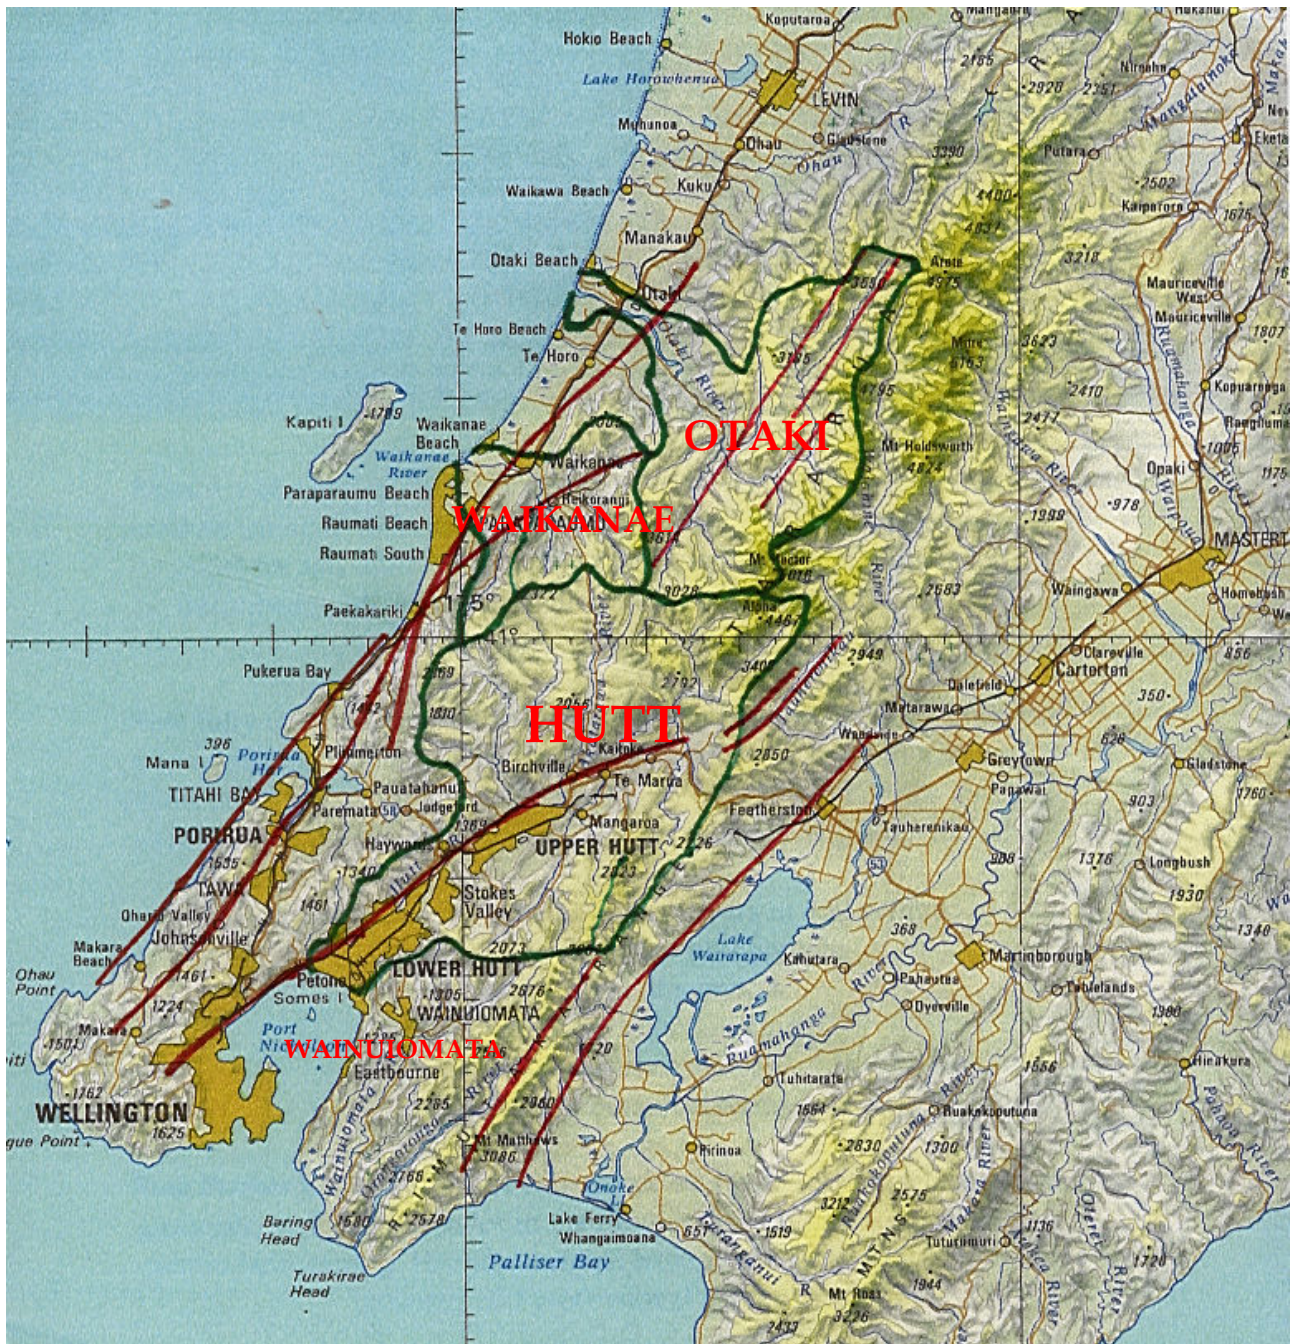
# WESTERN RIVER CATCHMENTS

Catchment boundaries and major active faults shown

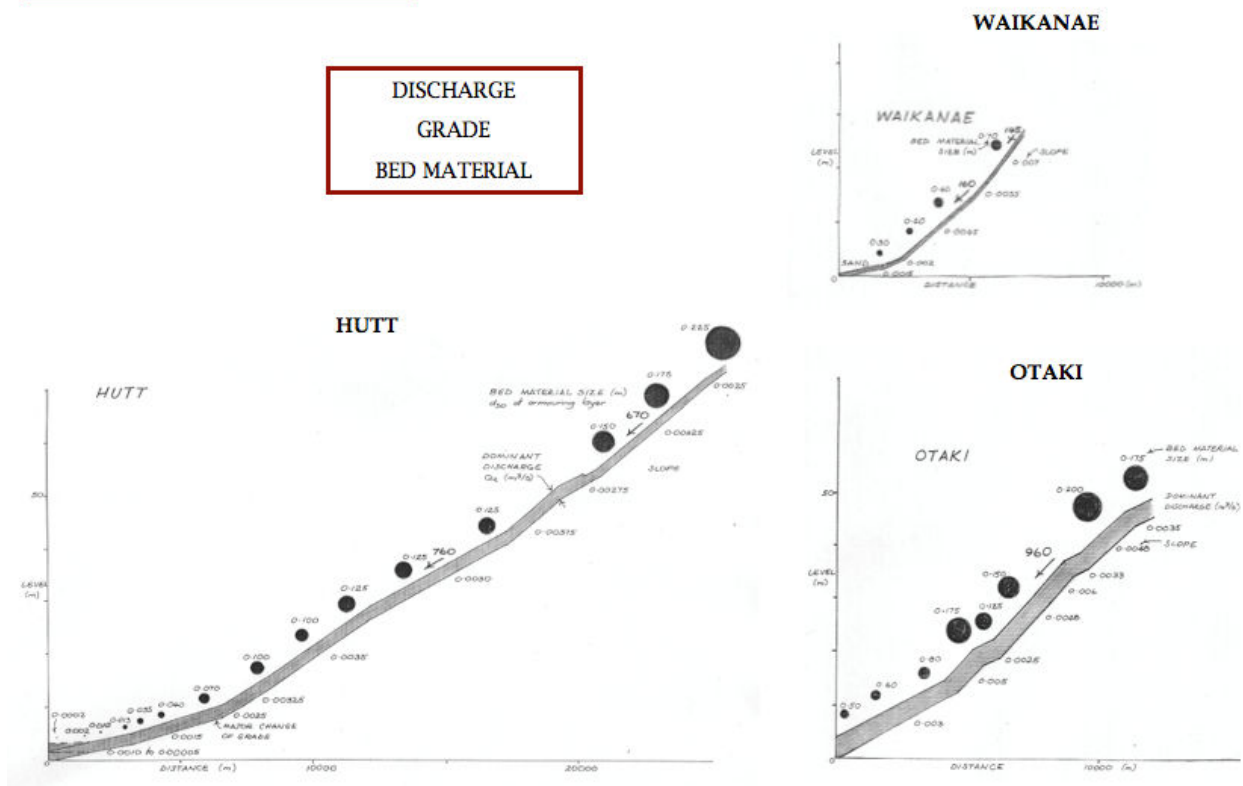
## RIVER CHARACTERISTICS

These three main characterising parameters are shown diagrammatically below, with the river characteristics plotted to the same scale.

### Representation of river grade, bed material size and dominant discharge

The type and form of river reaches along the three main rivers of the western region have been determined from the general characteristics of the reach and empirical relationships based on the determining factors of flow energy, gradient and bed material size. There is a basic relationship of the power of a river, derived from the flow mass and slope, being expended on the transport of bed (or bank) sediments, with the amount being moved dependent on the size and grading of the bed material. Given the interrelationships of flow, sediment transport and channel form, natural meander widths can be determined from formulae using the dominant flood flow (or 2 year return period flow), the slope and

the medium size of the armouring bed material. The radius of curvature and wavelength of a channel meander can then be derived from its width using general wave relationships. In general, the radius of curvature of the meander is taken as 4 to 6 times the width, and the wavelength 10 to 12 times the width.
