## **Baring Head, Ōrua Pouanui**

### **Archaeological Survey for Wellington Regional Council**

Kevin L. Jones  
Kevin L. Jones Archaeologist Ltd

25 June 2010

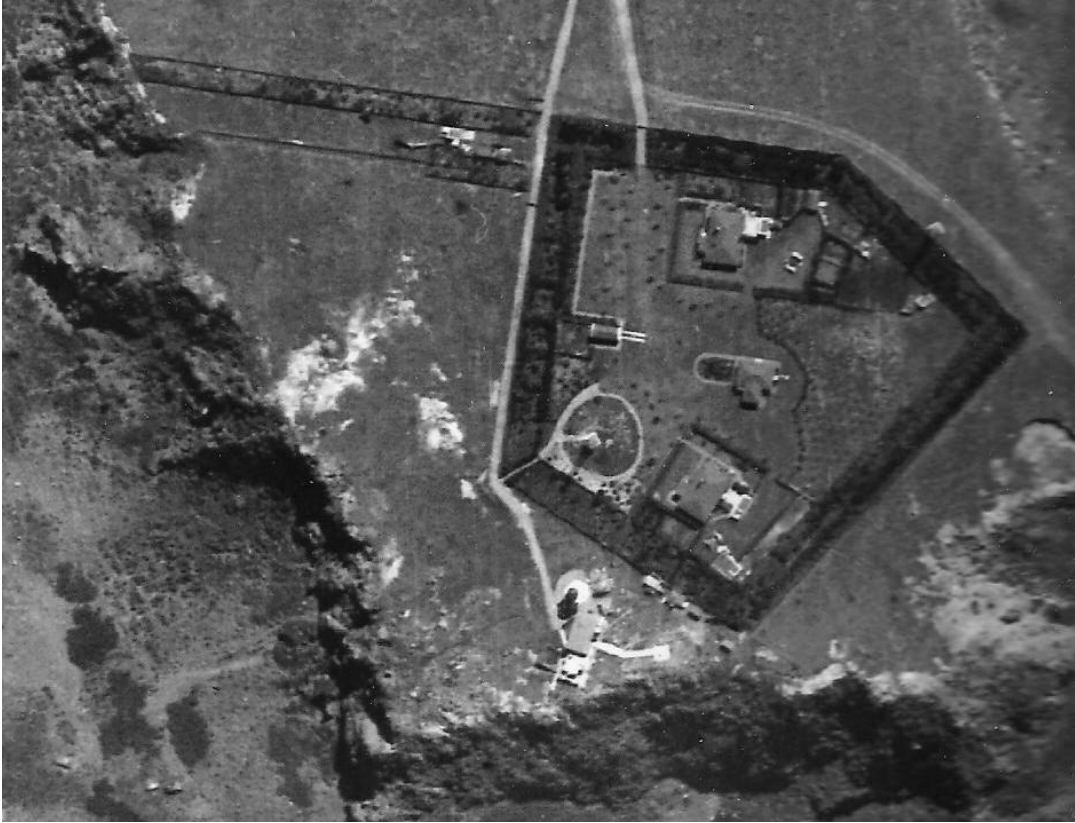
Fig. 2. Baring Head lighthouse reserve area 17 February 1941. North is to the top. Crown copyright photo New Zealand Aerial Mapping no. 24773. Note the waste rock at the foot of the cliff below the signal mast platform.

This information allows the true scale of the vertical photograph (17 February 1941) (Fig. 2), purchased for this project, to be determined and from that mapping of the position of original features. In addition the GPS points will allow the plan to be registered on the regional council GIS system.

Immediately south of the lighthouse, the 1941 photograph (Fig. 2) shows a grey-roofed building about 12 x 4.5 m in plan, probably a barracks.

In the 1941 aerial photograph, the south end of the concrete platform has a wall which is casting a distinct shadow. On the pad as we recorded it, there is a 100 mm wide concrete sill across the southern edge with light inset bolts and short lengths of returns on either side. Inside the returns in the concrete are shallow channels or gutters so that the pad would drain, i.e. there was no enclosed building over the pad.

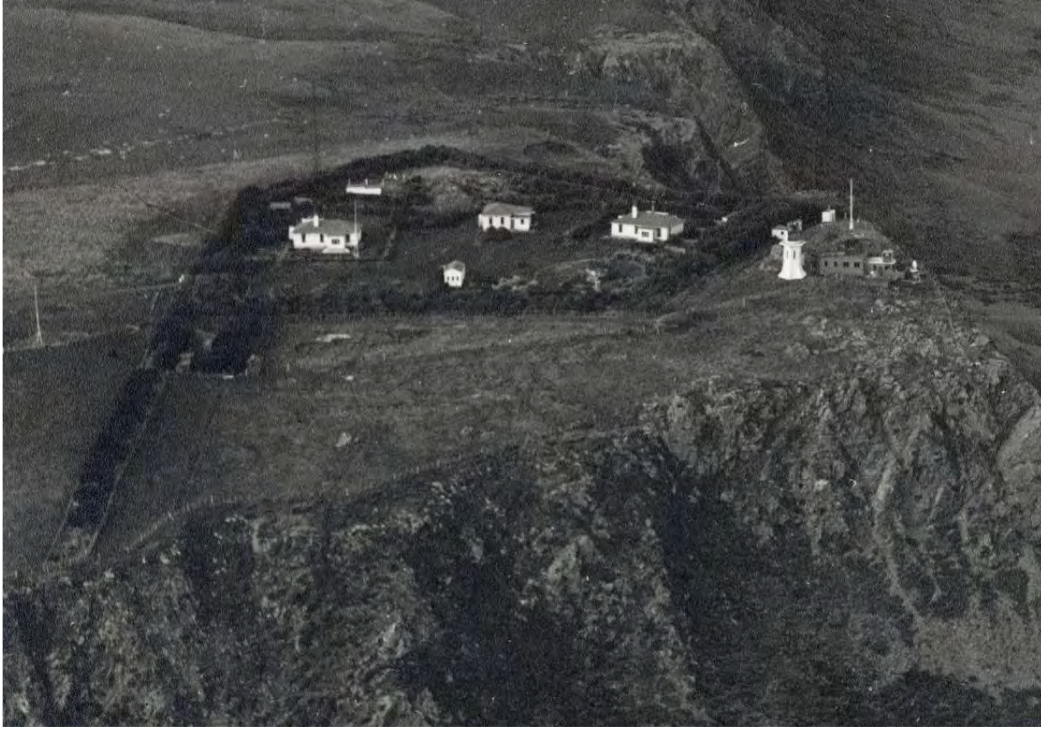
Fig. 3. Detail of Whites Aviation aerial oblique from the west. The date is estimated to be in the 1950s. Some salient features deserve note: 1) radar hut with possible aerial and barracks by the light, 2) signal mast, 3) signal hut (left of the mast)? 4) both no. 1 and no. 2 houses have small third bedrooms off the entry hall, 5) the second (WAAC?) barracks has been demolished. Courtesy National Library/National Archives ABPL W5221.

The radar building can also be seen in the 1950s photograph (Fig. 3). There appears to be a radar transmitter and aerial still on the roof. The adjacent barracks is also visible in that photograph.

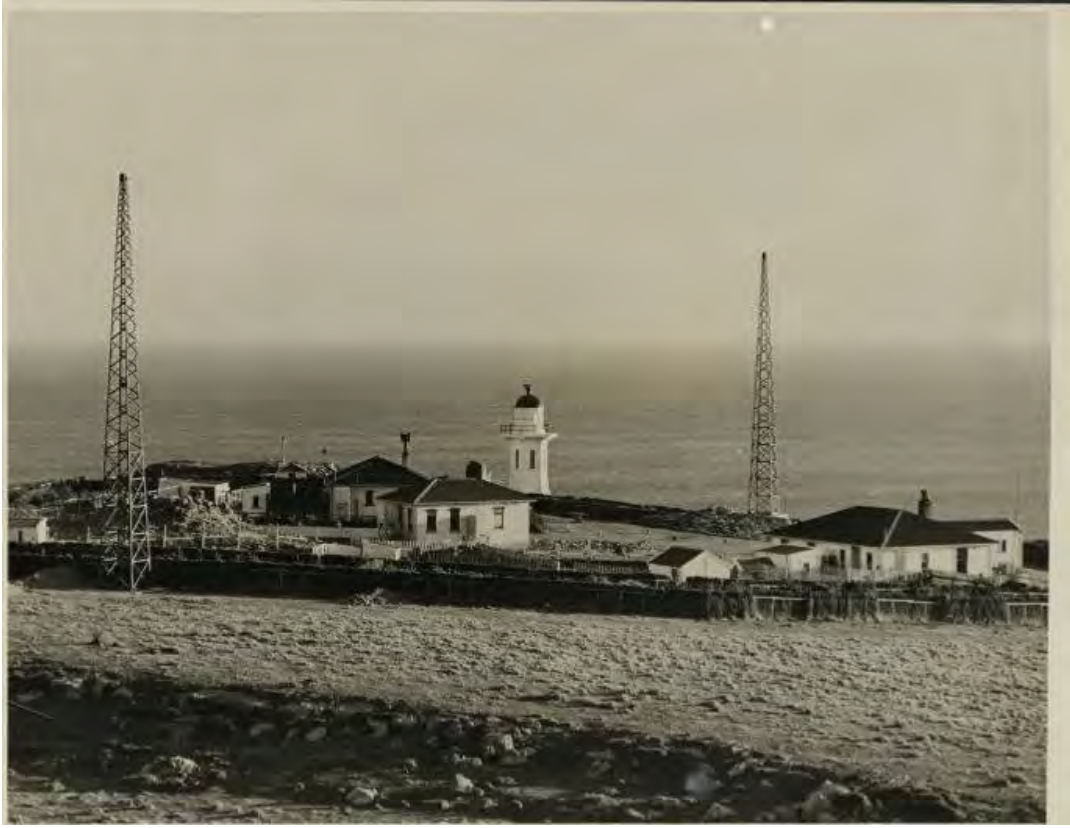
Fig. 5. A view from the north-east, 1937. National Library of New Zealand

Figures 5 and 6 show oblique views of the lighthouse taken six decades apart.

In 1937 the lighthouse settlement was surrounded by two lines of approximately 2-m high post and rail fence or post and wire forming a corridor about 7 m wide. The two lines of fence had chain-link wire netting or wire laced with manuka bundles to stop the wind. By 1941 there was a distinct dark area of tall grass and shrub and tree plantings in the corridor (see Figs 2 and 5). There seems to have been interior cross fences as well, creating cells about 7.5 m square.

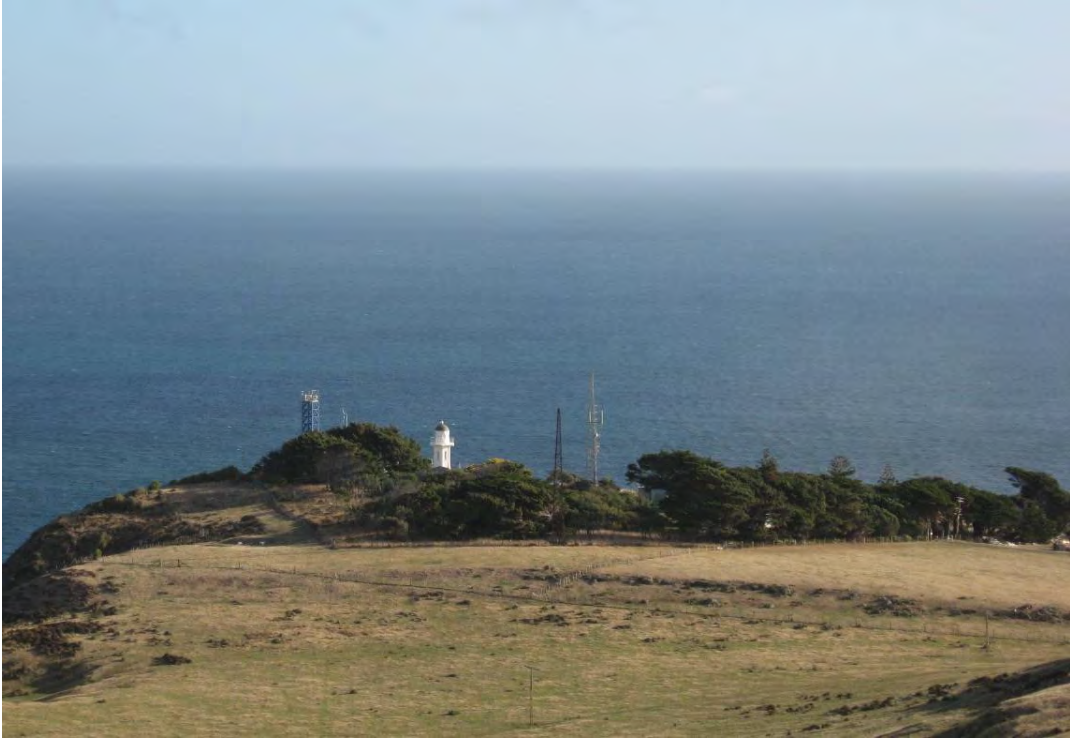
Fig. 6. Similar view May 2010.

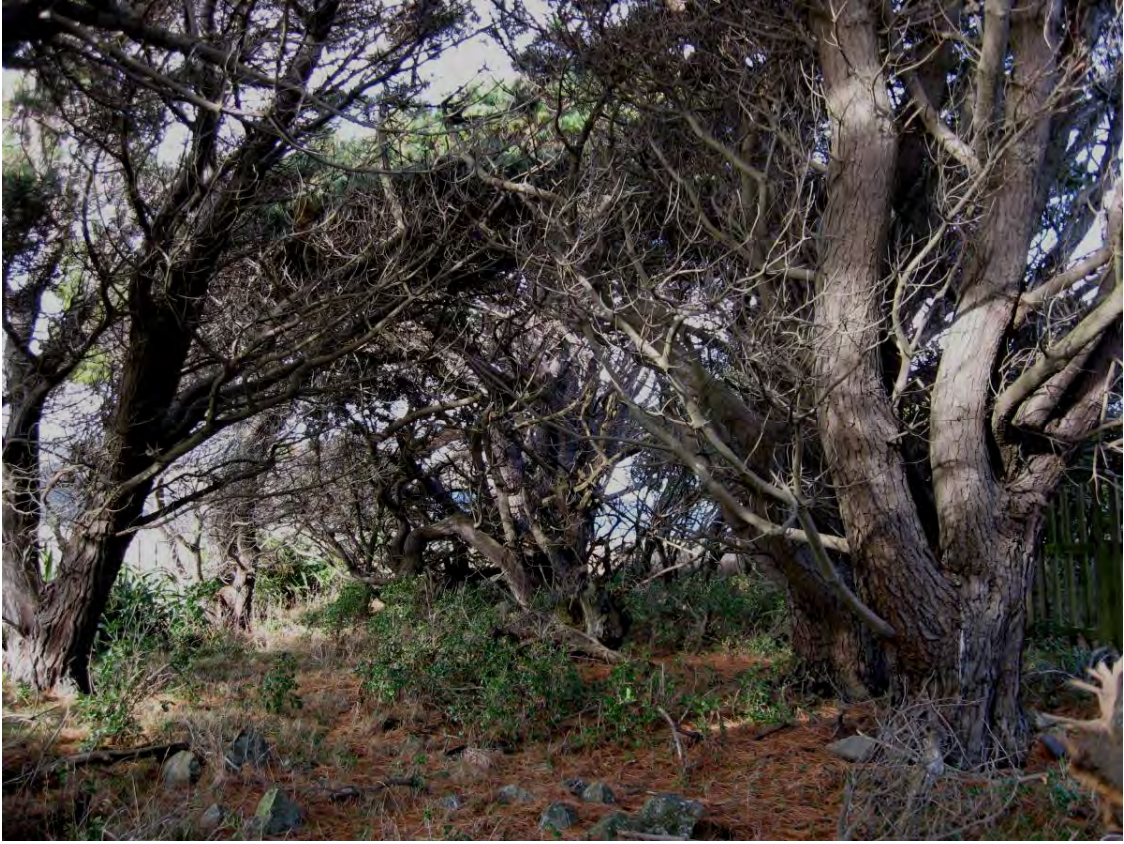
Fig. 7. Open *Pinus radiata* treeland with taupata and flax understorey in northern part of shelter belt. The trees are over 70 years old.

Tree species which appear to have been planted in 1937 and which have survived as an open tree land were macrocarpa (including a golden cultivar), *Pinus radiata* and pōhutukawa (Fig. 7). Norfolk pine may have been planted later. Significant specimen trees that survive today, such as the macrocarpa specimens, can be detected in the 1941 aerial photograph.

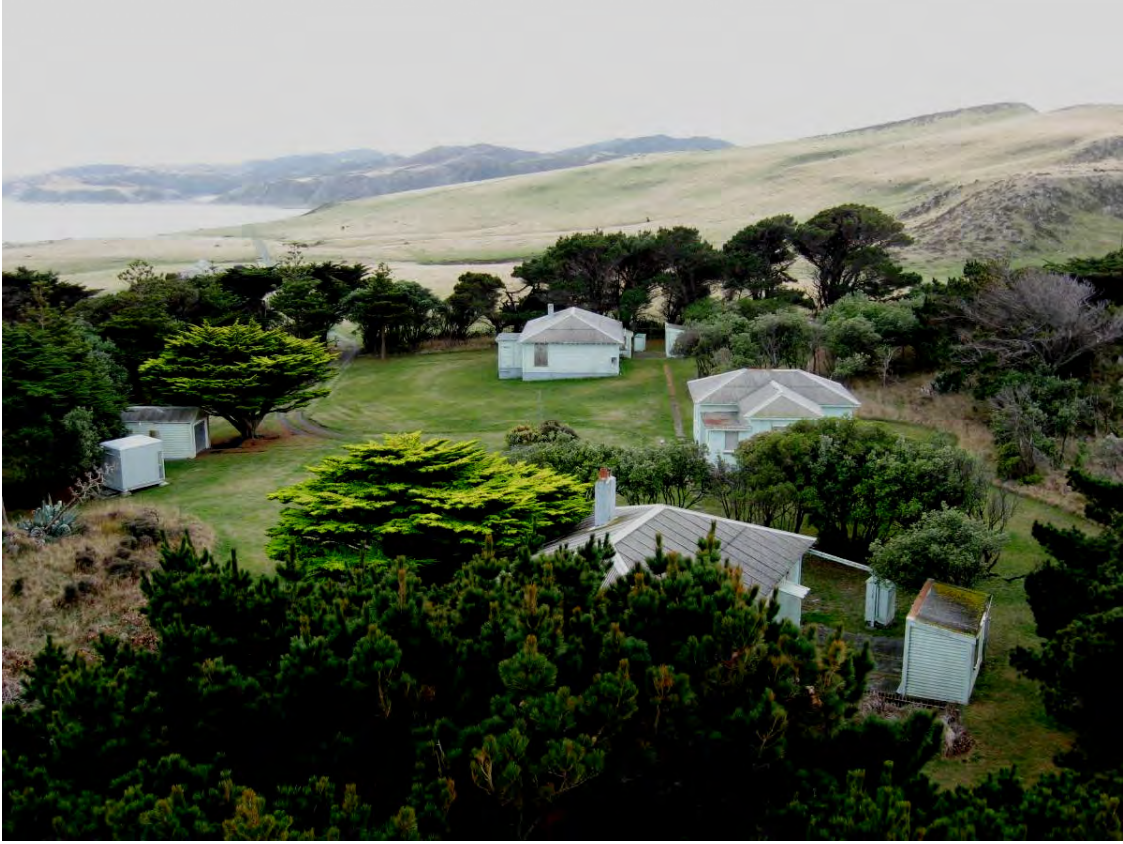
Fig. 8. Keepers' houses and the generator (power) building (centre right) from the south. The garage is at left.

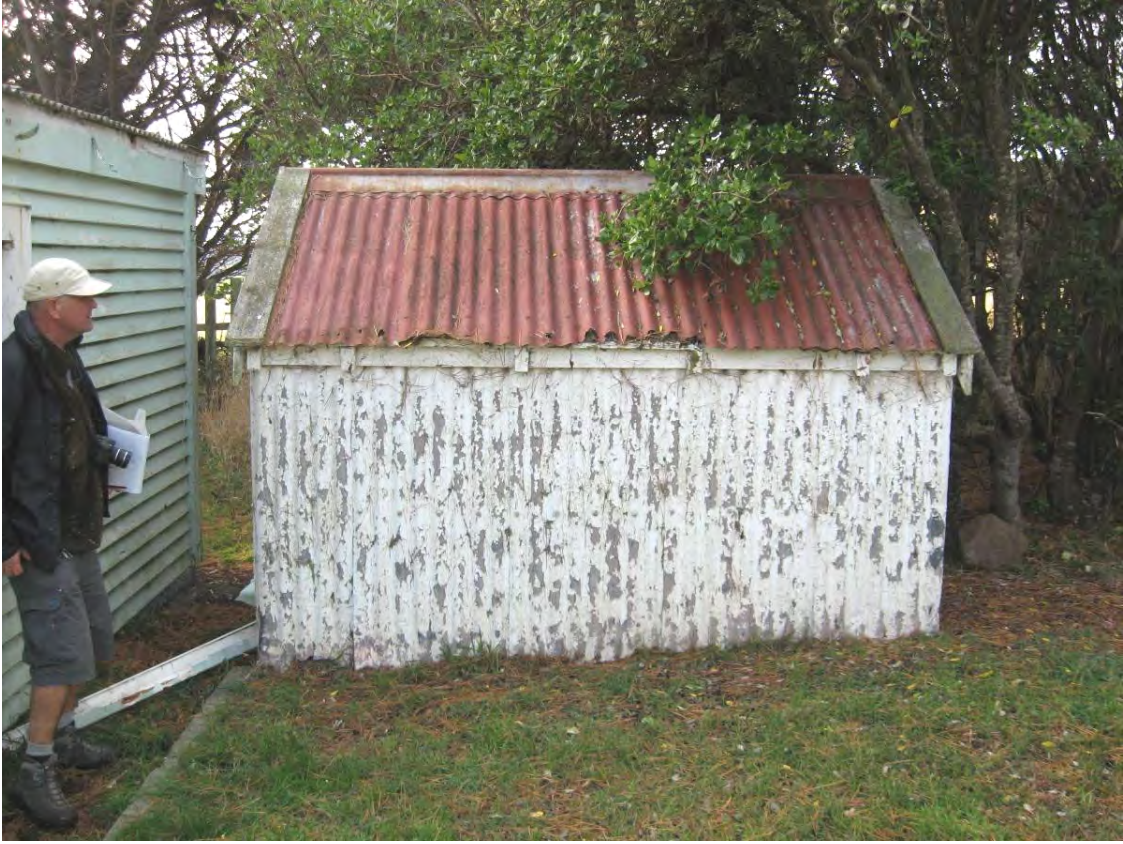
Fig. 11. The Marine Department type store behind keeper's house no. 2.

There is a small Marine Department type storehouse behind the no. 2 outhouse (Fig. 11); this is lined with dressed timber inside and clad with corrugated iron. It may have been

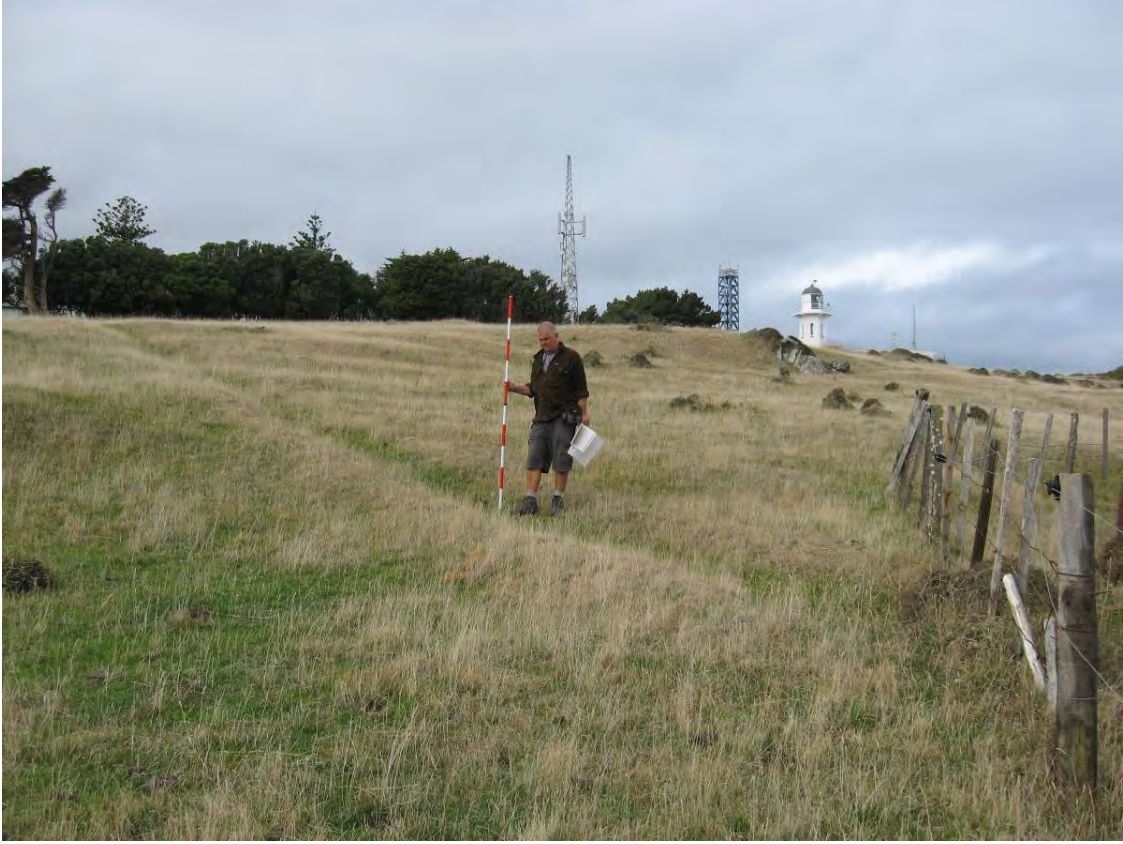
Fig. 12. The drain from the no. 2 keeper's house.

Waste water and possibly sewage from the no.1 house was piped south-east to the southern cliff edge. The no. 2 house was piped downhill west to the western cliff where there is still a substantial trench (Fig. 12).

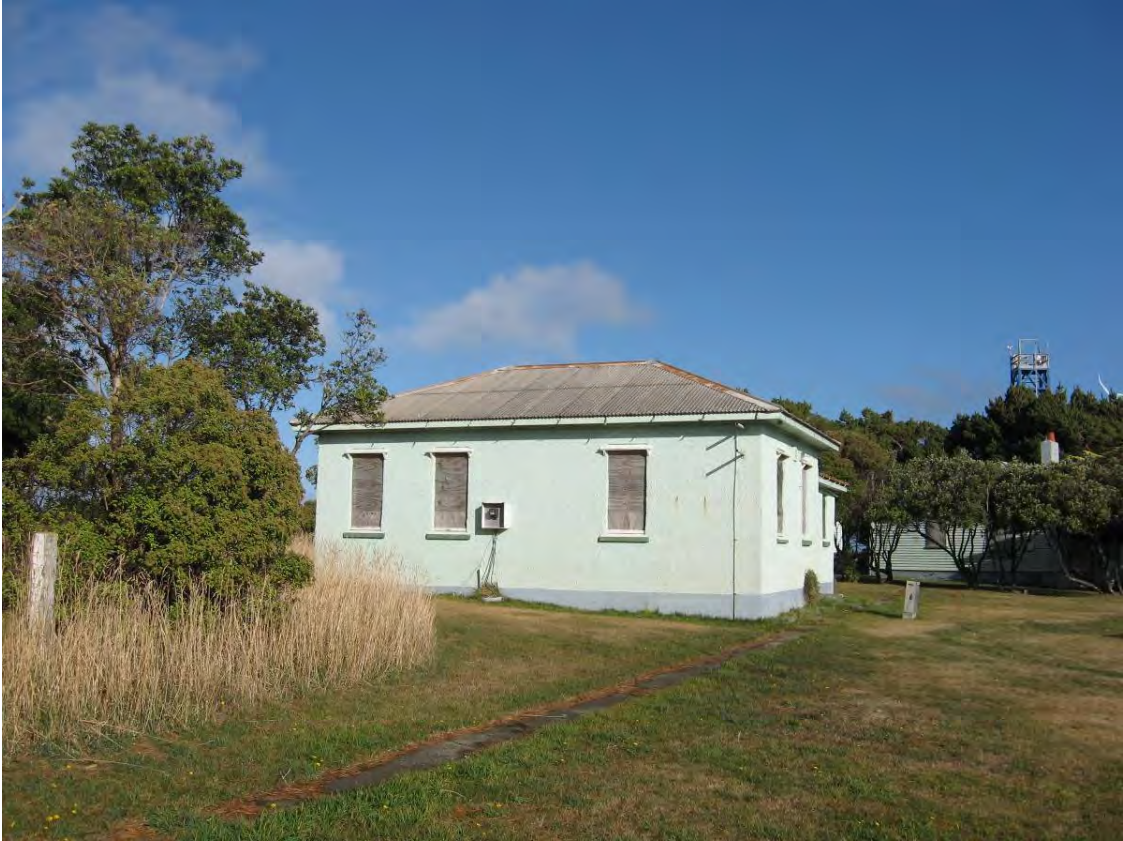
Fig. 13. North elevation of the concrete generator building. Note twin galvanized pipes under the eaves (upper right) which may have held a bracket for the feeder wire to the radio antenna.

room (another reason for disguising/camouflaging it as a keeper's house). There is a twin galvanised pipe bracket on the northern elevation (see Fig. 13) which may have secured the lower part of the feeder wire. Figure 19 shows part of the 1936 plan for the antenna.

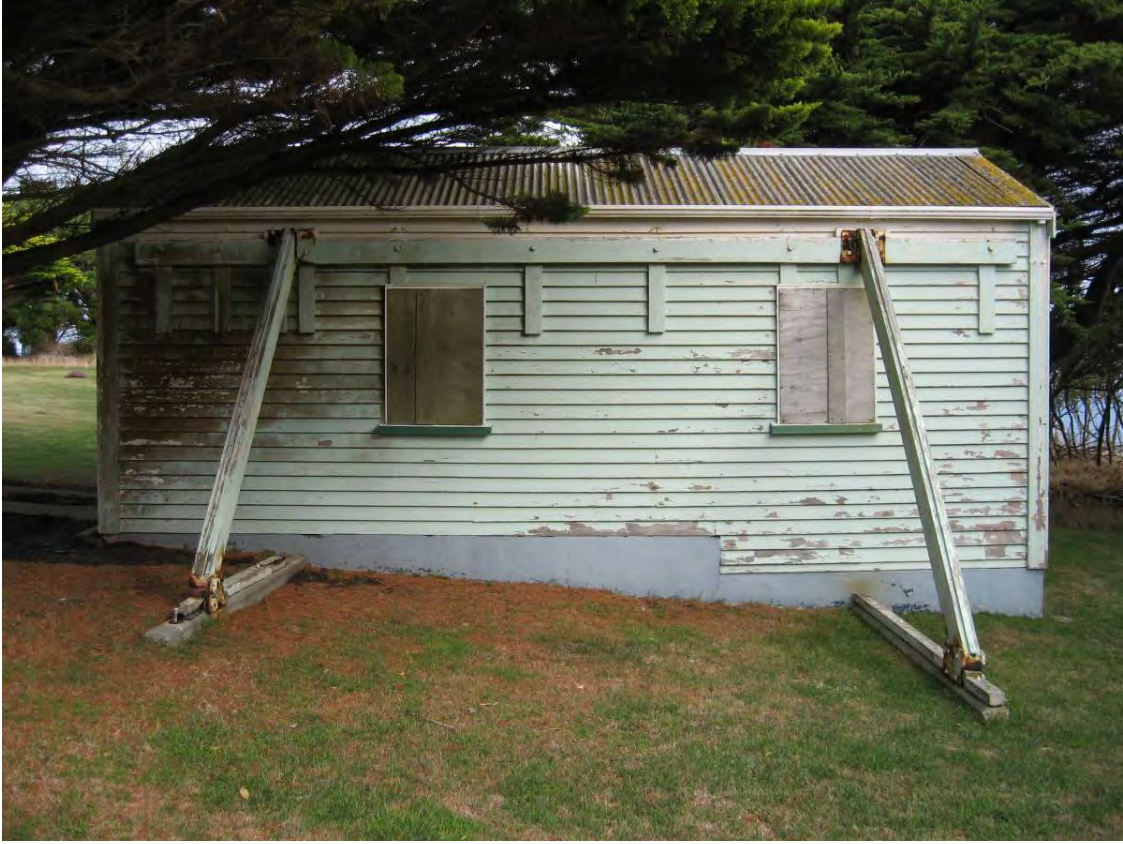
Fig. 14. North elevation of the garage with later buttresses.

The weather board *garage* has two substantial bracing timbers on the northern side (Fig. 14).

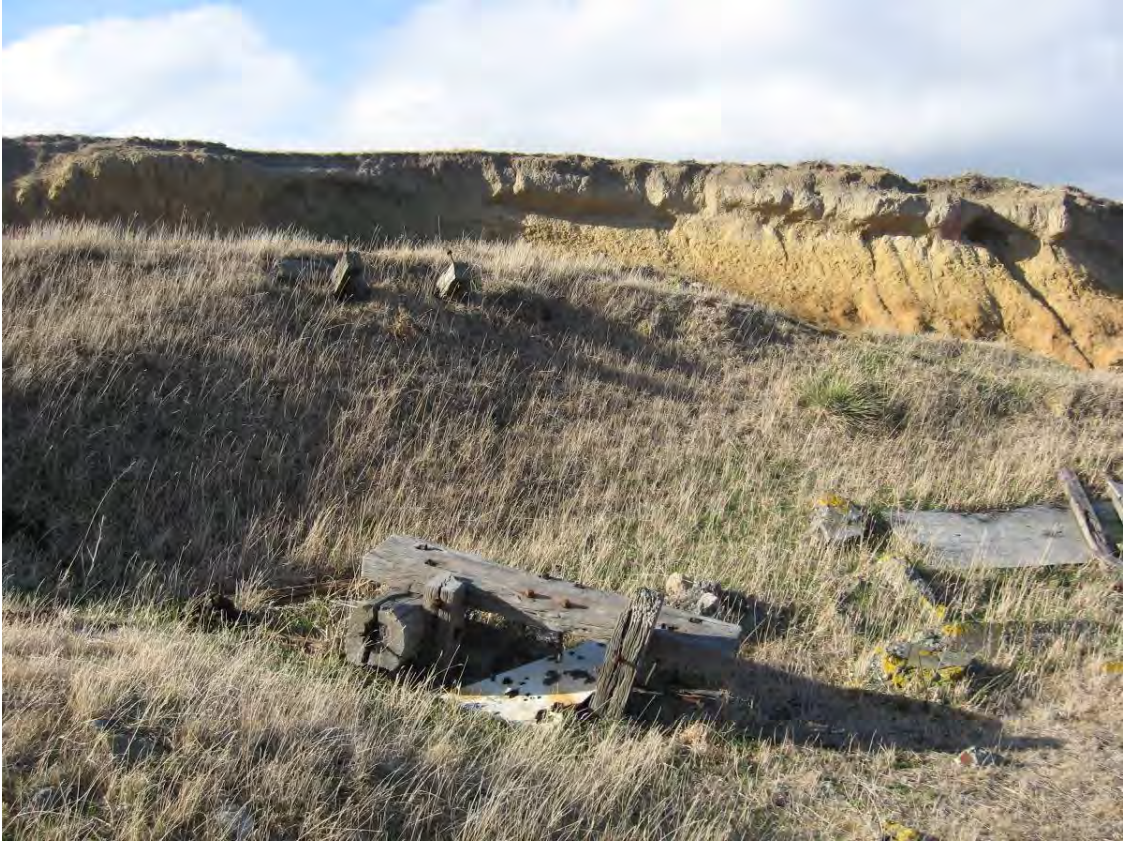
Fig. 15. The quarry area with wooden relics and bracing timbers.

There is an oval area about 12 x 6 m of excavation and levelling at the cliff edge 100 m east of the keepers' no. 1 house (Fig. 15). There are large sections of bolted hardwood including some bracing timbers on the surface. This area is at the head of an open gully with an even, steep slope to the beach below.

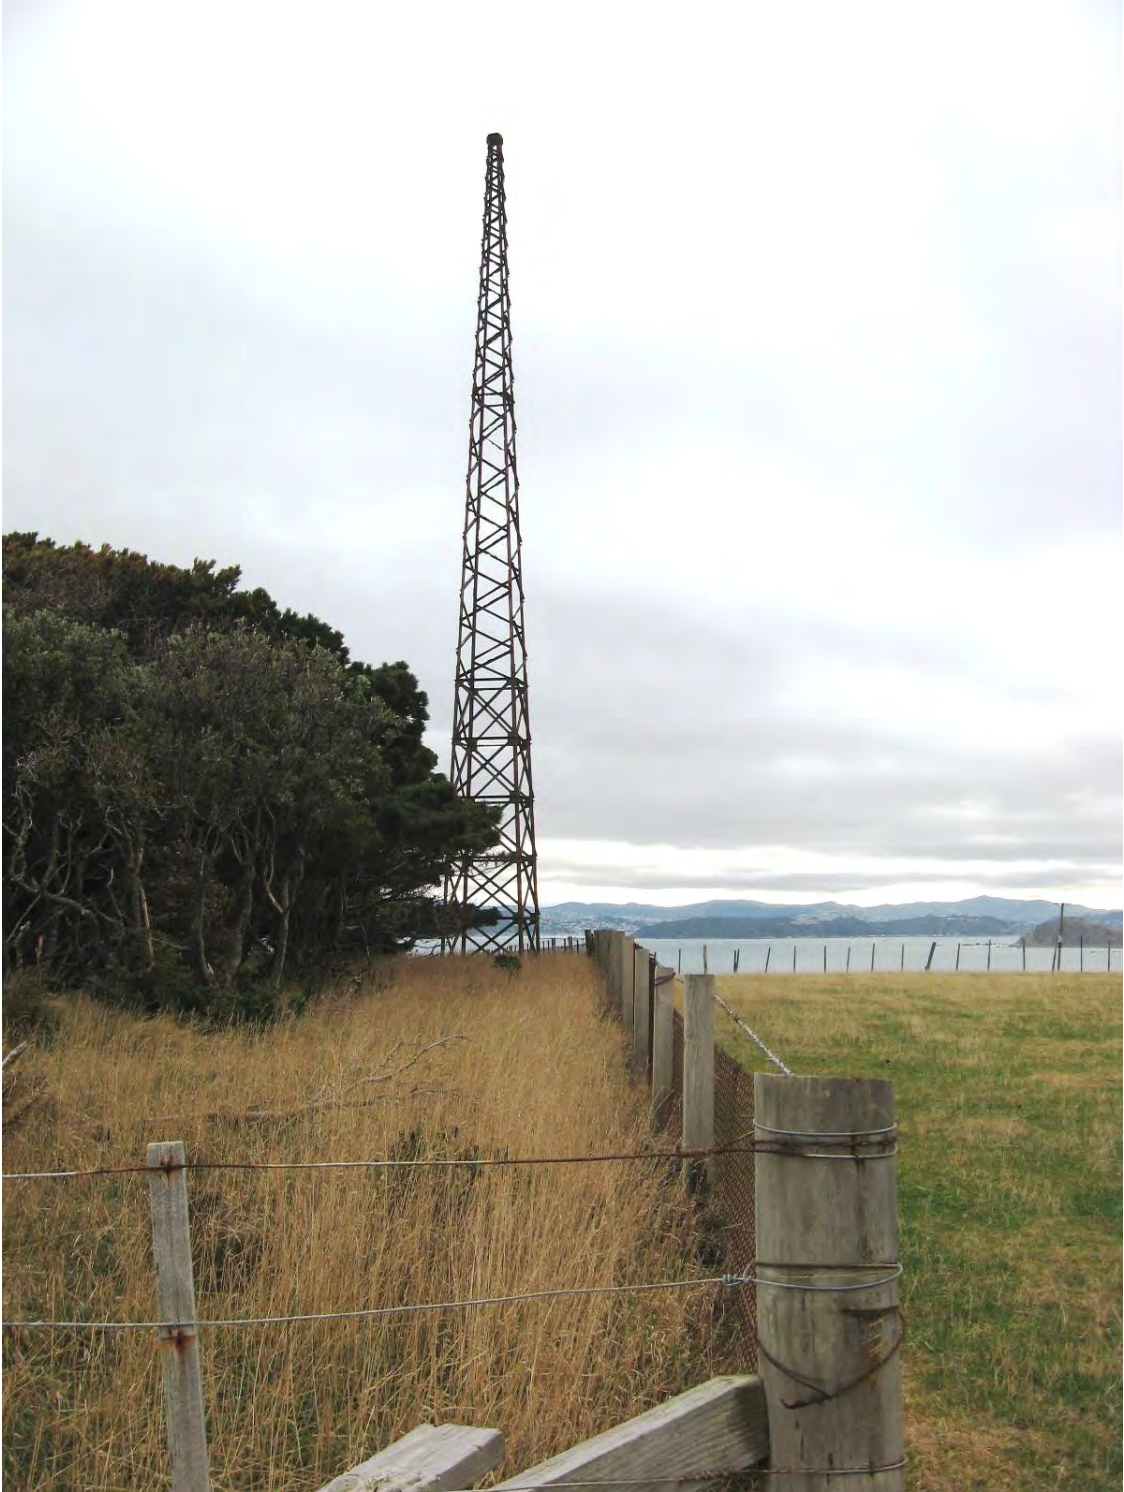
The south-western mast is maintained and painted. The north-eastern mast is visibly rusted at many of the bolted joints and also on the concrete base which needs to be kept dry and clear of soil, grass and encroaching vegetation. The stability of this mast needs to be reviewed. It is unclear as to whether it is in the reserve area or in the adjacent land.

Fig. 16. The north-east aerial mast.

6. Detailed safety check and maintenance schedule for the north-eastern radio mast which appears to be badly rusted; it also needs to be determined whether it is in the reserve area.

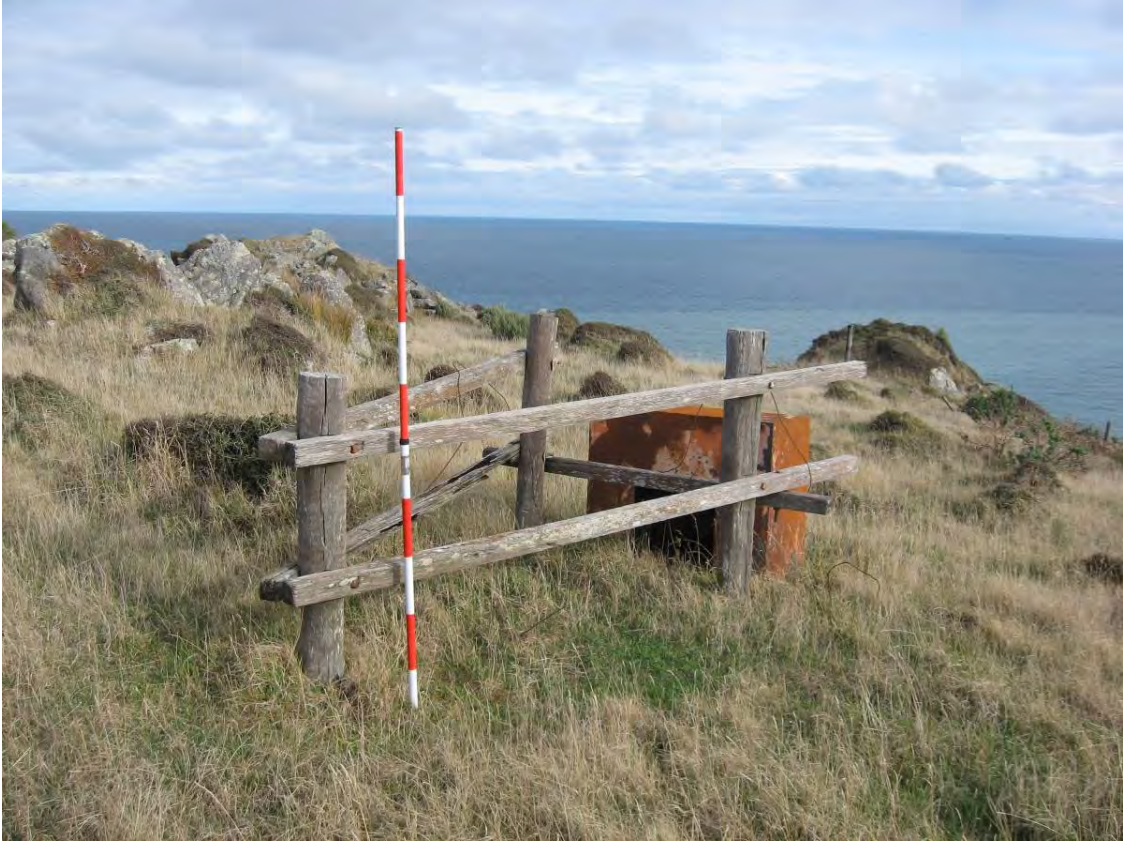
Fig. 17. The winch with the wing fence to keep stock away from the tensioning cable running across the top of the south-west mast to the Marconi T-antenna positioned between the masts.

Overall, this arrangement may be interpreted as: (1) a semi-static stay with counter-weight holding the cable over the north-eastern mast and (2) a live tensioning cable over a pulley or pulleys (the pulley shafts are still visible) atop the south-western mast to raise and lower the aerial.

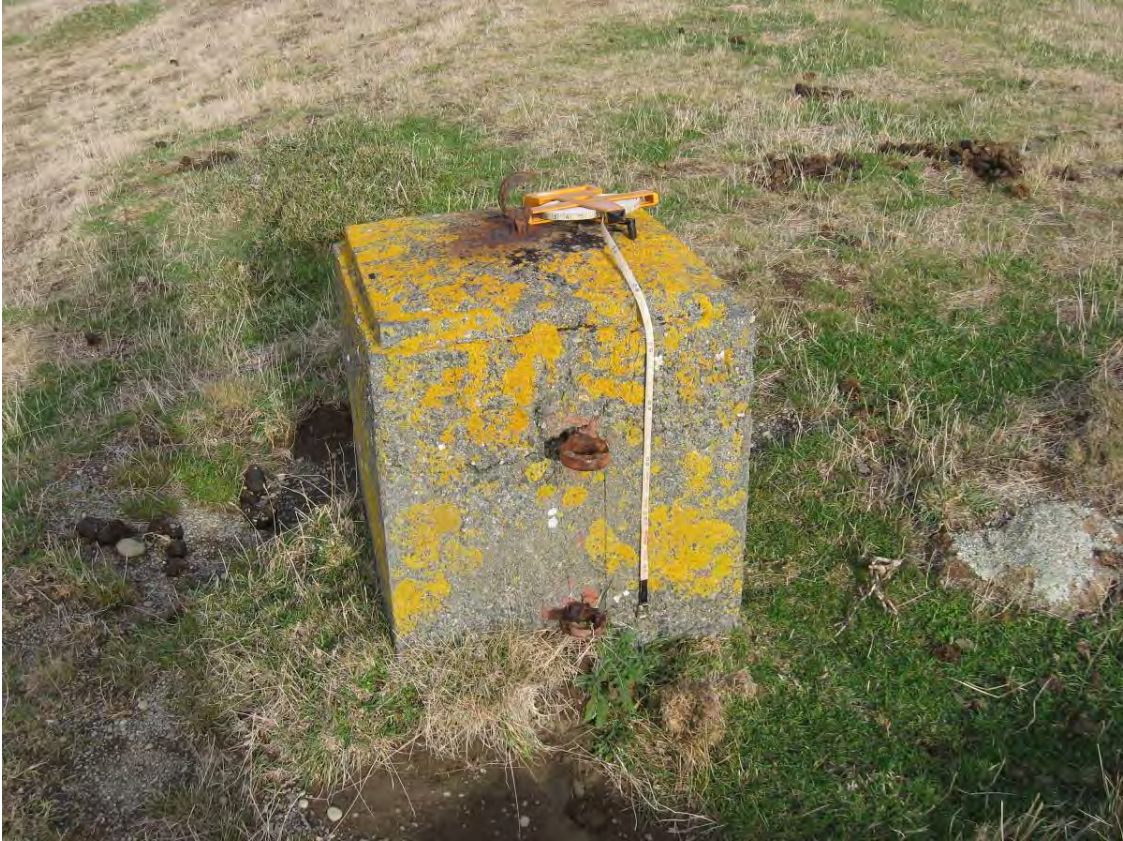
North-east of the north-eastern mast and about 25 m from the fence is a concrete block counter-weight (weighing about 500 Kg) and two *galvanised anchor stays* (Fig. 18). The cable from the aerial came down to a steel bracket (held by the stays) from which the counter-weight was suspended. South-west of the south-western mast is a *winch* with galvanised wire cable and a distinctive acute-angled wing of post and rail fence (presumably to keep stock from rubbing against the tensioning wire). There seems to have been no lateral stays to the towers.

Fig. 18. Concrete counter-weight for the static tensioning stay to the north-eastern mast. It was originally suspended in a steel frame (see Fig. 19).

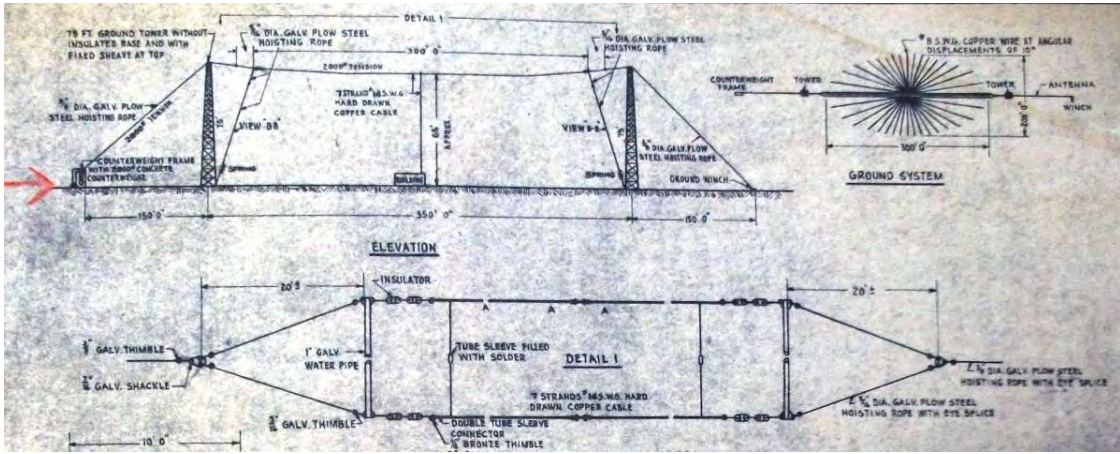
Fig. 19. Masts and Marconi T-type antenna as designed (P. and T. Department W.6649 A, 19 August 1936).

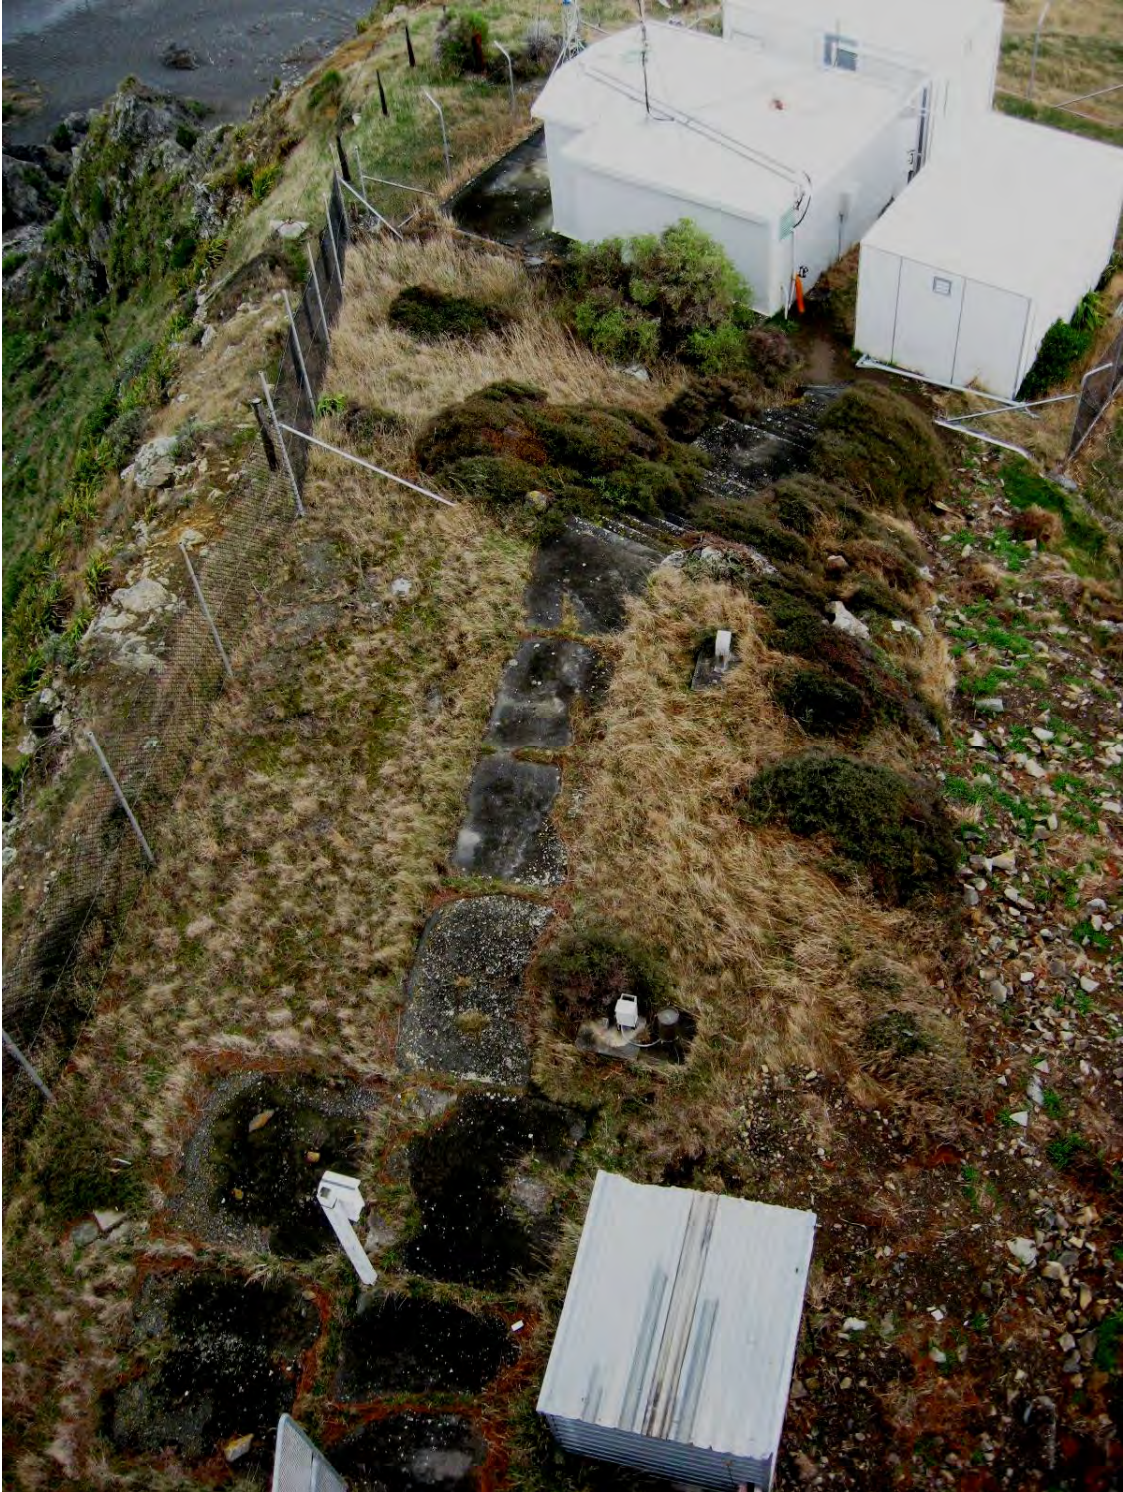
North of the lighthouse and within the fenced NIWA compound are a number of concrete structures. The 1941 photograph shows steps rising to a natural mound, a path and a square platform in a bright colour (new concrete) to the south-south-east of the lighthouse. This feature is still extant with two flights of 1.2 m wide steps and a path ('1939' marked in the concrete) which leads to a concrete platform overall 4 m square made up of four 2 m-square pads (Figs 20, 21).

Fig. 20. The signal platform (at bottom), path and steps dated 1939 and the concrete radar building centre top. The WW II barracks would have extended out to the right where the near NIWA hut stands.

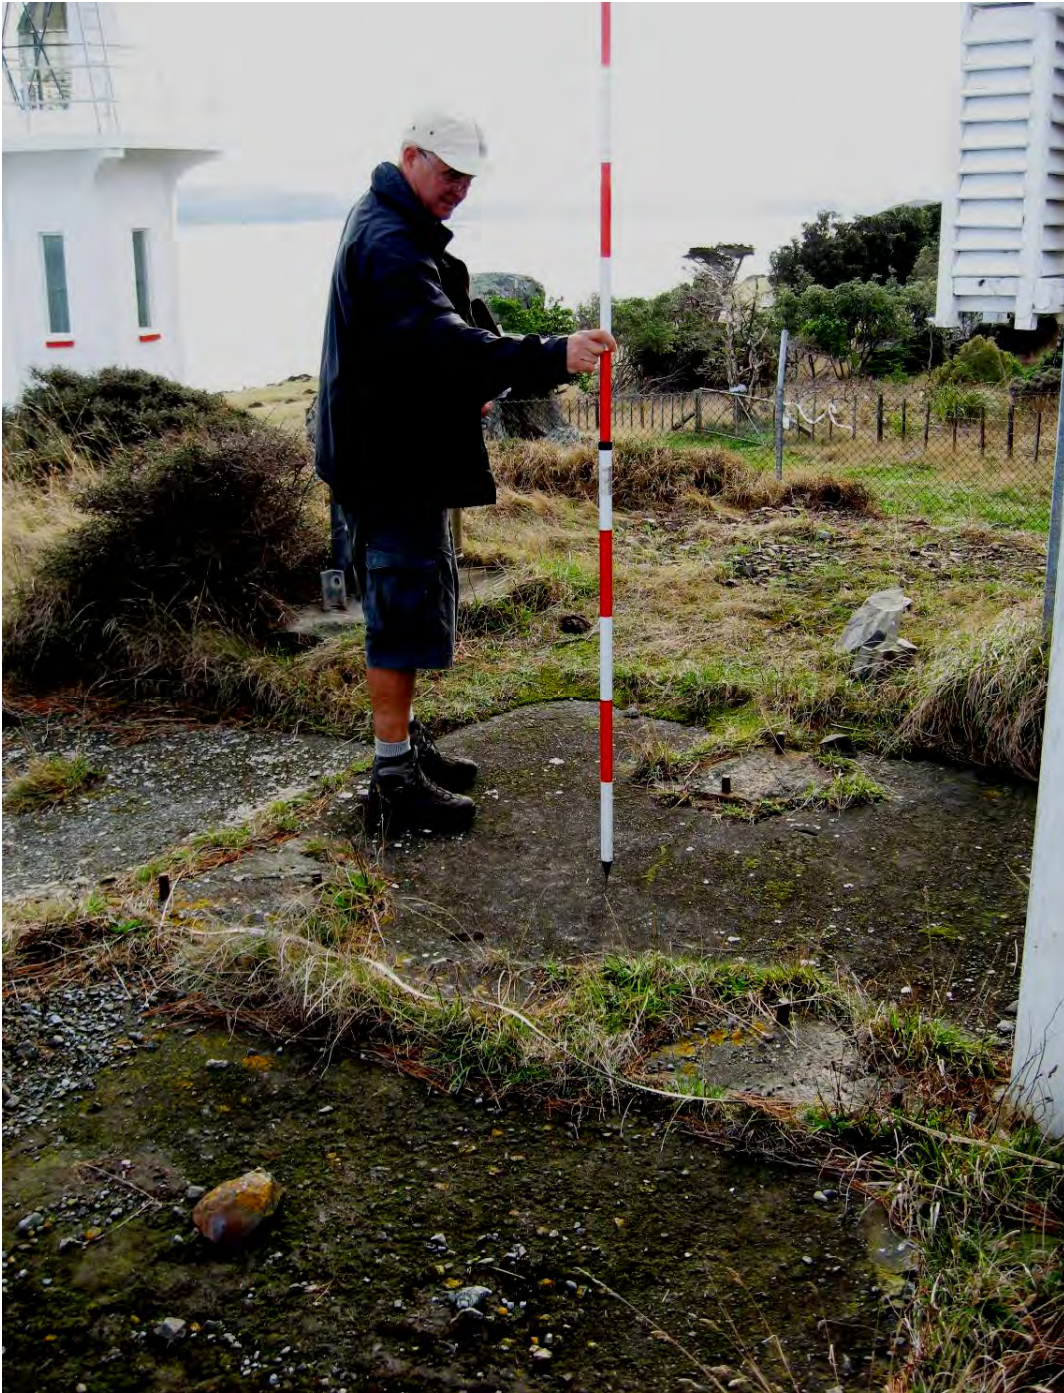
On the north-eastern pad are three sets of two 7/8-inch bolts set in a radial triangular pattern with an impression on the concrete surface of a short length of steel RSJ held down by the bolts. This is probably the ground bracket for the white-painted steel or wood *signal mast* about 12 m tall with crosstrees which can be seen in Figure 3.

Fig. 21. The radial arrangement of bolts for the brackets holding the signal mast.

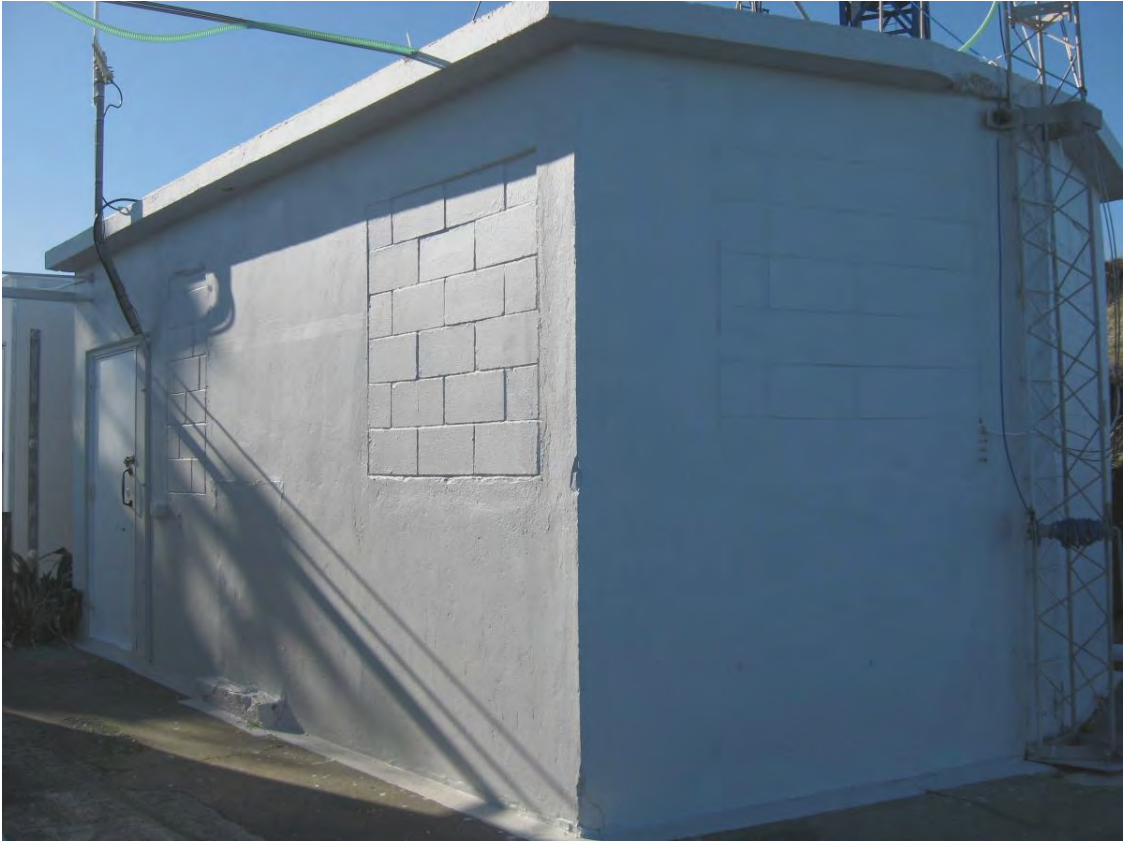
The porch-like extensions survive as: 1) a foyer/storage area on the east of the NIWA lab and 2) a section of truncated wall base on the west side. The north end of the concrete building has been infilled with sheet cladding and may have connected to the wooden barracks to the north.

Fig. 23. The WW II radar building from the south-west with the blocked-in bow window and other window apertures.

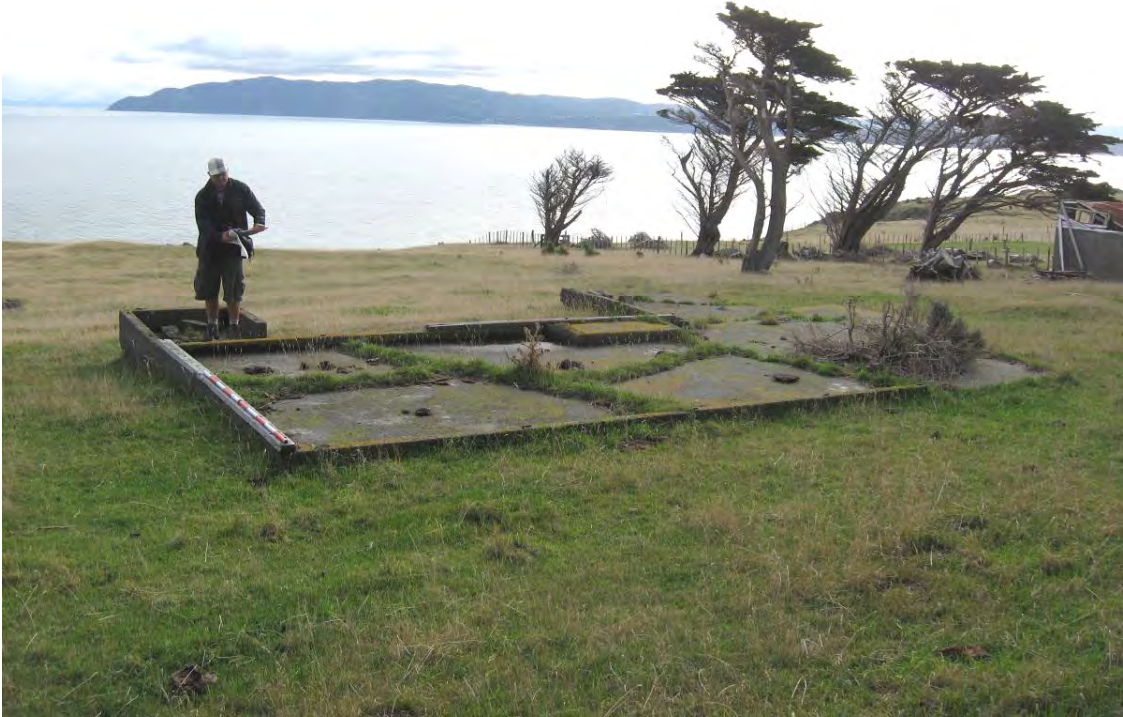
Fig. 25. Foundations of the WAAC barracks, western extension of shelter belt beyond Sinclair Head and western Cook Strait in the distance.
