**To:** Te Awarua o Porirua Whaitua Committee

**Date:** 21 March 2018

## **Wastewater Network Activities in Kenepuru Stream Catchment**

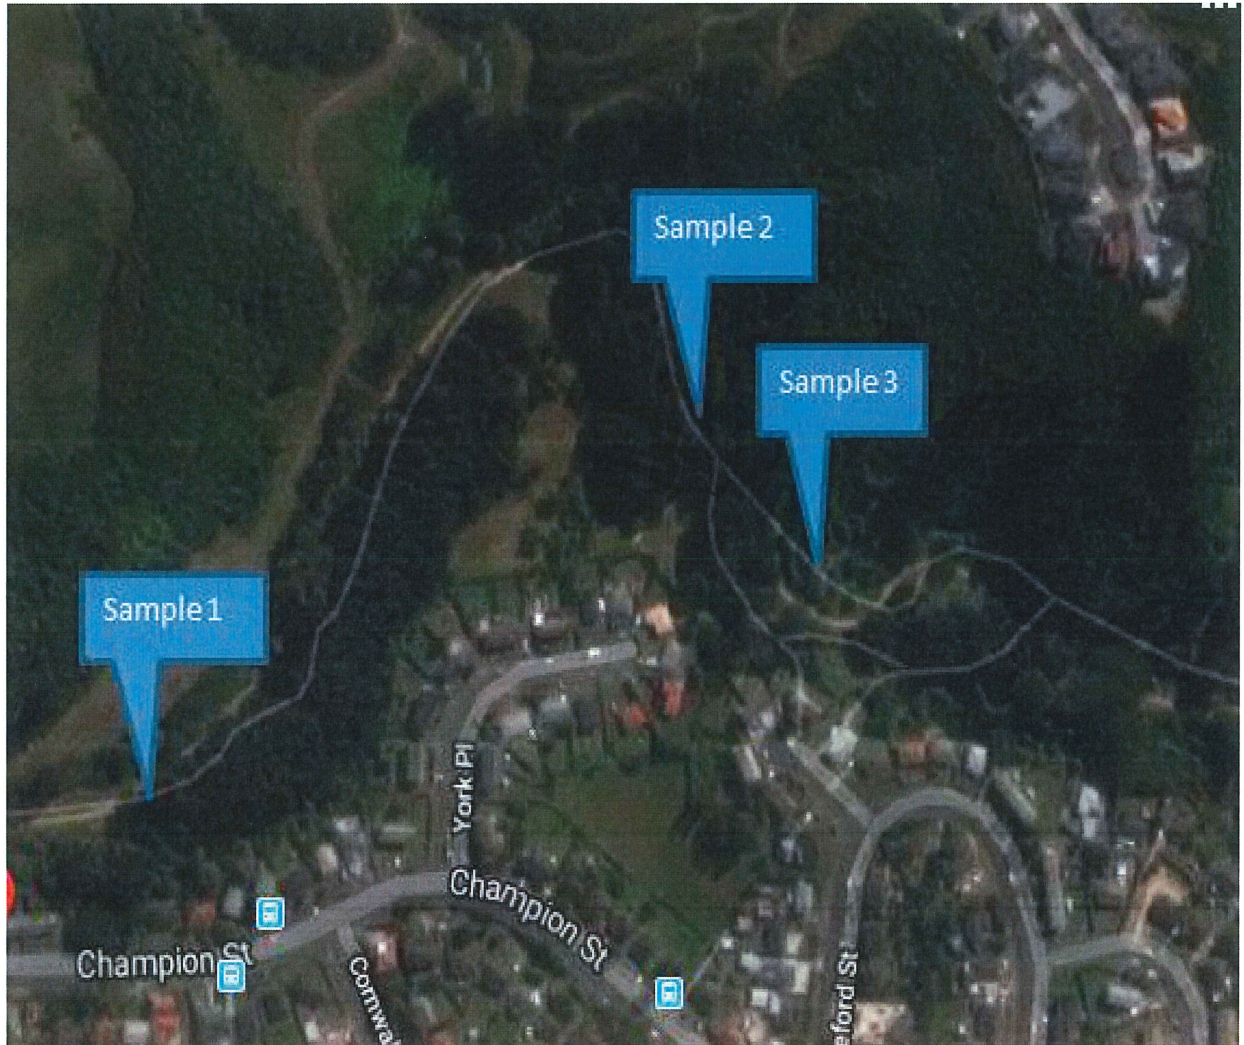
## WATER SAMPLES IN KENEPURU CATCHMENT, 31/01/2018

This paper comes as a response to the Committee's Bothamley Park field trip on 14 December 2017 where Committee and Te Awarua o Porirua Whaitua Project Team members noted significant sewage odour from the Kenepuru Stream catchment. In response and with Greater Wellington Regional Councils' support, WWL undertook visual and odour inspections as well as sampling at seven (7) sites within the Kenepuru Stream catchment – the sampling results are provided at Appendix A.
