HUTT RIVER FLOODPLAIN MANAGEMENT PLAN

phase 1: HUTT RIVER FLOOD CONTROL SCHEME REVIEW

HUTT RIVER

CHANNEL MANAGEMENT

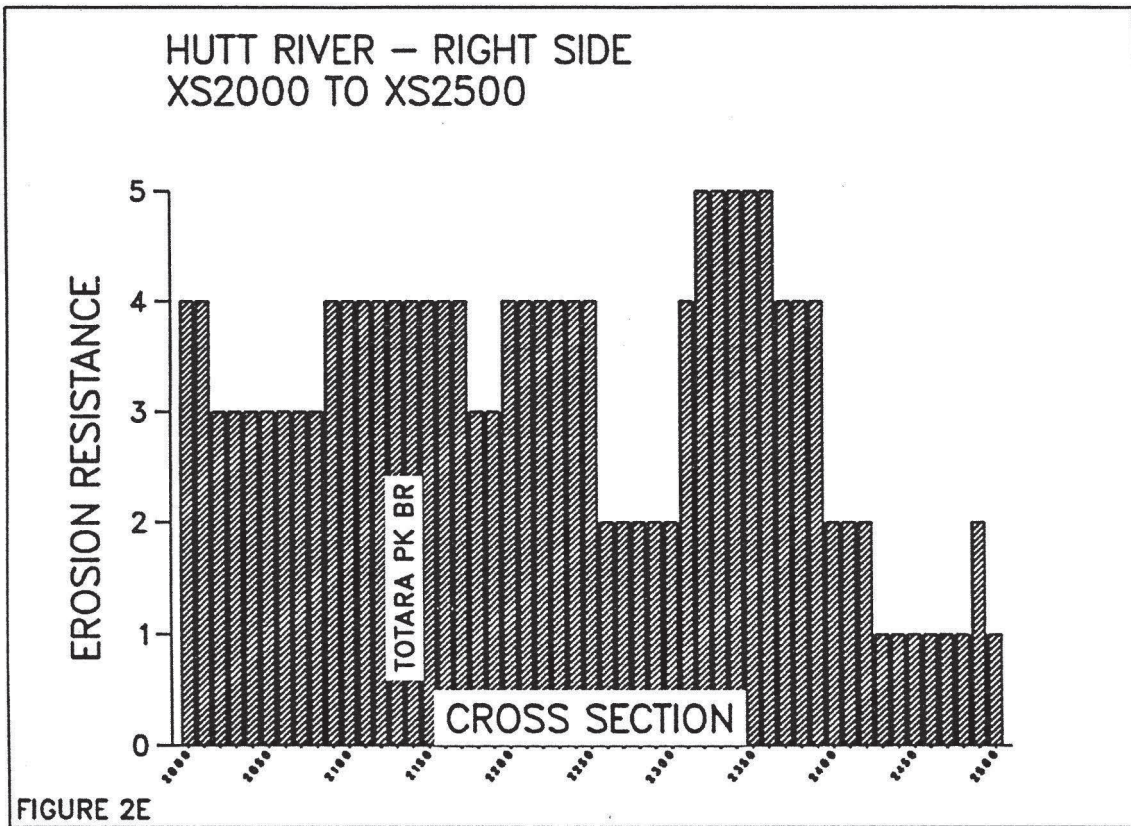
EROSION RESISTANCE STATUS

qualitative assessment, of the likelihood of the eroding away of the berm under existing conditions. Where flood defences exist this is equivalent to the likelihood of flooding due to eroding away of the flood defences.

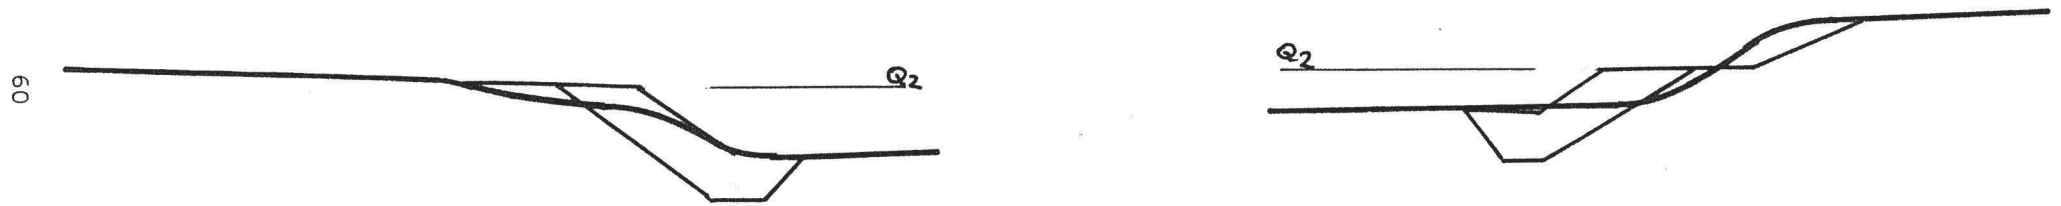
DESIGN CROSS-SECTION

REPRESENTATIVE ACTUAL CHANNEL BANKS

MINIMUM DESIGN CHANNEL
